Investigations into Mechanisms of Involvement of Objects and Personnel in Lightning Disasters

Abstract: Cloud to ground lightning causes damage to objects and injures people by different mechanisms like direct hit, contact voltage, side flash, step voltage etc. Understanding the different ways of involvement of objects and personnel in lightning disasters is helpful in deciding the type and level of external protection. Details of investigations conducted in 47 lightning disasters spread over several years are presented. The different types of mechanisms of involvement of objects and personnel in these incidents are discussed. All the incidents investigated were from Kerala, India which is a region of relatively high vegetation density. In 51% of the cases objects and personnel were found to have got involved by ground conduction of lightning energy into dwellings. Some of the cases of ground conduction involvements are unusual. The high degree of damage in some of the unusual cases is attributed to the continuing current component. The role of metal objects in charge collection and dissipation is also discussed. The relative importance of ring conductor to the lightning conductor

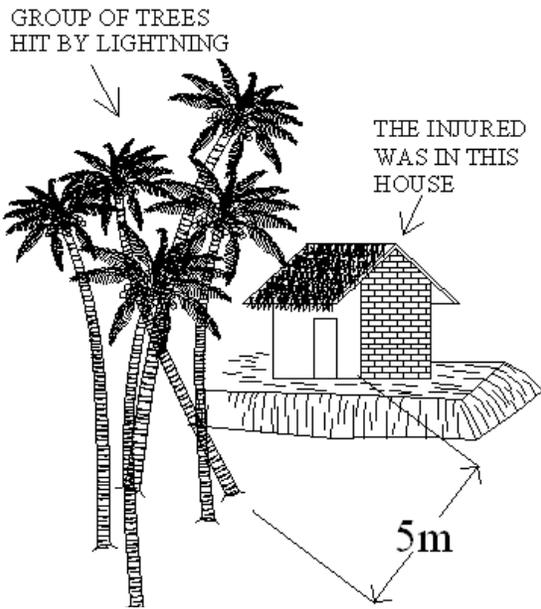
The G1 site is in an area in Kerala which has relatively more lightning incidence. Lightning seems to have hit a group of five isolated coconut trees. A thatched house which had power wiring was only 5 m away from the trees. In the accident the floor was cracked, and wiring destroyed. A person lying on the floor was injured due to step voltage between his head and feet. All the five trees were destroyed. A drawing of the site is shown in Fig. (1).

Fig. (1). Lightning accident through ground conduction from an isolated group of coconut trees to a house which had electric power wiring. Only these trees were present at the time of accident.

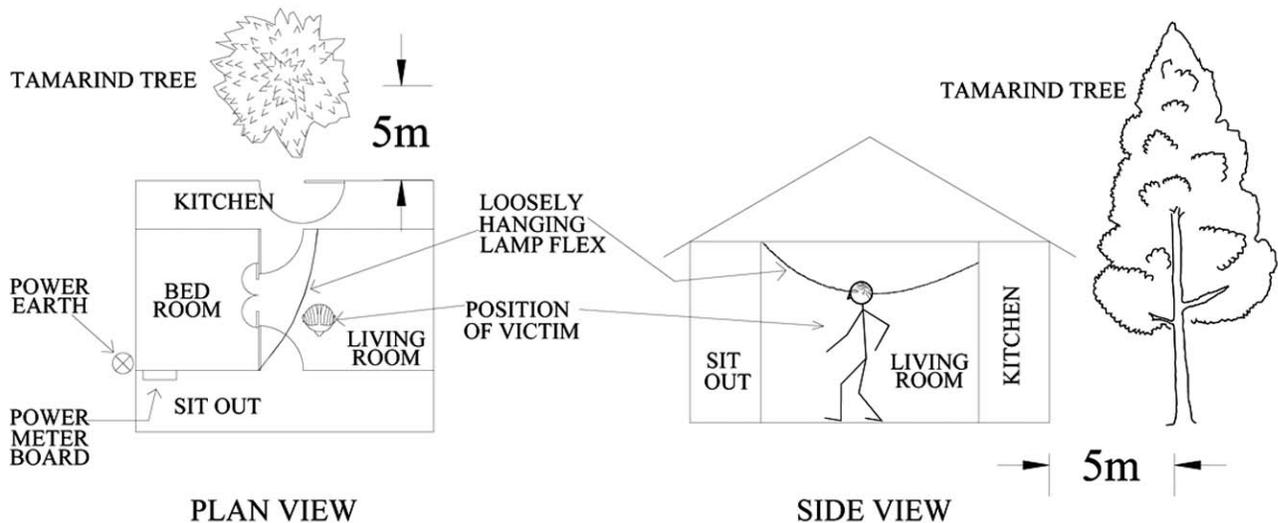
Fig. (2). Plan and side views of the G2 accident site showing the position of the victim at the time of lightning strike. Lightning hit the tamarind tree. Location of power earth is shown in plan view.

The house had electric power wiring with properly done connection from power meter board to a lamp 2 m away from it on the same wall. This was in the sit out. A second connection was given to another lamp in the living room using a thin PVC lamp flex (twisted pair) wire. This wire was hanging loosely to about 1.5 m height from the floor so that it could have touched any body passing by. At the instant the lightning struck, a girl was moving with a pan of water and was near the hanging wire. The wire exploded involving the girl by flashover. The possibility is that the energy spreading by ground conduction got connected to the wiring through the girl to the loosely hanging lamp flex. Through the lamp flex the lightning energy must have got connected to the power earth through the power meter board. Between earth connection and phase or neutral there must have been another flashover or insulation breakdown. In other words a significant component of the lightning discharge current must have flown from power earth and got connected to the tree through meter board, the lamp flex, through the body of the victim by ground conduction. Copper conductor of the lamp flex got vaporised and was missing. All the wiring of the house was destroyed. A 'v' shaped channel was found from the base of the tree to inside the house. The house floor was made of mud plastered with cow dung mix so that the channel of conduction could be seen terminating near the living room-kitchen door. Here the tree was not destroyed.

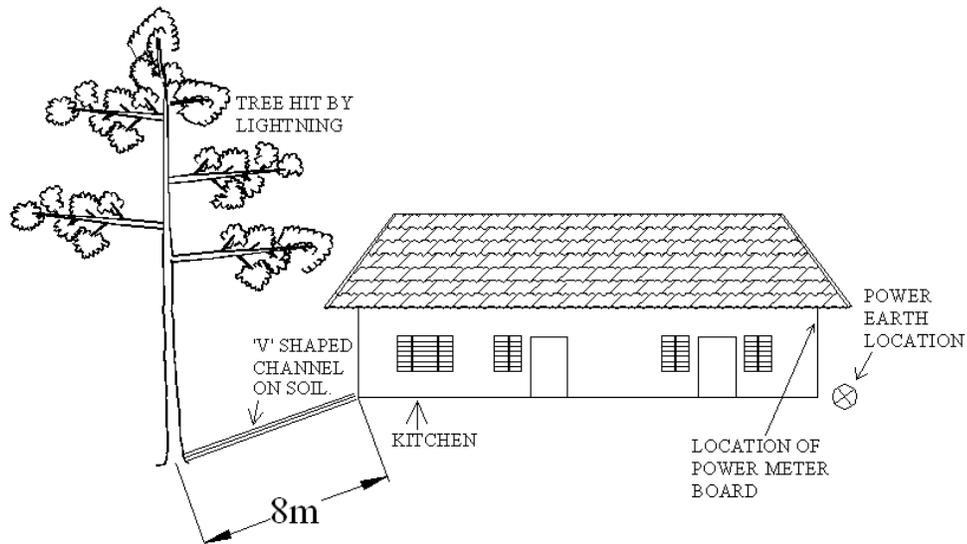
At G3 accident site also a 'v' shaped channel was seen. Here it was on the soil outside the house. Lightning struck a tall isolated cotton tree (elavu) about 8 m away from the kitchen side of a house and spread through ground conduction to the power wiring of the house and destroyed it. The power wiring could be seen opened up and the multi strand copper conductors were looking somewhat like wire brushes caused by innumerable breaks. A drawing of the site G3 is shown in Fig. (3).

Fig. (3). Side view of the accident site of G3 indicating the tree hit by lightning and position of ‘v’ shaped channel on the soil. The tree was an isolated one.

and was eating food kept on an RCC slab at a height of about 0.75 m. The RCC slab was on the wall, projecting inside from the kitchen wall. Probably the victim’s body carried one of the branches of currents between ground and the wiring through the RCC slab by contact with the slab. The tree was destroyed. The power supply connection wire and the power meter board at the other end of the house were intact.

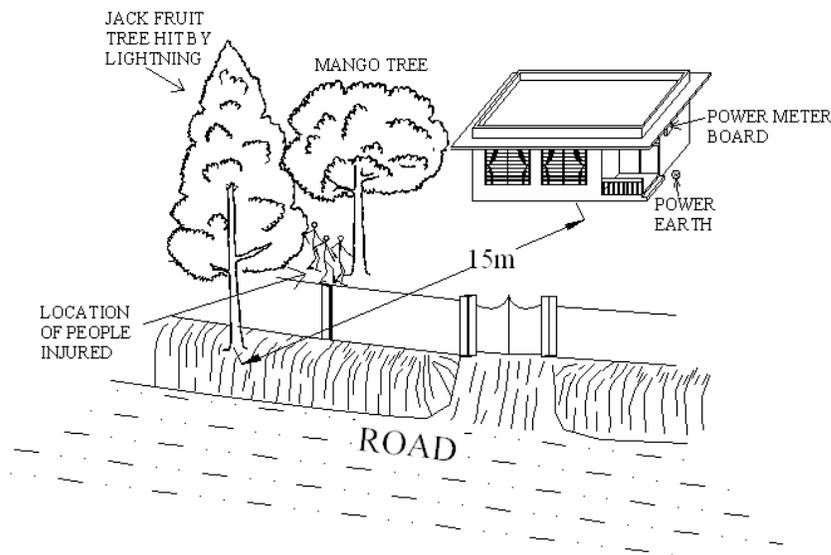
Fig. (4). A drawing of the G7 location indicating position of victims at the time the accident occurred. The jackfruit tree is relatively much taller than the mango tree. One of the injured was plucking mangoes from the tree with a pole while lightning struck.

The power wiring in two rooms adjacent to the main power meter board, main meter board and telephone network of an RCC roof house was destroyed by ground conduction of energy. Lightning it seems hit a tall jack fruit tree which was on a road side as shown in the figure. This tree was just outside the compound wall of a house. The other side of the road sloped further down. Because of this height difference and presence of road the jackfruit tree essentially was an isolated tall tree vulnerable for lightning hit. Close to the wall and inside the compound wall was a much shorter mango tree, near which were three people standing close to each other. The leaves of the mango tree were touching the leaves of the jack fruit tree. One of the people was plucking mango from the tree using a pole at the time lightning struck. All the three were injured. The one who was plucking mangoes was injured fatally. The possibility is that the mango tree was live by contact voltage from the jack fruit tree and the fatally injured got electrocuted through the pole by contact voltage from the mango tree. The ground also was live and the other two must have got injured by step voltage. The bark of the jackfruit tree was found strewn around it exposing the inside cork cells. Removal of patches of bark are known to happen [11]. Both the trees were not destroyed in the incident.

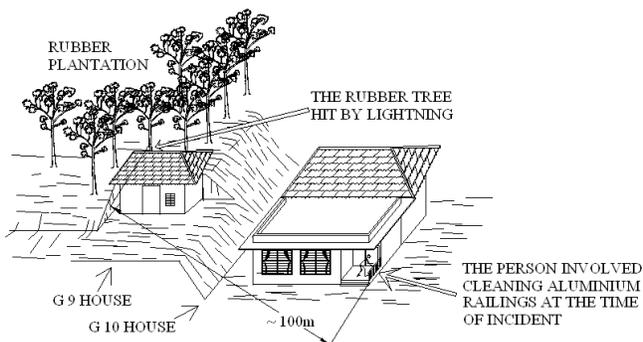
Fig. (5). A drawing of the G9 and G10 accident locations, which are houses.

The houses are near a rubber plantation. Lightning seems to have hit a rubber tree near G9. Five days later the rubber plant which was hit by lightning was found completely dead and another one next to it had a few branches dried up. Power wiring in the G9 house was damaged completely and switches and wall sockets in many rooms were blown off from the wall. The G9 house is about 3 m below the tree

level because it is built on a cut on sloping ground. G10 is a partial RCC roof house which is about 100 m away from the tree which was hit. A lady who was cleaning the Aluminium railings in front of the G10 house was injured. No damage to power wiring or electrical equipment was reported in the G10 incident.

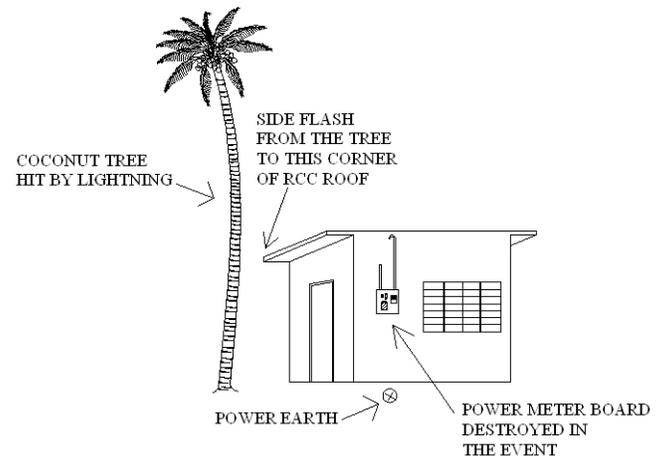
Fig. (6). Drawing of the site G11 showing the isolated coconut tree which was hit by lightning and the close by RCC building. The building and personnel inside were involved by side flash and ground conduction.

Lightning hit a tall isolated coconut tree only a metre away from an RCC roof house at about 0010 h local time. One corner of the RCC roof was close to the tree trunk by about a metre. Side flash seems to have occurred to the roof corner because the corner was found cracked exposing the steel rod inside. The tree was destroyed. The RCC roof seems to have become live and then through the walls lightning energy seems to have entered the electrical wiring of the house. The power meter board located on the opposite side and the whole wiring of the house were destroyed. Switch boards on the walls were blown off. It seems the lightning energy conducted through the power meter board to the power earth right below it. Simultaneously, it seems the ground also became live because three people sleeping on the floor were injured by step voltage between their heads and feet. The ground seems to have become live by ground conduction from the tree.

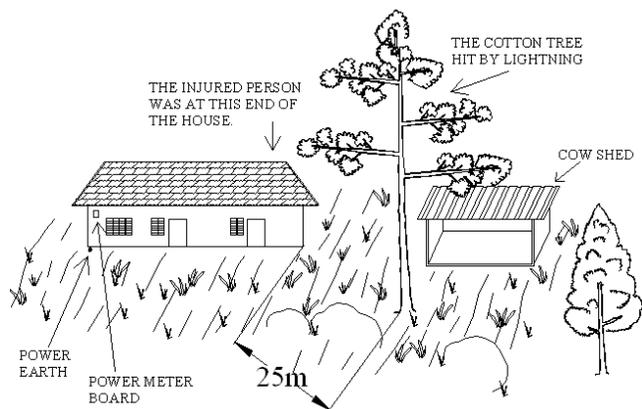
Fig. (7). Depiction of accident site G12. A person in the house was injured fatally.

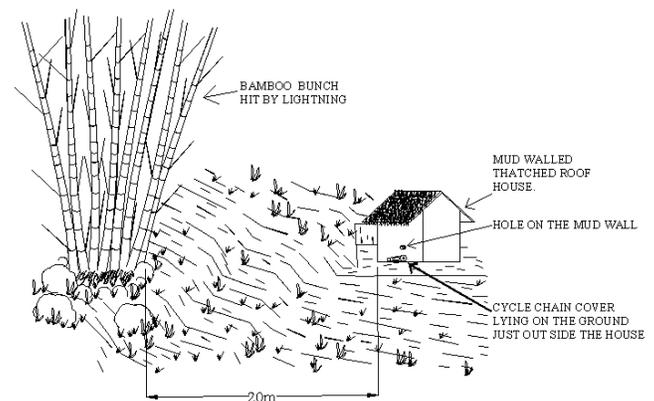
At site G13 lightning struck a bamboo tree bunch. The bamboo bunch was found growing in the crevices of rocks. The rocks near the roots of the tree bunch bore somewhat greyish white marks indicating that ground arcing had taken place. The tree bunch is on a slope. Down below at a distance of about 20 m and a level difference of about 2 m is a thatched roof house with mud walls and floor. A rusted bicycle chain cover was lying on the ground near the side of the house facing the bamboo bunch. The scene of the accident is shown in Fig. (8).

chain cover. It is likely that the cycle chain cover was instrumental in supplying some amount of charges and also in establishing the route to the lady. Probably the lady's knee was touching the wall at 0.3 m height and her hand or so was touching the wall at a higher point. One of her feet could have been touching the floor also. The lady was injured fatally and the infant was not injured. As the greater proportion of the human body resistance is on the limbs [1] the infant who must have been in contact with the torso could not have experienced considerable difference voltage across it's body. Two other people sitting on the other end of the cot were also injured probably by the difference voltage between the floor and the cot. These two were injured, probably because the cot had current flow through it and so had potential difference relative to the floor. Here an aspect to be noted is that the cot, made of wood, was also live with the lightning energy. The wiring of the house was found destroyed. Window glass of the power meter box was found broken. Here, the metal cycle chain cover and the electric wiring of the house seem to have been instrumental in involving the house through ground conduction. The bamboo tree bunch did not show signs of destruction. Puffs of fibrous roots of the bamboo tree were found hanging on leaves at a height of 2.5 m. This indicates that a small explosion caused by the continuing current had happened near the roots of the bamboo tree bunch.

Fig. (8). The scene of the G13 accident. The position of the hole on the wall of the house is indicated. The fatally injured victim was on the other side of the wall. The bamboo bunch was not the only tree in the vicinity.

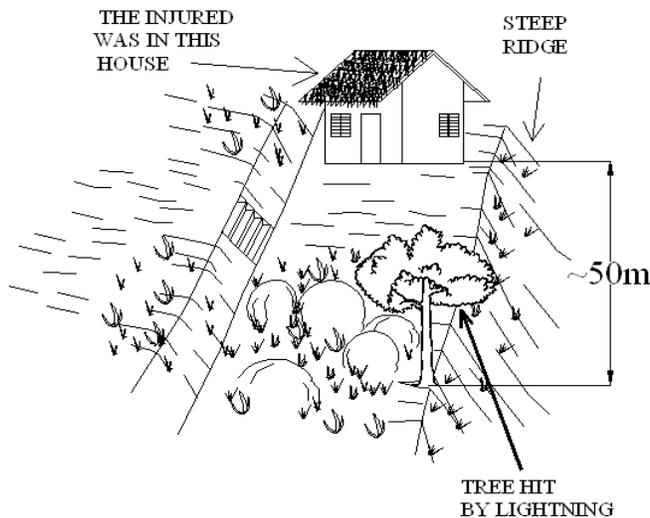
There was only scanty soil seen on the surface near G14 which is an indication of low conductivity. This house also had power wiring. A small isolated tree growing in the crevice of a rock was hit and a person standing on the doorway of a thatched house was injured fatally. The victim had hip and hair burns. The incandescent bulb in the room was found broken. The tree was destroyed. The tree was only 3 m tall but was located at the corner of a steep ridge as shown in Fig. (9). The long distance of conduction in this incident is attributed to the low conductivity of the rock.

Fig. (9). Depiction of the accident site G14. The tree which was hit by lightning as shown in the figure was short, an isolated one and was growing in the crevice of a rock.

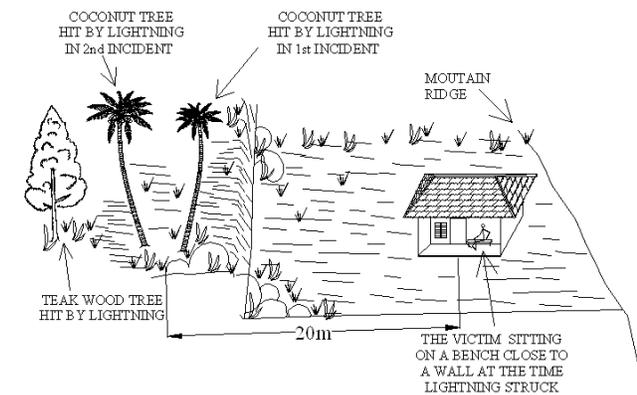
Fig. (10). Location of the two accidents G15 and G16. Both times the victims, first the husband and second time the wife were seated on the bench shown. The location is close to a steep mountain ridge.

First the head of the family was sitting on the bench and escaped with an injury to his eye brow. Second time it was his wife who got injured. She was wearing a gold chain around her neck and had an ear ornament too. She was

sitting on the same bench at the same location. The bench was put close to a wall and so the victims could have been touching the wall or must have been very close to it. The lady’s injuries were to the spots where the ornaments were, namely the ears and the neck. The burn mark along the line of the neck chain could be seen by the investigators when they visited the site 43 days after the accident. Probably as described in Kitagawa *et al.* [12] the ornaments had triggered flashover to the live wall of the house. A coconut tree was hit in the first incident and was destroyed. Another coconut tree which was about 5 m away from the first one and a teak wood tree close to it were hit the second time. This coconut tree also was destroyed. The teak wood tree suffered only partial damage. Mountain ridges are known to be relatively vulnerable for lightning strikes [13]. It is possible that the site had two incidents within 20 days because of this characteristic of the location.

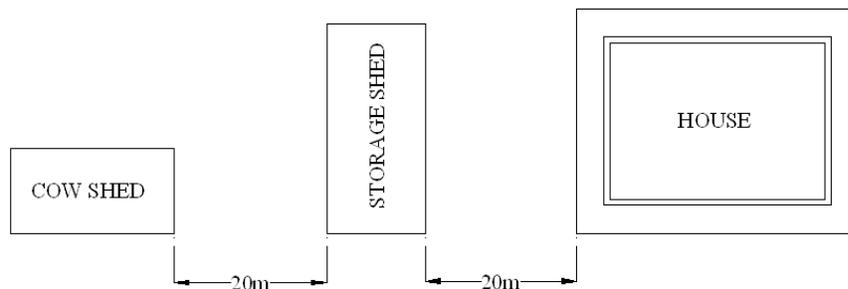
Fig. (11). Plan view of the structures at site G19.

Of all the ground conduction accidents the one at G19 was an incredible one. The significance of presence of a metal object in the vicinity of a lightning discharge in contributing to the lightning currents is seen in this incident. Probably the suitable description for the involvement of the metal object in this incident would be to say that the lightning discharge 'sought' the metal object which was kept in the inside room of an asbestos roof shed. The G19 location has three structures. The layout of the three structures is shown in Fig. (11).

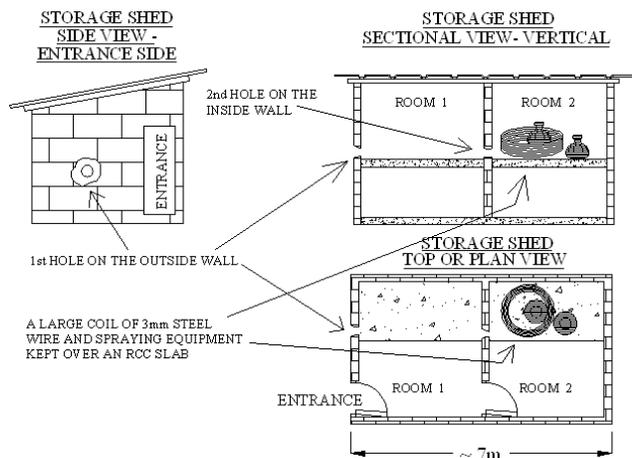
Fig. (12). Side view, vertical sectional view and plan view of the storage shed which was involved in lightning by ground conduction at site G19. The holes on the outside wall of Room 1 and the wall of the inside room namely Room 2 are shown.

The cow shed and the storage shed were involved in the lightning incident. The cow died and the walls of the cow shed developed cracks from the incident. No tree or other tall objects with marks of lightning hit were to be seen in the vicinity. On one side of the structures mentioned trees were present but on the other side no trees were there. Hence it is assumed that the cow shed could be the primary object hit. The storage shed, as shown in the figure, had two rooms and had a continuous RCC slab extending to both rooms. The shed was constructed using hollow cement bricks and had an asbestos roof. After the lightning incident a hole at a height just above the RCC slab in the storage shed appeared outside Room 1. On scrutiny it was found that a similar hole at the same level had appeared on the wall of Room 2 also. In Room 2, on the RCC slab was kept insecticide spraying equipment made of brass and a large coil of galvanised steel wire. It is deduced that the lightning discharge has got connected to the metal objects in Room 2. Since the current from and to the metal objects, possibly, were high the walls developed holes, probably due to Joule heating in a way as given in Rakov and Uman [9]. Considering the route taken and distance covered, the mode of establishment of contact to the coil of wire is quite an uncommon one. Had the conductivity of the steel reinforced slab been sufficient for conduction of current to the coil of wire, it is likely that the

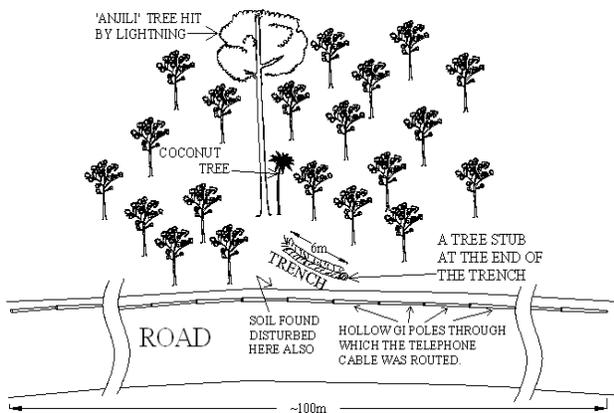
The G21 disaster was a phenomenal one. This incident is illustrative of the role of metal objects on ground in effecting a higher lightning current. Soil was thrown up several meters high into the air by an explosion on ground. Electrical wiring, electrical equipment and land telephones of nine houses were destroyed because of the involvement of land telephone network. Near the primary objects hit, namely two close by trees, the explosion on ground left a 0.5 m deep, 1 m wide and 6 m long 'V' shaped trench. It was reported that blown up soil was found resting on leaves and nodes of rubber trees near the trench. Of the two trees involved one was a very tall anjili tree and the second was a relatively very short coconut tree less than a metre away from the first. The trees were among rubber plants. Upon visit to the site twenty two days after the incident the coconut tree was found dead and dried up. The taller tree looked unaffected as in the case of the jack fruit tree in G7 incident. However it seems the coconut tree, which was shorter than the anjili and rubber plants, got involved either by side flash or by step voltage to its roots. The trench is between the trees and the nearby road. A drawing of the location is given in Fig. (13).

At another point on the edge of the road and near to the poles soil had the look of having been ploughed. This is marked as 'soil found disturbed here also' in Fig. (13). On the near edge of the road was run a multi-core telephone

cable connected to land phones of nine houses. For protection, the cable was routed through a chain of old, hollow, tapered, galvanised iron (GI) poles of about 12 cm diameter at the broader end. These poles, each of about 5 m in length, were not joined together but narrow end was let into the broad end to form a continuous cover for the cable run through it. The poles were in contact with one another and were lying half submerged on the ground to a length of about 100 m. The anjili and coconut trees were at a shortest or perpendicular distance of about 10 m from the chain of poles and were at a distance of about 15 m along the trench. The part of the soil where it looked as if ploughed, mentioned above, was at this shortest point to the trees. The energy of the lightning discharge seems to have got connected to this chain of poles and then to the cable inside it and this way entered the nine houses. Because of the involvement of the grounded metal poles, the telephone network of the houses and the power wiring in those houses, the charge collection and dissipation efficiency was very high. Metal objects on ground are known to become instrumental in causing high lightning currents [14]. The cable inside the poles was found burnt and broken. The chain of poles and the connection through the cable to houses seems to have facilitated charge collection from a large area resulting in a relatively high magnitude lightning current. The ground was wet with rain of previous days. The excessive current, possibly long term continuing current seems to have heated the water soaked soil resulting in formation of steam which must have led to an explosion.

Fig. (13). Depiction of the lightning accident site G21. Heavy lightning current due to the presence of a chain of galvanised iron (GI) poles of about 100m length and telephone wires to several houses resulted in formation of a trench of 6 m length on soil.

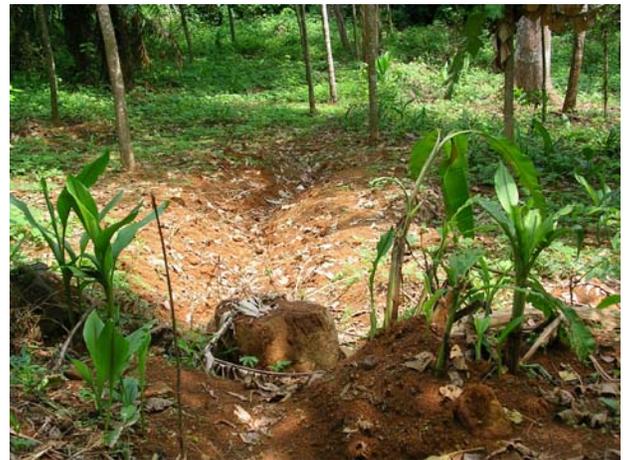
Fig. (14). The trench on soil caused possibly by continuing current at the accident site G21. The anjili tree, the coconut tree and the tree stub which blocked formation of a longer length trench are shown.

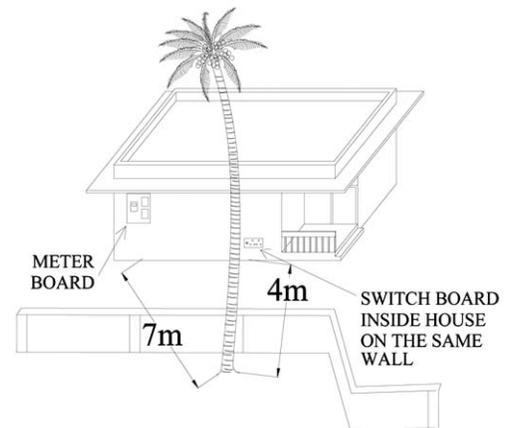
The incident happened at about 2000 h local time. The house is located in the coastal plains of the capital city of Thiruvananthapuram. The first visible effect of lightning strike was a burning power meter board (MB) of a house. The MB is at a height of 2 m above ground and the power earth of the house is just below the MB. A tall coconut tree at about 7 m away from this earth point was found

significantly damaged. The tree was cut and removed next day. The tree trunk was found split at several places which is indicative of the severity of lightning current. It was clear that the tree was the primary object of strike. The damaged power meter board was on the outer side of a wall. On the same wall but inside the house a small switch board (SB) having two switches, two 5 A power sockets and a cable TV termination was found damaged. An aspect noticed was that no other wiring or electrical equipment of the house was damaged. On closer inspection a difference in the mode of damages in the MB and SB were noticed.

Fig. (15). The G23 location of accident. Power earth, power meter board and location of the switch board inside the house are shown.

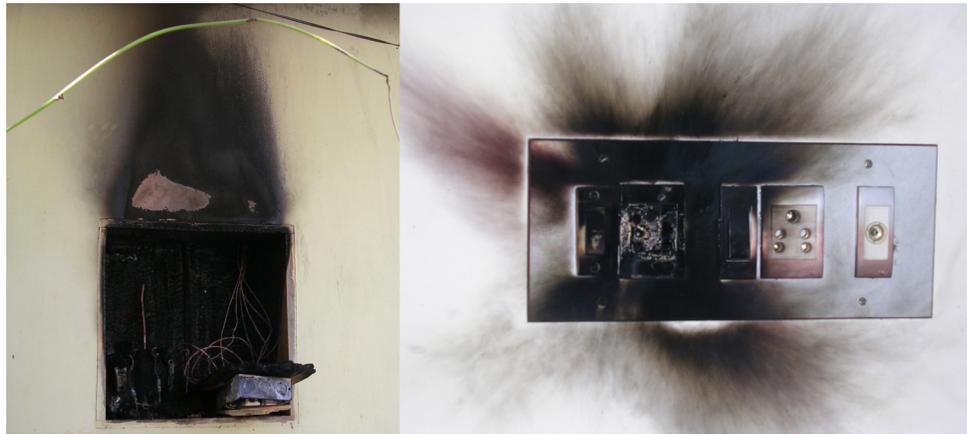
At the MB soot of the smoke could be seen only on the top portion of the box. The smoke mark was caused by continuous burning of the electronic power meter which had considerable plastic components. At the SB the soot was found spread in all directions including the down ward direction. This is an evidence of occurrence of an explosion. Photographs of the MB and SB are shown in Fig. (16).

The SB is at a distance of 4 m from the lightning hit tree and is at a height of 0.75 m above ground. The explosion at SB, its distance being less than power earth and MB points to the possibility of the SB being the first object which was

Fig. (16). The damaged Main Power Board (MB) of the house at location G23 is shown in photograph on the left and that of the Switch Board (SB) is shown on the right. It is clear that there was an explosion under SB panel.

involved in the lightning. That no other equipment in the house was damaged is a supporting piece of evidence. Possibly, after involving the SB, the energy got terminated at the MB where good earth connection was available. In other words a high current component of the discharge emanated from the power earth near the MB and through the nearest object, namely the SB got connected to the coconut tree which was the primary object hit. There is one similarity of this incident to the A9 accident. In both cases because a good earth was available to provide sufficient discharge current, rest of the wiring of the house was not damaged. People were present in the house and nobody had any injury and did not feel anything. This shows that upon establishing a good contact with an earth terminal the discharge did not involve any other object in the vicinity as the potential gradient on the floor was insignificant.

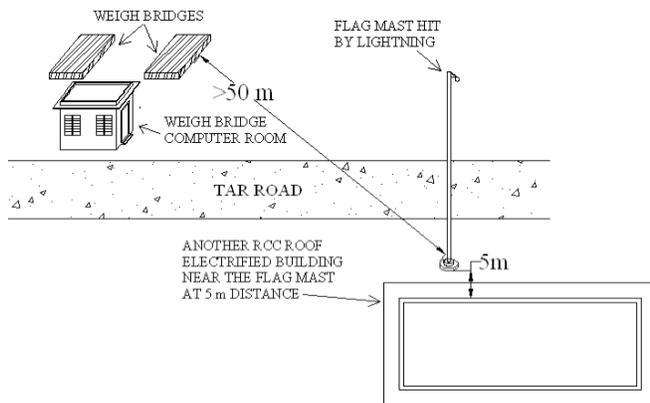
Fig. (17). Plan view of the accident site G24. The flag mast which was hit by lightning, the weigh bridges and the computer room can be seen.

Accident happened inside a Titanium complex factory located in the coastal part of Thiruvananthapuram district. The date of accident was not reported. The result of the accident was destruction of the electronics and computer of both weigh bridges of the factory. Lightning seems to have hit the steel flag mast of the factory shown in the figure. The circular base of the mast, made of bricks and cement, was

found broken considerably after the lightning strike. The distance of the nearest weigh bridge to the mast was more than 50 m. Upon careful inspection of the weigh bridge the flexible earth connection ribbon cables of the weigh bridges were found to be mostly corroded. This seems to have resulted in a very ineffective grounding of the weigh bridge mass. An illustration of electrical nature of one load cell of a weigh bridge and strain gauge is shown in Fig. (18).

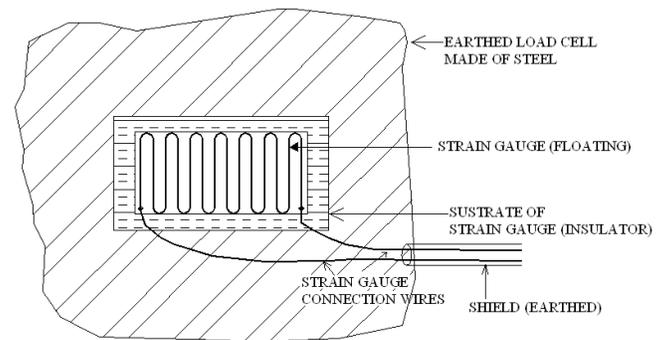
Fig. (18). Illustration of electrical nature of one load cell of a weigh bridge and strain gauge. Wires of the strain gauge going through a shielded cable is also shown.

The strain gauge is normally etched over a substrate which will be a good insulator for voltages at a level used in industrial instrumentation. This is fixed on the load cell made of steel. Several load cells will be supporting the earthed steel platform of weigh bridge and will be in good electrical and mechanical contact with it. Hence normally the voltage that the substrate will have to withstand is the working voltage of the strain gauge of the order of a few Volts. The load cell and the steel platform will be at earth potential. In the accident that is being discussed the load cells and the platform were not earthed well enough. A good earthing would not have allowed raise of potential difference between the load cell and the strain gauge. On the contrary the earthing was ineffective and resulted in the lightning energy entering the strain gauge signal line by breakdown of the substrate insulation.
