Rock Slope Stability Problem Modeling and Remediation of the Arabian Shield Rocks: A Case Study From Werka Descent Road West of Saudi Arabia

Bahaaeldin Sadagah*

King Abdulaziz University, P.O. Box 80099, Jeddah 21589, Saudi Arabia

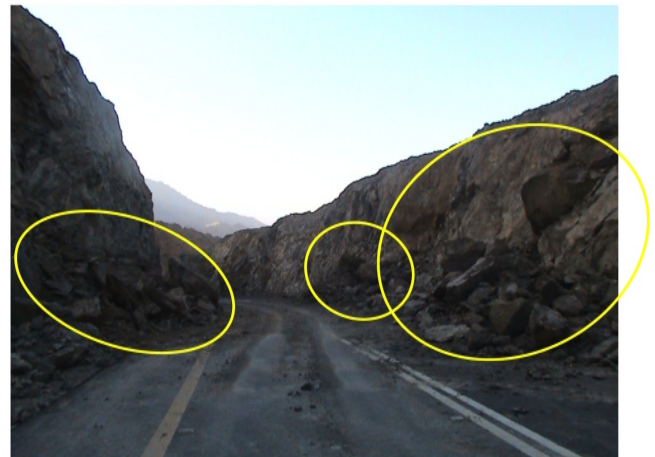
The rock slope along the road cut at slope angle 85° and 7 m height, suffers from frequent failures on the road, mainly in rainy seasons (October to April). No support measures were taken at the site (Fig. 4).

Fig. (4). Rock slope failures shown at yellow circles at the northeast (right) and southwest (left) slope face cuts. Rock blocks were removed aside after the rainfall to clear the road.

Location of the stations along the Werka descent is traced by the GPS. It happens that in some places rock slope failures were so heavy at one spot, and took place on both sides of the road and blocked it (Fig. 4). The results of the stereographic projection show that wedge, plane and

5. Rock bolts, in addition to shotcrete and slope face mesh could be the appropriate solution to stabilize this rock mass of such geotechnical quality and properties.
6. The analyses indicate that the intensity of rainfall, joints set attitudes with the slope face attitude, J_v , block size, block shape, specific gravity, and the slope geometry are the main factors causing rock slope failure and problems.

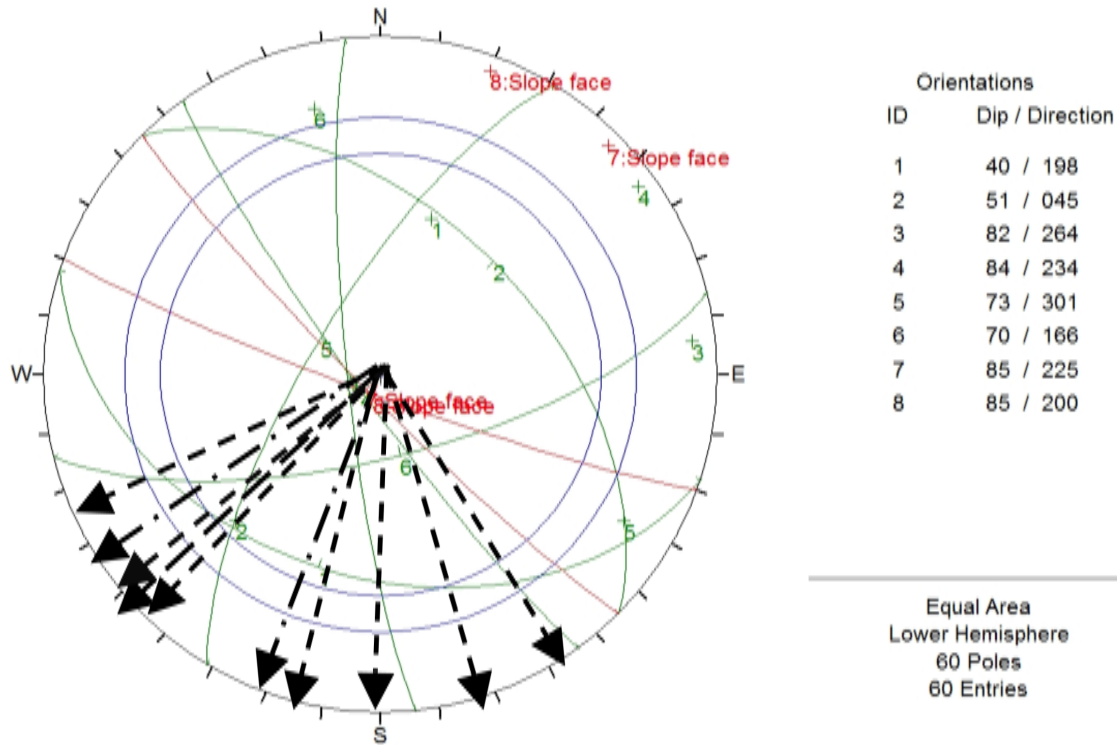
The graphical method [9] shows that the factor of safety is critical along man-made slopes. The stereonet made (Fig. 5) using *DIPS* software [10] shows that the friction angles at dry and wet seasons are 35° and 25° , respectively.

Fig. (5). Stereographic projection of the joints sets along the northeastern side, show the failures directions.

toppling failures took place, (Fig. 5). Failures types and directions are given in Table 1.

The great circles of the prevailing joints sets show that the plane failures (Fig. 5) could take place, as they are close to the friction angle value at wet conditions. The great circles also indicate that a number of wedge failures are likely to take place at rainfall conditions.

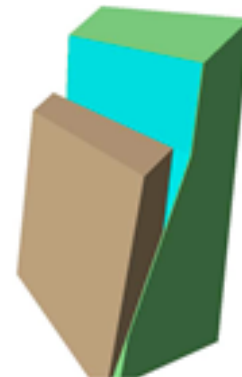
The deterministic analysis was applied using the RocPlane computer program, to draw the three-dimension and side view graphs of the rock slope (Figs. 6, 7). The input data collected from the lab and field tests are as follows: slope angle = 80°, slope height = 8 m, tension crack angle = 85°, upper slope face = 35°, $m_i = 13$, $m_b = 1.15$, $s = 0.0005$, $a = 0.52$, $UCS = 7,440 (t/m^2)$, $GSI = 15, 22$, and 30 , unit weight = $2,760 (kg/m^3)$, rock bolts = 8 m, rock bolt angle = 15°, rock bolt capacity = 20 (t/m). The percentage of water filling in the tension crack was assumed to be 100%, as a

Fig. (6). The 3D plot of the plane failures north east side, similar to the actual failure shown at Fig. (4).

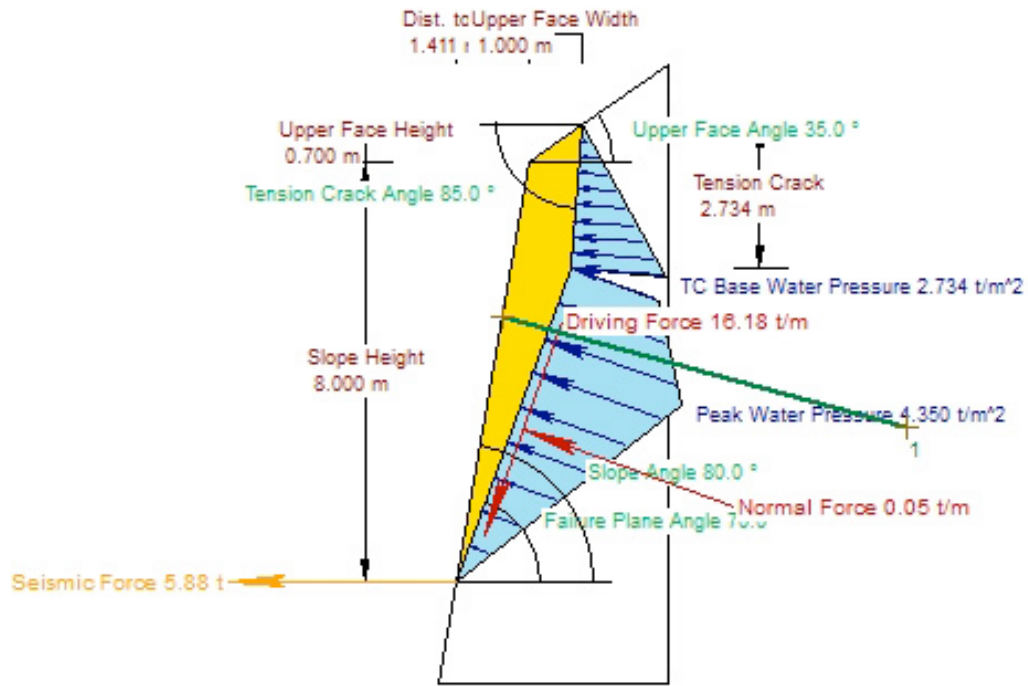
Fig. (7). A side view of the forces acting on the plane failure.

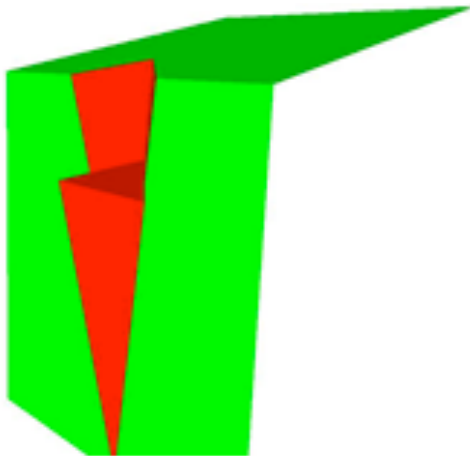
Modeling of the wedge failures (Figs. 4, 8) shows that failures are possible to take place. Graphical modeling of the joints sets indicates the possibility of many wedge failures directions to occur (Fig. 5).

The factors of safety of the wedge failures vary in a wide range (Table 2) before and without support. At seismic coefficient = 0 after support, the factors of safety generally increase to more than 1 (Table 3). In case of the intersection of joints sets 1&3 and 1&4, where the factor of safety after support is <1, the instability could be overcome by installing a mesh over the slope face, as the slope is relatively short, and the rock mass is highly fractured and had a low quality geotechnical properties as indicated.

Fig. (8). The 3D plot of one of the wedge failures northeastern side, similar to the actual failures shown through Fig. (4).

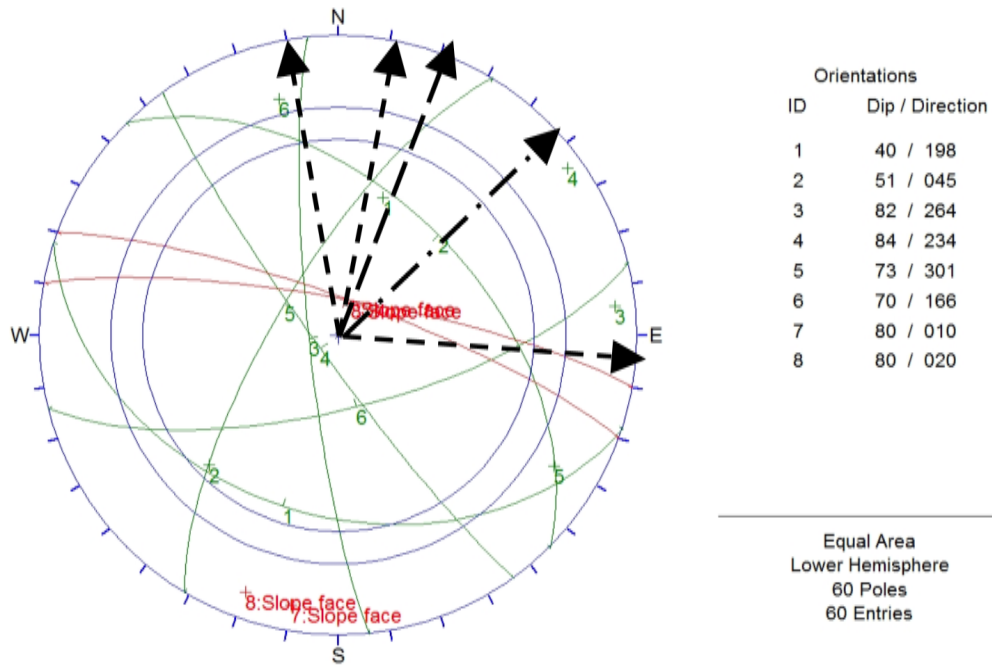
The great circles of the prevailing joints sets show that the plane failures could take place (Figs. 4, 9), as the friction angle value at dry condition is close to that value at wet conditions. The plane failure and other modes of failures results are given at Table 4 and Fig (10).

Graphical modeling of the joints sets (Fig. 9) indicates that many wedge failures are possible to take place (Figs. 4, 11).

Fig. (9). Stereographic projection of the joints sets along the southwestern side shows the failures directions.

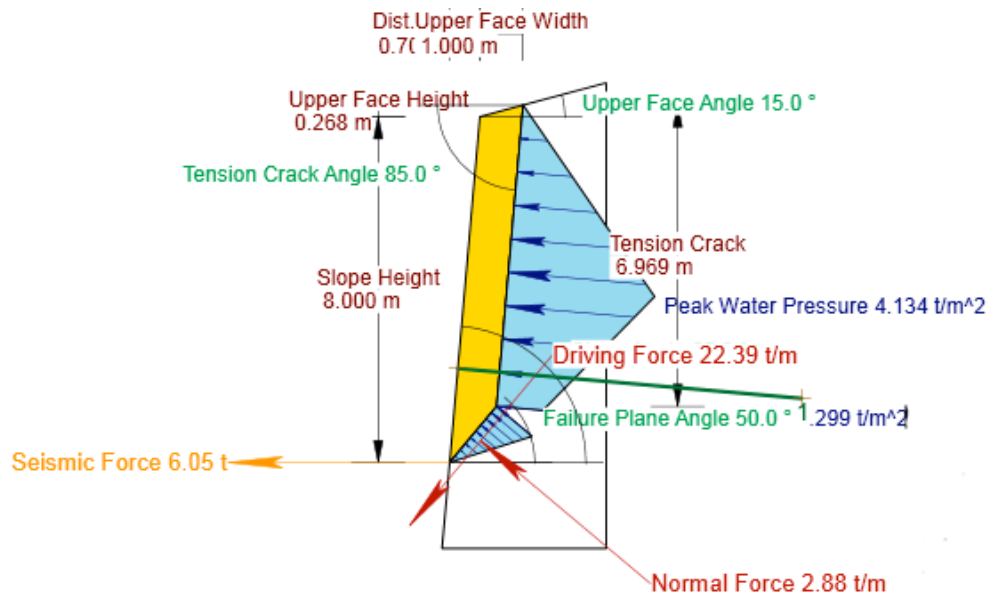
The factor of safety equals to 0 at this station at wet condition. However, after performing the support analyses by adding rock bolt of 11 ton/m capacity (Fig. 10) at seismic coefficient = 0, the factor of safety reaches up to 1.99.

Fig. (10). A side view of the forces acting on the plane failure of rock slope at south west side.

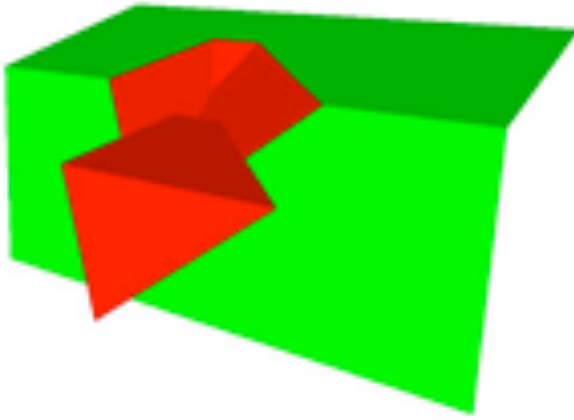
The deterministic analysis was performed using the RocPlane computer program, to draw the three-dimension and side view graphs of the rock slope (Fig. 11). The input data collected from the lab and field tests are as follows: slope angle = 85°, slope height = 8 m, tension crack angle = 85°, upper slope face = 15°, mi = 13, mb = 0.63, s = 0.0008, a = 0.56, USC = 7,440 (t/m²), GSI = 15, 22, and 30, unit weight = 2,760 (kg/m³), rock bolts = 8 m, rock bolt angle = 15°, rock bolt capacity = 20 (t/m). Similarly, the percentage of water filling the tension crack was assumed to be 100%, as a conservative value, in the process of calculating the factor of safety.

The factors of safety of the wedge failures are all less than 1 (Table 5) before and without support (Fig. 11). At seismic coefficient (S_c) = 0 after scaling, the factors of safety modeling results are generally more than 1 (Fig. 4 and Table 6).

Fig. (11). The 3D plot of one of the southwestern side wedge failures, similar to the true failure shown by Fig. (4).
