Waste Management of Emergency Construction Work. Case Study: 40 Dwellings in Seville (Spain)

Antonio Ferreira-Sánchez* and Madelyn Marrero

In this work, from the case study of the emergency repair of a residential building of 40 dwellings in Seville (Spain) seriously affected by a soil displacement, Generated C&D waste are identified and the waste reduction techniques used are shown. These techniques contributed to achieve the planned objectives and to control in advance the cost.

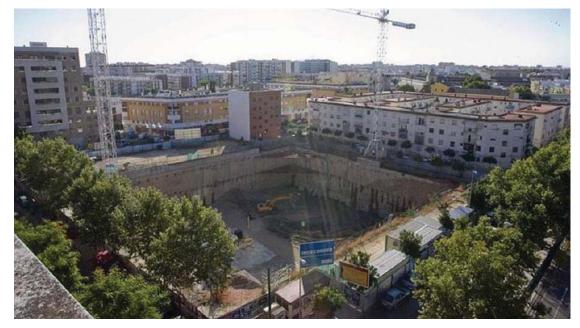
The information obtained in the tests determined that the land had poor bearing characteristics; heterogeneities in its layers and hollows were detected with evidence of underground water streams [16]. Since it was a terrain of alluvial materials with minor consistency, the land had little resistance above a depth of 20 metres. It was also observed that the underground water level had large variations in the area closest to the diaphragm wall.

Fig. (2). Condition of the work on the day of the accident.

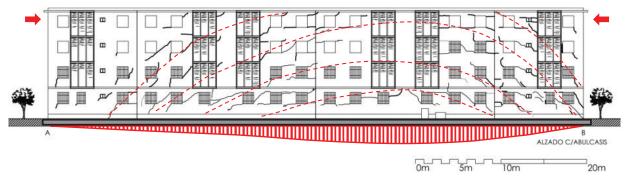
The brick masonry presented longitudinal and transversal arches of various sizes depending on the position in the building (Fig. **3**). In addition to the reconnaissance and monitoring of the building, a damage characterization according the Burland scale [17] was carried out. The classification ranged from serious to moderate damage (3-4 damage levels).

Fig. (3). Arches of displacement in brickwork.

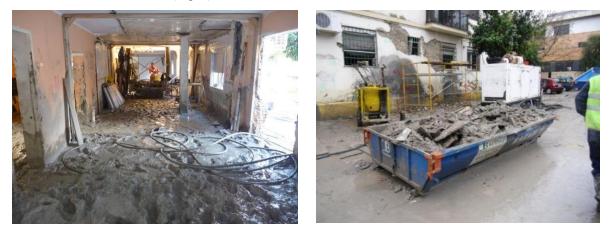
The alluvial soil characteristics contributed towards complicating the work due to the drilling mud (composed of water and soil) that became concentrated on work surfaces, and therefore hampered activities and conditioned the risk prevention measures for workers (Fig. 4).

Fig. (4). Drilling sludge inside homes.

In order to deal with this waste, a provisional central slurry management site was established to decant the sludge for separative treatment. Two tanks were placed outside the building into which the sludge was poured alternately and, after extracted the water, the residue was subsequently transferred to landfill (Fig. 5). After the completion of the work, these tanks were dismantled and the area was filled.

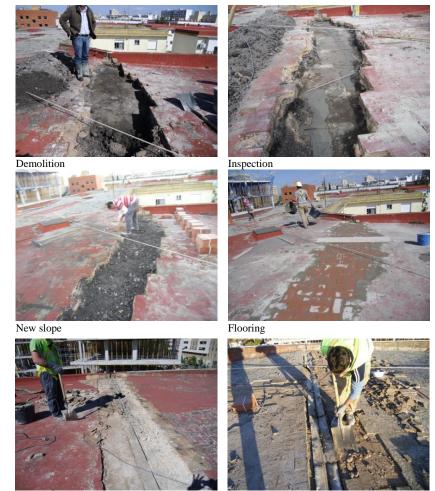
Removing lead elements

Fig. (9). Roof repair. Part I.

The process for the reparation of the roof was as follows (Fig. 9):

- 1. Demolition of affected joints, stockpiling lighting material.
- 2. Inspection of the structure.
- 3. New slope with stockpiled lighting material.

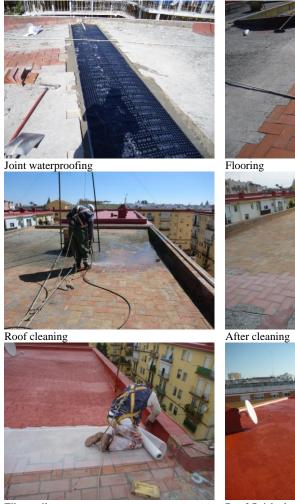
Fig. (10). Roof repair. Part II.

- 4. Waterproofing of joints (in compression fractures).
- 5. Flooring.
- 6. Waterproofing the entire surface with chlorinated rubber paint and fibreglass veil.
