Analysis of a Tower Crane Accident

M. H. Arslan* and M. Y. Kaltakci

Selcuk University, Engineering and Architecture Faculty, Department of Civil Engineering, Konya, Turkey

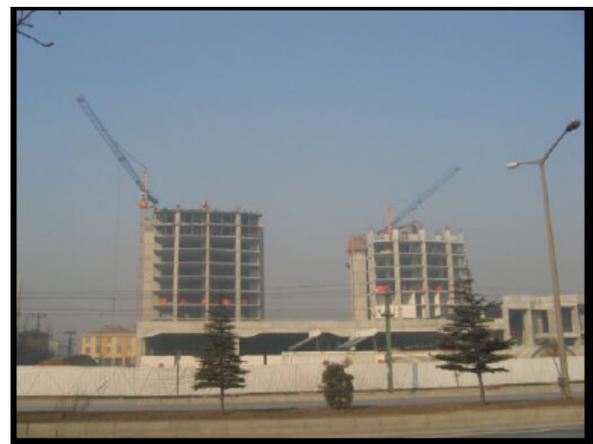
One of these tower cranes was overturned in 2006 (seen at the left side of Fig. 1), and resulted in serious damages beside the death of the operator. The tower crane was 30 m high when

Fig. (1). General view of the construction.

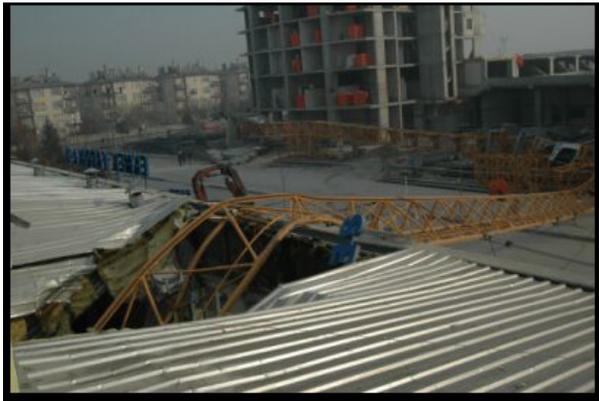
it was overturned. The building near the crane and a nearby bread factory (Fig. 2-3) faced to significant structural damages with the collapse.

Fig. (2). Roof of bread factory.

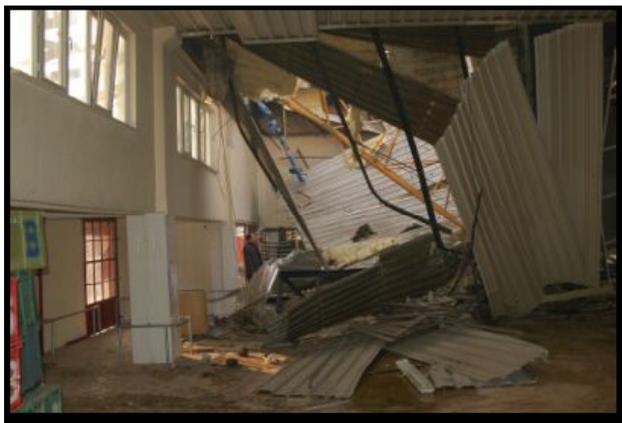
Fig. (3). Inner view of factory

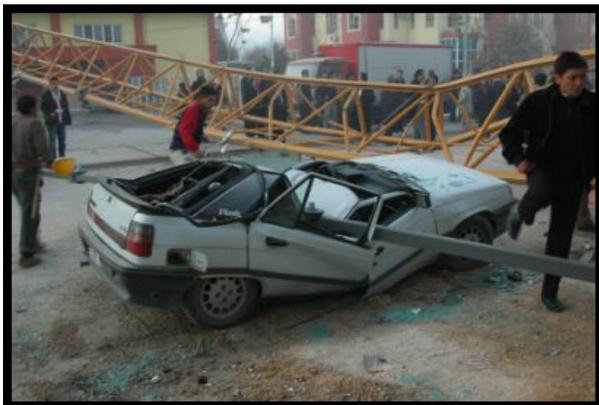
Especially a reinforced concrete column and a part of the slab have met important damage. The operator of the crane got caught inside the cabin and died at the hospital. The operator’s personal car became unavailable after the supports of the crane have been overturned as seen in Fig. (4). There was a big LPG tank and pipe line near the accident region (Fig. 5).

Fig. (4). Effect of the overturned crane.

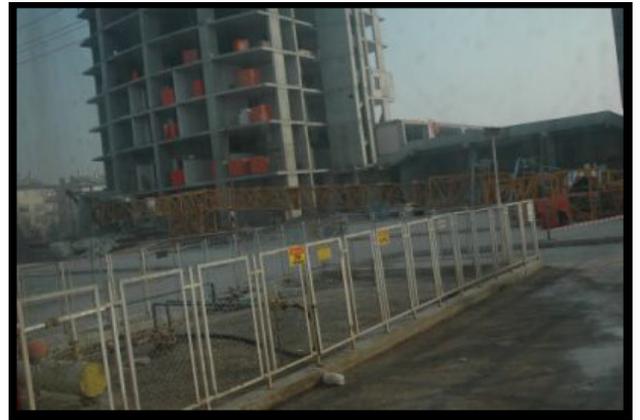
Fig. (5). Effect of the overturned crane (LPG pipe line).

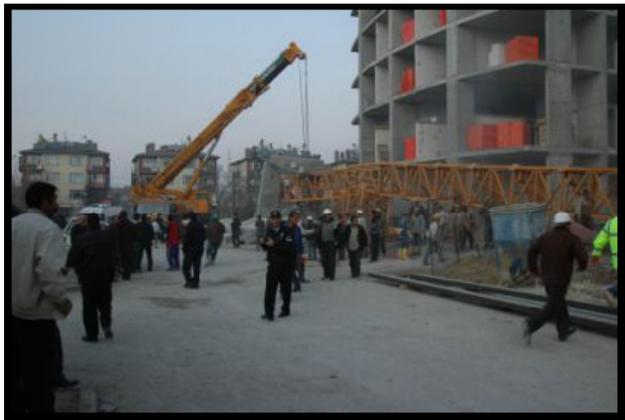
In order to adjust this top displacement, the crane was pulled on the middle level with the using a mobile crane. In the (Fig. 6), the mobile crane is seen. Since the lateral load carrying capacity of the mobile crane was not enough for adjusting the tower crane, a part of the balancing concrete block masses on the tower crane foundation were wanted to remove. But with the removing these mass blocks, the tower crane was faced incalculable turning moment by the removing these overturning safety masses.

Fig. (6). Mobile crane.

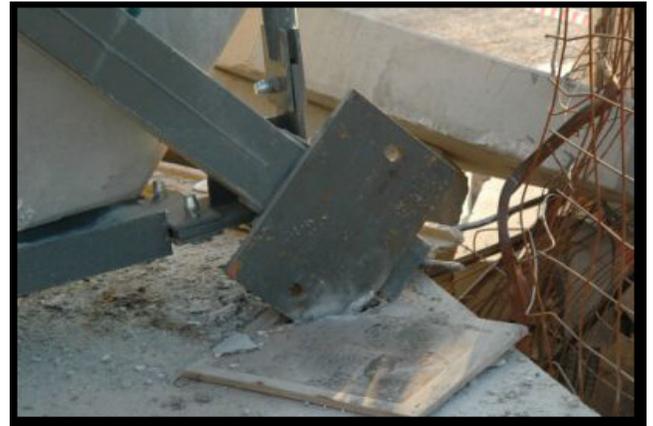
In the present application, beside the connection of the crane to the concrete platform has not been made, the required anchorage members have not been used in the profiles fixing the crane footings to the ground. Under this circumstance, the tension force that should be carried by 8 anchorage bolts of $\phi 32$ could not be responded by any apparatus. The number of anchorages was determined according to the moment. The unbalanced moment arisen with the overturning effect of the crane's load resulted in the rotation of the crane around its footings (Fig. 7a and 7b).

Fig. (7a). Unused anchorage members.

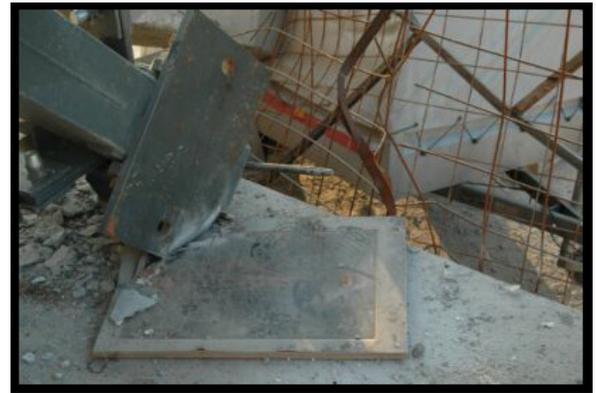
Fig. (7b). Rotation of the crane around its footings.

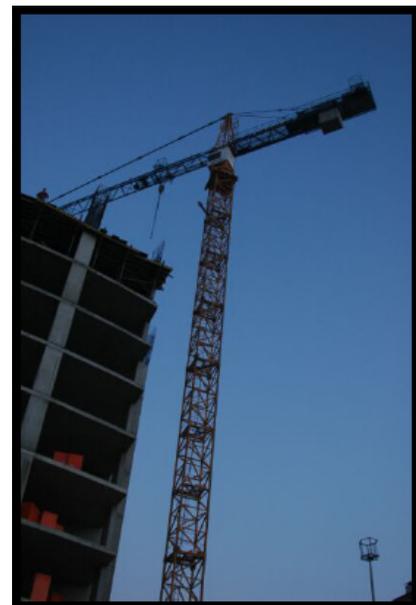
Although the crane has reached the height of 30 m, the supports that would prevent the overturning of the crane have not been made, and no other connection member has

Fig. (8). Having no connection with the building (Before the failure).

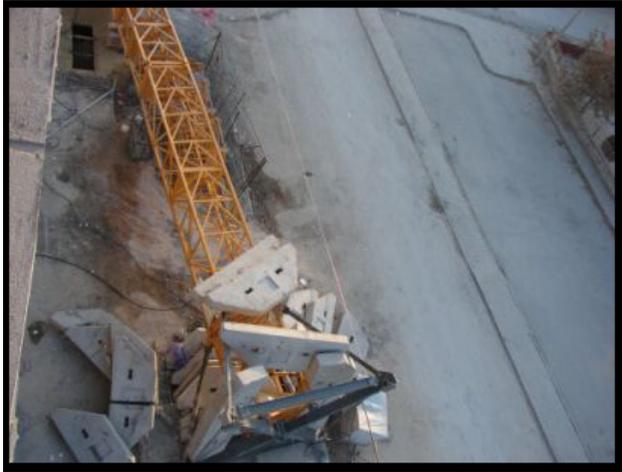
Fig. (9). After the failure.

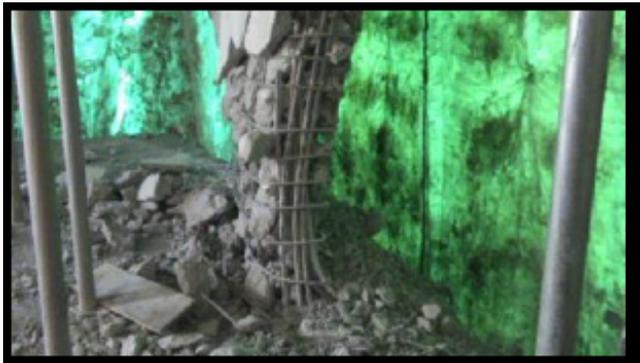
Fig. (11). The bottom of the column (narrow side).

After the tower crane overturned, the important damage had been occurred on the 5th floor side column and the different points of the same floor flat (Fig. 11-14). The effected side column had designed as rectangular shape as 300/1000 mm according to the TBC-500-2000 and TEC-2007 [7] rules. The longitudinal reinforcement is 20φ20. The longitudinal reinforcement bars ratio is about 0.02. The lateral ties are spaced 100 mm in the confinement zone and 150 mm in the middle zone.

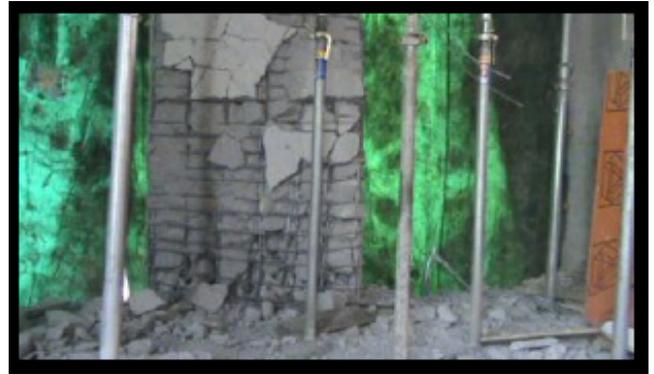
Fig. (12). The bottom of the column (wide side).

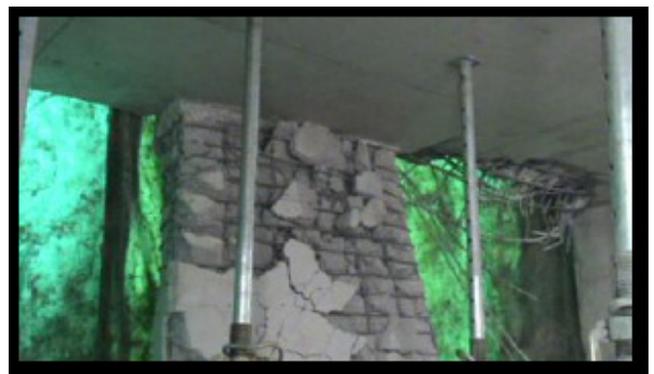
Fig. (13). The damaged slab and column.

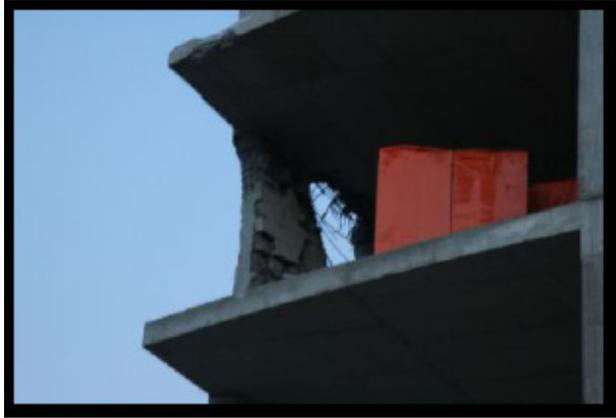
Fig. (14). 5th floor corner column.

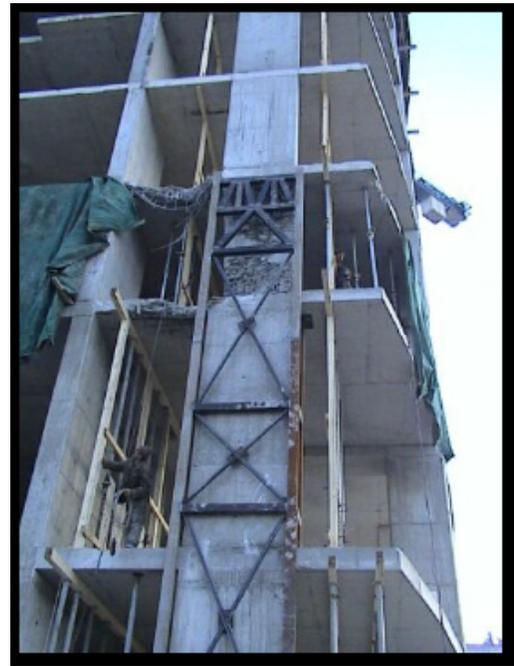
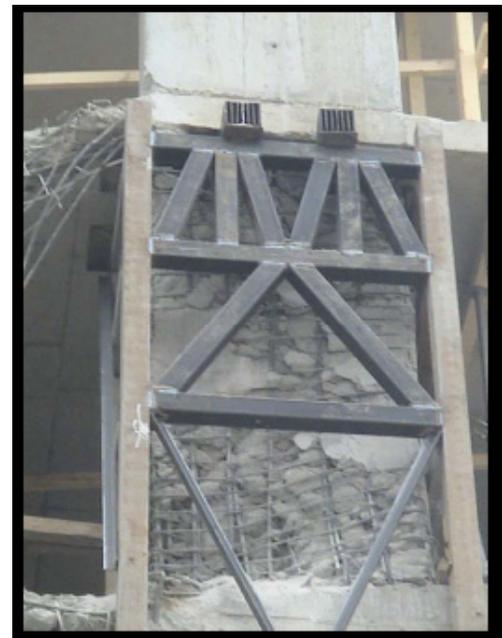
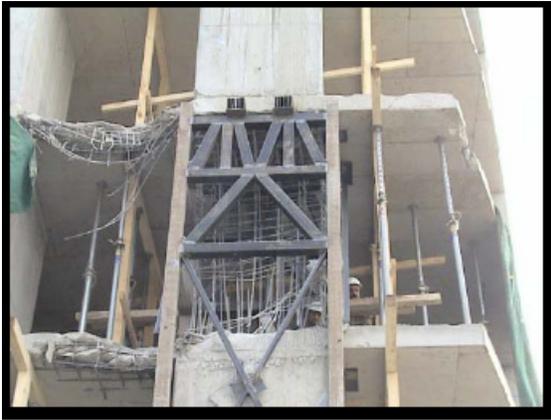
Fig. (15a). The column suspended with the steel bars.

In this approach, although there was no dangerous situation in this section, right after the event took place, temporary supports were placed adjacent to the heavily damaged column and the column was suspended with the steel bars in the first stage. After that, the primary strengthened was performed and the causes of damage determined by examining the entire building. The suspended column was bonded by steel profiles. At the column-slab connection region the new steel member which can transfer the all shear force was placed. The shear member consists of two fabricated U 180

profiles and in order to increase shear capacity of the member 4 steel plates were added into profiles inner faces. In Fig. (15) and (16), the detail of this member is given.

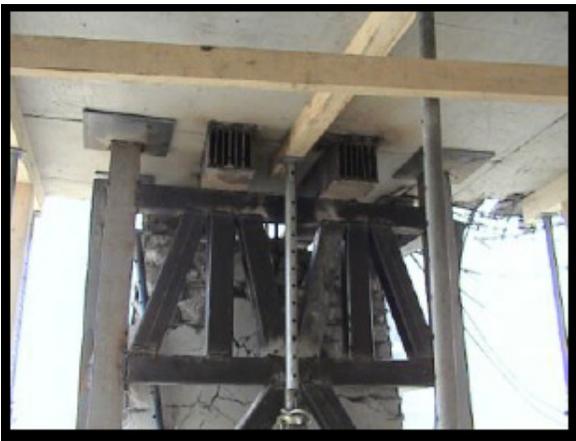
With the damage of the column, this region of the structural system has become as a console (Fig. 16). This situation would have caused the important deflection to increase in the slab system if the important precautions were not taken.

Fig. (16). Detail of the shear member.

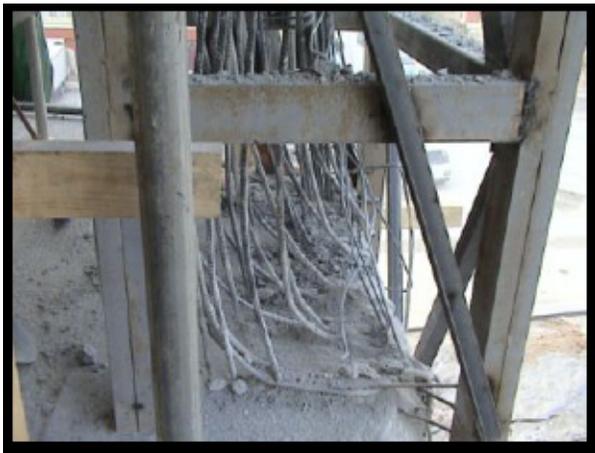
Fig. (17). The bottom of the column.

The bended longitudinal steel bars with buckling were fixed in the column (Fig. 17).

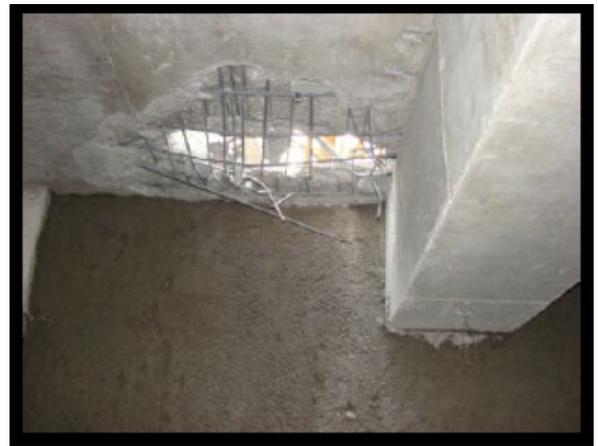
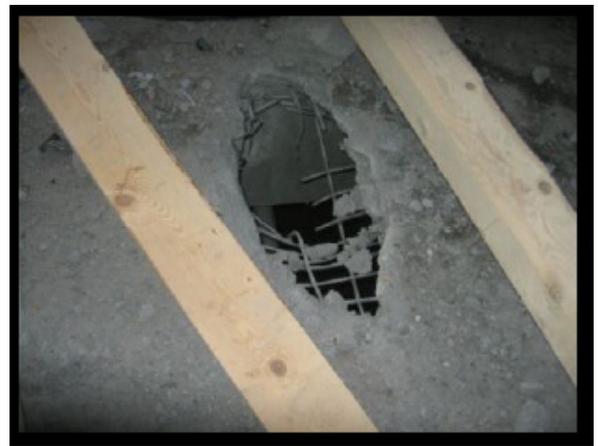
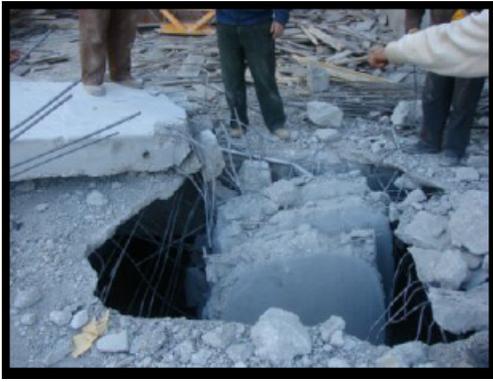
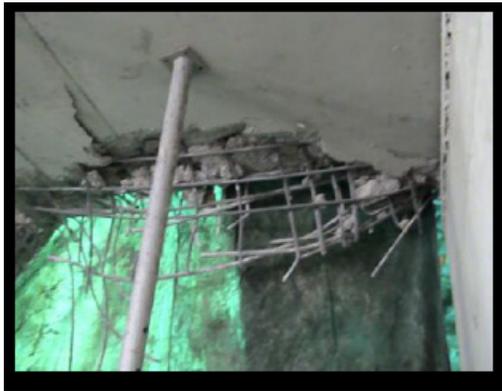
The flat slab thickness is 26 cm and after the tower crane crashing, three regional holes opened. These damages could not affect the rigid diagram behavior of the slab as seen in Fig. (18).

The building located in Konya city which is in the inactive seismic region (4th degree) and the total areas opening with the accident is lower than 1/3 of the gross floor area, there is no potential risk about transferring lateral (seismic) loads to the vertical structural elements.

Fig. (18a). Failures and holes on the slab.

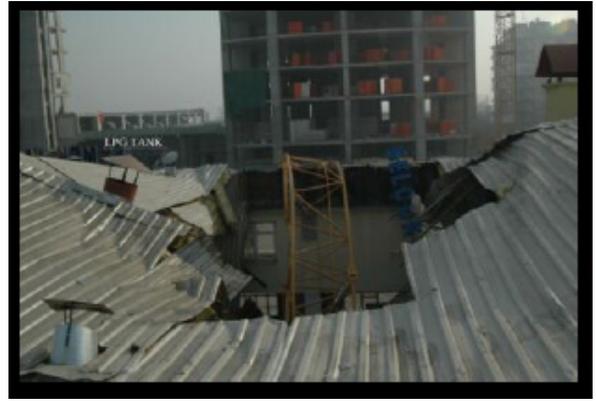
The roof and parapet system of the bakery belonging to Selcuklu Municipality located at the back facade of the building was mostly effected building. Since the members were prefabricated, they were easily changed after the accident. Fortunately, there was no occurring explosion in the LPG tank of the bakery as seen in Fig. (19).

Fig. (19). The roof and parapet system of the bakery.
