# Suitability of Current Assessment Techniques to Retrodict the Seismic Damage of Buildings: A Case Study in Van, Turkey

**Abstract:** Two strong earthquakes hit the region of Van (Turkey) in 2012, generating major losses. A large part of the building stock was damaged causing the evacuation of the residents. A post-earthquake investigation team dispatched by the UNESCO through the IPRED platform, six month after the earthquakes, observed the damage state in some still standing buildings. Ten buildings having different structural characteristics were observed. Slight structural damage and severe non-structural damage were observed in three multi-storey apartment buildings, being evacuated at the time of the investigation. Despite the slight structural damage, two multi-storey reinforced concrete shear wall buildings were listed for demolition based on the results of the post-earthquake rapid assessment. These two buildings were recently built based on modern seismic design regulations. The design blueprints were available to the investigation team with the support of the local community of Van. Various rapid post-earthquake investigation techniques applied by the investigation tea

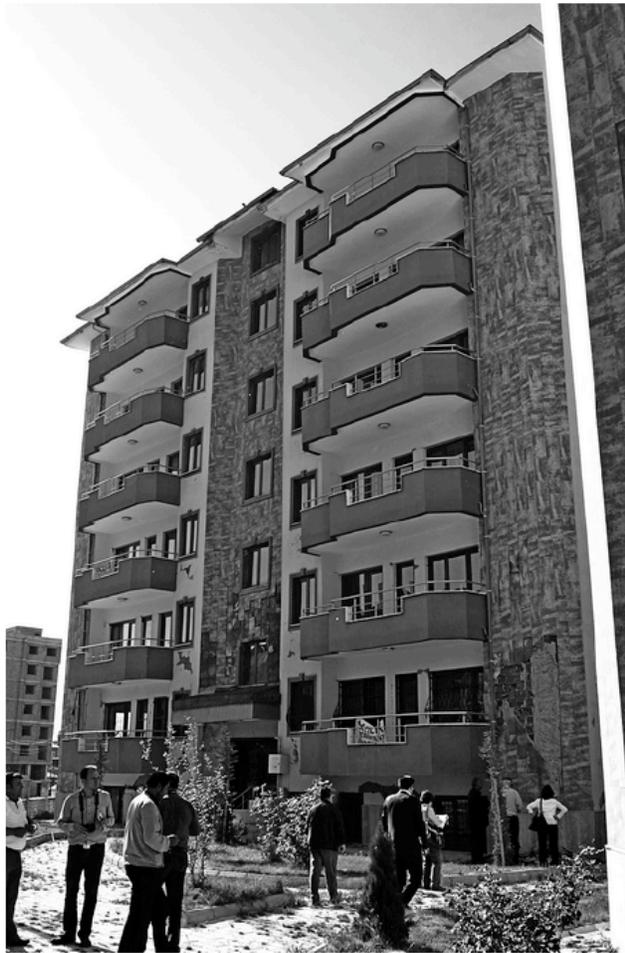
This paper refers at two identical RC residential buildings (A and B) with seven stories located in Van downtown inspected by the authors. The most damaged one, *i.e.* building B (Fig. 1), was analysed in detail. Both buildings were designed and built in 2005. The structural system consisted of cast in place reinforced concrete shear walls and frames (Fig. 2). In the transversal direction the lateral resisting structure consisted mainly of shear walls. Five shear walls were identified during site inspection. In the longitudinal direction only two shear walls were identified. In this case, the concrete frames were an important part of the lateral resisting structure.

Fig. (1). Main façade of building B.

For building A, no major damage could be observed from the outside. Building B sustained more severe damage as reported in the following.

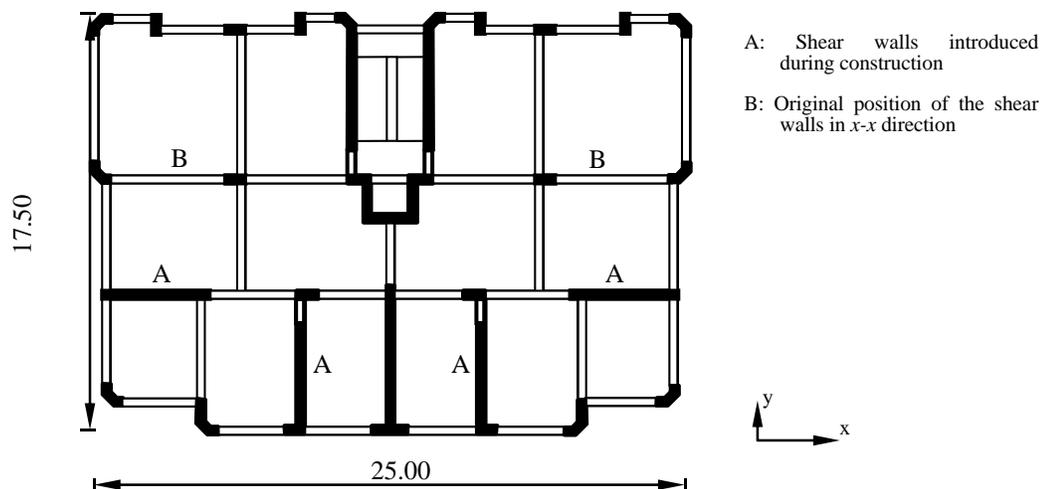
Important changes in the layout of the shear walls in contrast with the specifications in the design drawings were observed. Apparently, these changes were made without any structural engineer guidance. Shear walls in the longitudinal ( $x-x$ ) direction were relocated during construction from one axis to another. Their web length was reduced from 6.55m to 4.55 while the width was preserved. In the transversal direction, two additional shear walls were erected increasing the shear strength in this direction and improving the torsional stiffness of the building. Shear walls had rectangular cross sections having 30cm width and were horizontally and vertically reinforced with  $2\phi 12$ mm bars at 150cm. Boundary elements at each end of the cross section were vertically reinforced with  $4\phi 16$ mm bars. Confinement of the boundary elements was made using  $\phi 8$ mm closed stirrups spaced at 150mm.

Fig. (2). General layout of the structural system.

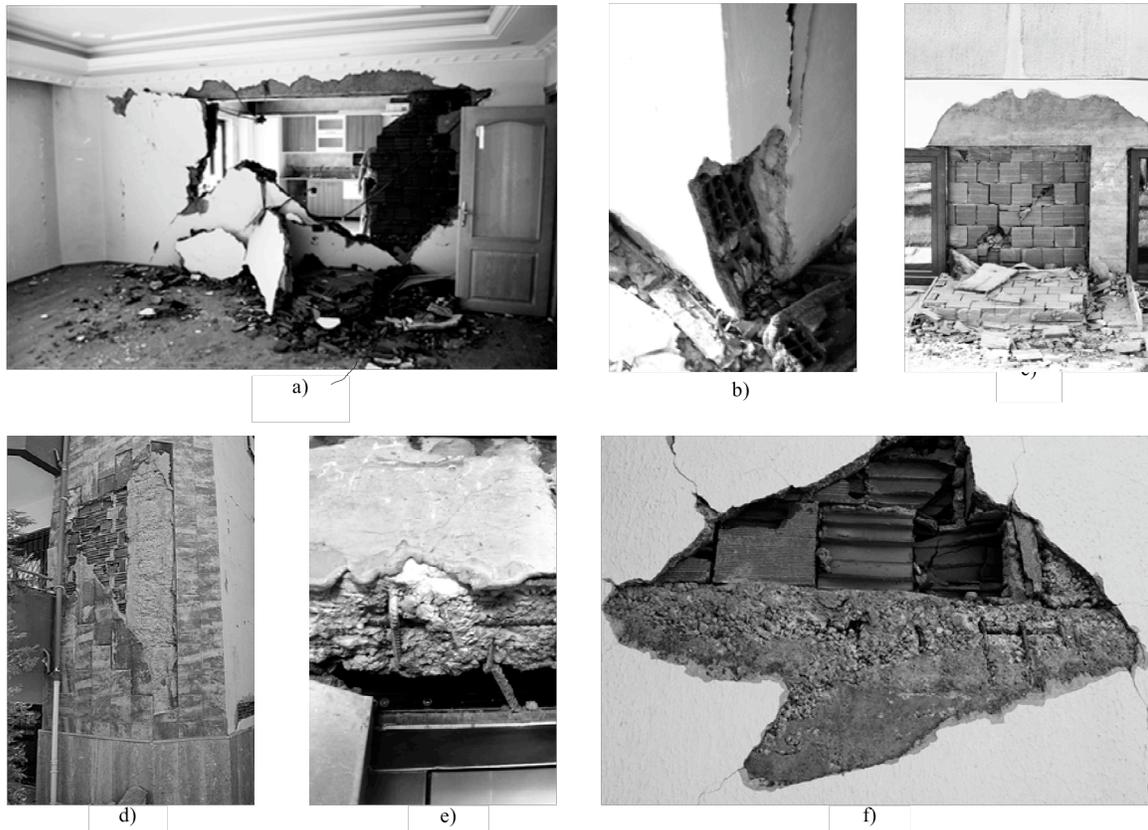
**Fig. (3).** Observed building damage.

Most of the outer masonry panels and parapets below the windows at the lower stories were damaged. Most of the interior masonry panels at the first three stories sustained severe damage beyond reparability. Replacement of these panels was considered necessary for future use of the building. Full or partial collapse of some masonry panels parallel to the  $x$ - $x$  direction at the ground floor was observed (Fig. 3a). These masonry infills replaced the concrete shear walls that were relocated to the adjacent bay.

Damage to the non-structural masonry panels with no corner bonding can be noticed in Fig. (3b). Two perpendicular panels connected using just polyurethane foam inserted in the vertical separation joint detached from each other with a vertical crack. The panel oriented in the  $x$ - $x$  direction of the building crashed at the bottom corner.

Overturning of an exterior leaf of a double layer masonry panel is represented in Fig. (3c). No connectors between the leaves were noticed on the site. In the same figure, the shear crack developed in the captive column between the basement windows can be noticed.

Despite the shallow structural damage, the site inspection revealed the low quality of structural concrete. Removal of the finishing layers exposed the members' concrete surfaces (Fig. 3d). In some members even the steel reinforcements were exposed as can be seen in the case of the coupling beam connecting two sections of the shear wall around the elevator shelf (Fig. 3e). Ready mix concrete for building construction is available in Van area since 5-7 years ago [5]. Inspection showed that the construction quality of the concrete structure was rather poor. The low concrete quality is

further illustrated in Fig. (3f). Improper water/cement ratio, improper combination of gravel sorts, segregation, lack of vibration, and concrete settlements under steel rebars were noticed.

Samples of the concrete extracted from the columns and shear walls revealed a very low compressive strength of 6-7MPa for B building and 12MPa for A building.

The structural analysis proved that the buildings have suitable lateral strength and deformation capacity. Retrofitting of the buildings for future use is feasible. However, none of the advanced seismic assessment methods used in this research could predict the extensive damage sustained by the masonry partitions in the ground floor. All the assessment methods converged to a similar positive conclusion regarding the seismic vulnerability of the building.

Quality of the construction works represents the main reason for the damage suffered by this building during the earthquakes. The structural works presented major deficiencies opposite to the relatively good quality of the finishing's. Special attention should be paid to the quality of the retrofitting works as it strongly influences their effectiveness.

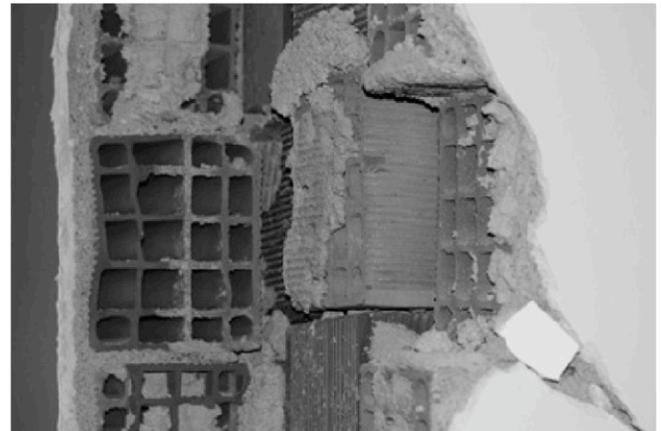
The contribution of the infill masonry panels upon the lateral strength and stiffness of the building is questionable. Interior masonry panels are 15 cm thick. All masonry panels were made with hollow masonry units. Multi-cell clay

blocks with large rectangular holes oriented in the horizontal direction were used. The vertical interior walls of the bricks had out of plane defects which significantly reduce their strength and stiffness (Fig. 5). Exterior masonry panels had large openings for windows and interior infill panels had door openings, usually located at one end. The formation of the compression diagonal struts was prevented as the small lateral drifts were usually accommodated by the door opening.

Fig. (5). Typical masonry work in the building.
