## Corrosion of *Askja*, the Natural Sciences Building in Reykjavik. A Case Study 2004-2014

**Abstract:** Corrosion problems related to the design, material selection and construction of *Askja*, the Natural Sciences Building at the University of Iceland have been followed through a period of ten years from 2004.

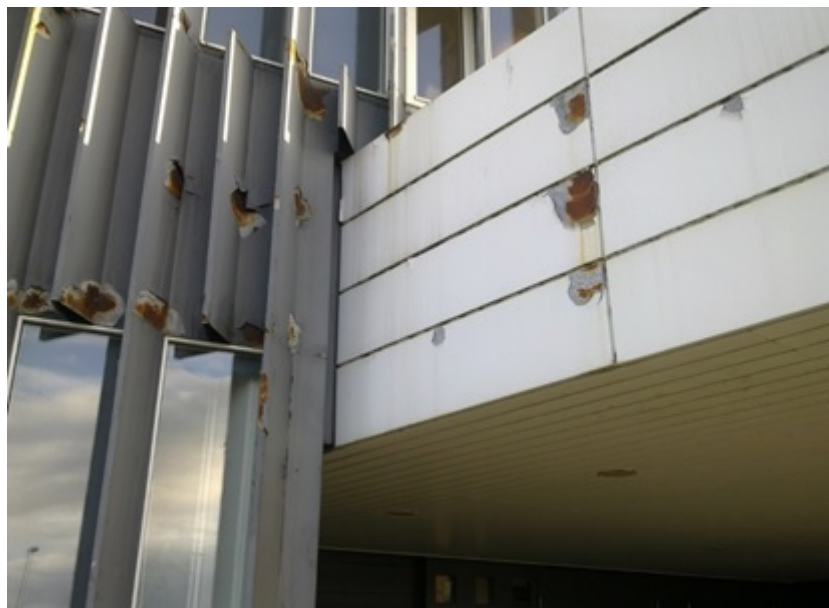
The metal cladding of *Askja* covers large parts of three sides of the building, to the East, South and West. It is a very complex structure with large protruding ridges (see Fig. 2). The cladding is made of 1 mm aluzinc (AZ150) fastened together with stainless steel (A4) screws and rivets.

**Fig. (2).** The *Askja* building showing the complex structure with its large protruding ridges. Photo taken in September 2011.

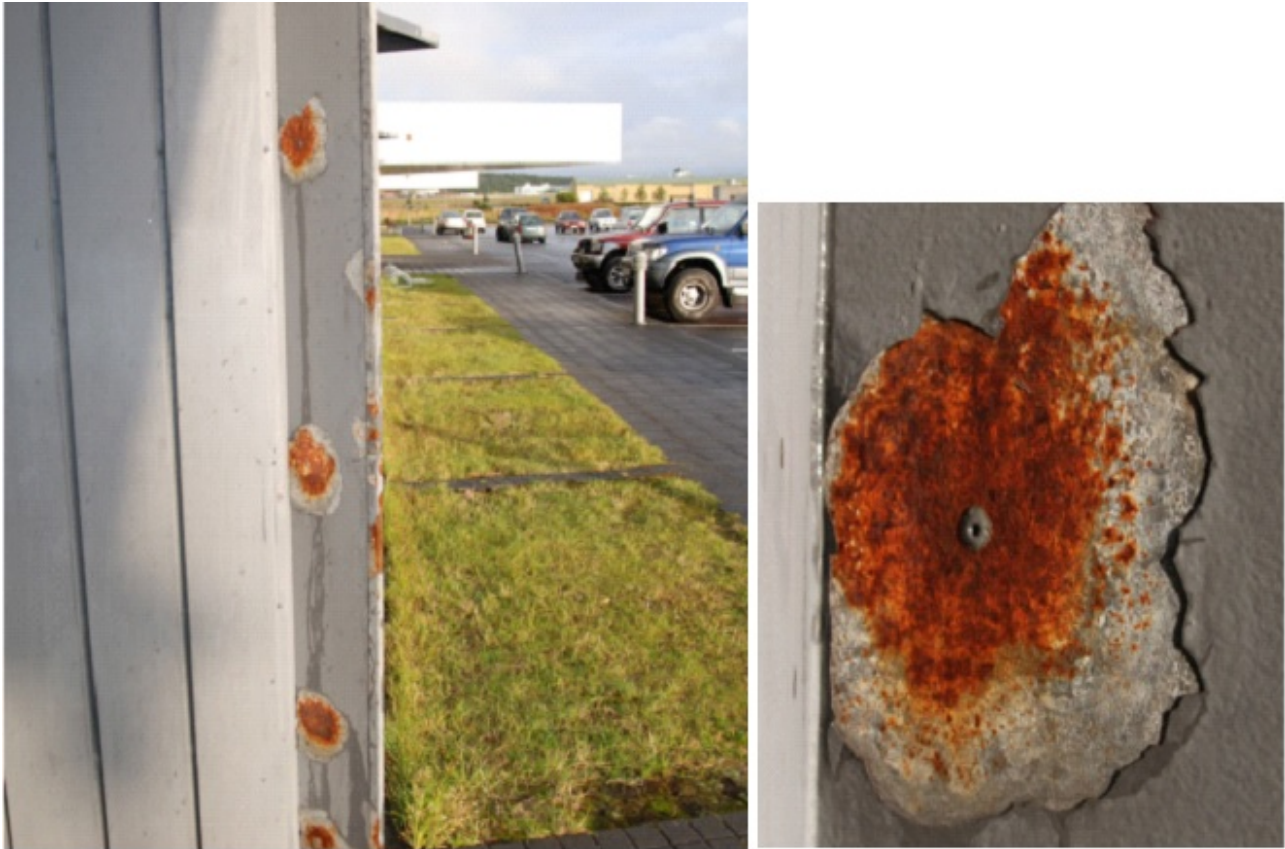
The corrosion problems are mostly observed around the stainless steel fasteners as shown in Fig. (3) (photo taken in September 2009) but also close to crevices. Even repainted areas suffer from galvanic corrosion within one year of the repair (see Fig. 4). Thus, the main corrosion cause is related to galvanic corrosion driven by the large difference in the corrosion potential between the stainless steel and the aluzinc. Secondly, the structure is complex, with narrow gaps

**Fig. (3).** The corrosion attack related to the stainless steel fasteners. Photos from September 2009 [4].

First of all, the use of stainless steel fasteners in the aluzinc cladding has led to severe galvanic corrosion of the

aluzinc adjacent to the fasteners. That using stainless steel fasteners in contact with aluzinc leads to severe galvanic attack in corrosive environments is well known [5].

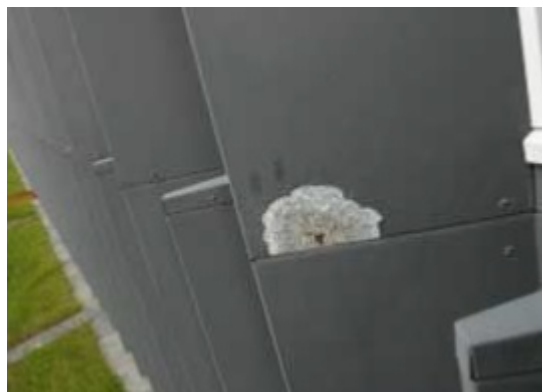
**Fig. (4).** Galvanic corrosion of a repainted part of *Askja* building in September 2013.

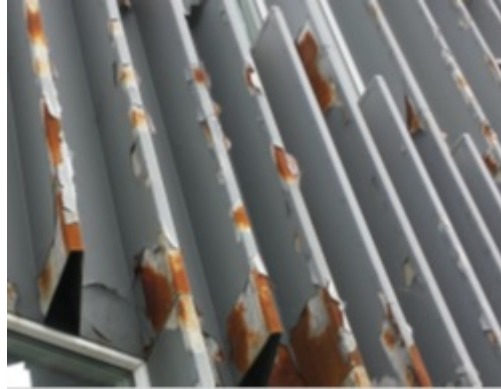
between surfaces allowing retention of water and pollution and thereby promoting crevice corrosion. In this case the crevice corrosion is compounded by galvanic effects. Fig. (5) shows the corroded building in September 2013.

**Fig. (5).** Corrosion attack on *Askja* building in September 2013.

Secondly, the design of the complex structure promotes crevice corrosion. The oxygen deficiency and retention of moisture in crevices between sheets, and between fasteners and sheets, forms aeration cells, accelerating local corrosion attacks. This is further promoted by chlorides and other pollution particles that get drawn into the crevices to balance the positive charge of metal cations created by corrosion. The pollution particles stay in the crevices and become more concentrated and more aggressive over time [6].

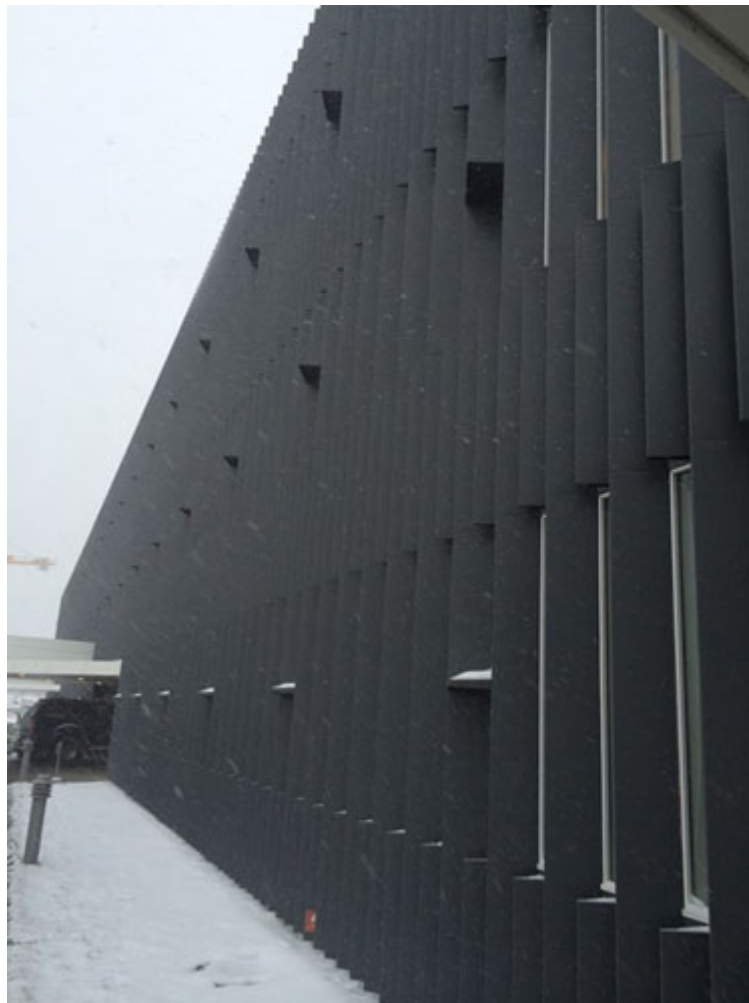
*Askja* has been renovated during the last year by polishing the cladding and repainting it (see Fig. 6). Alternative solutions providing a future solution to the corrosion problem were also discussed and estimated. This included redesigning the cladding with a simpler design and renewing it using aluminium. However, this would involve a high cost and moreover, approval would be needed from the building's architect [1]. Thus, the problem has hardly been solved with the recent renovation of the building, and the galvanic corrosion between the aluzinc cladding and the stainless steel fasteners will continue. Corrosion products can already be detected in a few places around stainless steel

fasteners. The complex structure with the many crevices, together with the weather conditions and the closeness to the coast, further accelerates the corrosion.

**Fig. (6).** *Askja* in February 2015, after renovation.

The repainting of the building without changing the stainless steel fasteners or isolating them from the aluzinc cladding will not last for a long time. Corrosion attacks can already be seen some places one year after the renovation. Due to the complex design and number of fasteners it is costly and difficult to change all the fasteners. In the future it will become necessary to replace the cladding and use fasteners of similar material, preferably aluminium as this has worked well in similar environment. This needs to be done before the corrosion becomes so severe that the cladding begins to fall off damaging properties, injuring or even killing people. It would also be preferable to simplify the design to reduce the susceptibility towards crevice corrosion.
