Safety Audits at Finnish Level Crossings

Veli-Pekka Kallberg^{*,1}, Antti Seise¹, Jouni Hytönen² and Tapio Ahonen¹

¹VTT Technical Research Centre of Finland, Finland

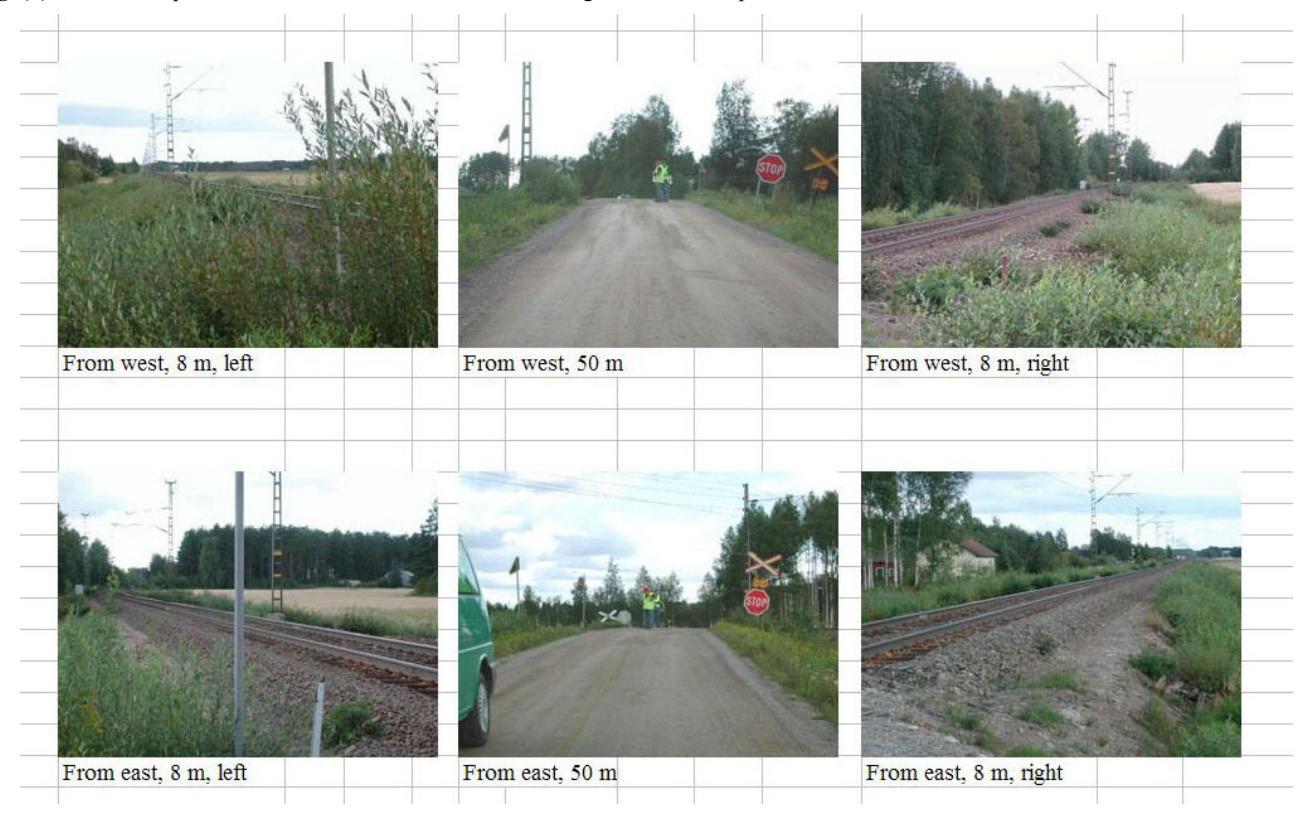
level crossing are summarised in photographs taken at fixed locations. The address and name of the level crossing are in the top left corner of Fig. (3). The estimated traversing times for a 25.25 m long truck and trailer combination and a car are 17 seconds and 5 seconds respectively, and in this case they are the same in both directions. The required sight distance in the guidelines [6] in metres is 6 times the maximum train speed in km/h, in this case $6 \times 140 = 840$ m. This corresponds to an actual traversing time of 21.6 seconds, which is usually long enough even for heavy truck and trailer combinations starting from standstill 8 m from the nearest track. Even after clearing of vegetation, the sight distances from the west to the right and from the east to the left remain shorter than required. The shortest sight distance of 350 m after clearing of vegetation means that if there is no train in sight, road users have at least 9 seconds to traverse the track. This is enough for cars but not for truck and trailer combinations. The recommended measures in this case were clearing of vegetation and a driving ban for truck and trailer combinations.

Fig. (4). Standard presentation of photographs in the audit reports.

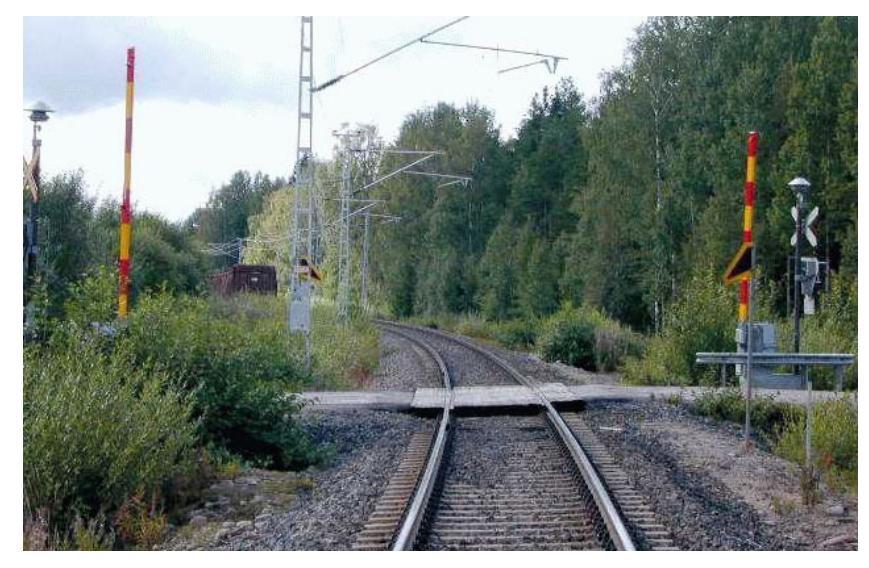
Clearing of sight-restricting vegetation should be carried out regularly in the summertime (Fig. 6). Clearing is usually possible only in the railway area, and it is not always possible to remove bushes and trees on private land.

Fig. (6). Sight-restricting vegetation.

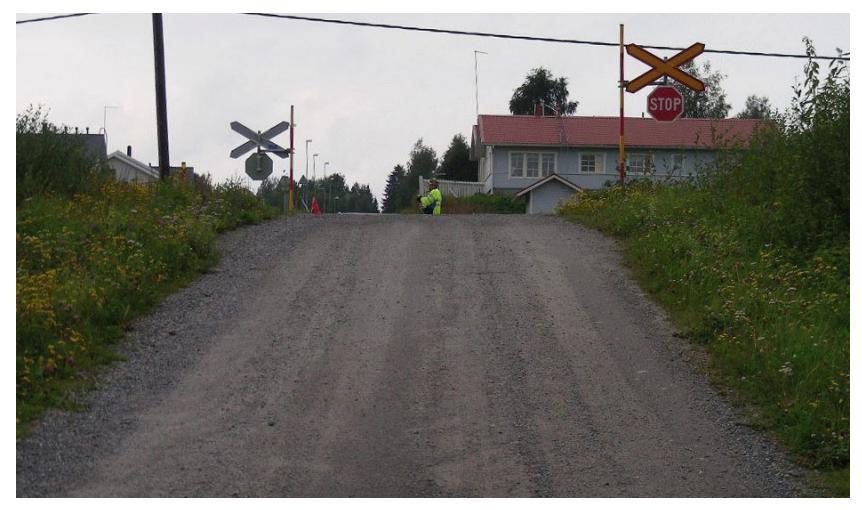
- The railway is often on a bank and the approach to the level crossing is steeply uphill, especially on minor rural roads (Fig. 7). Improvement of the road alignment is sometimes not possible without major reconstruction, especially when there is a road parallel to and very near the railway.

Fig. (7). Steep approach to a level crossing.

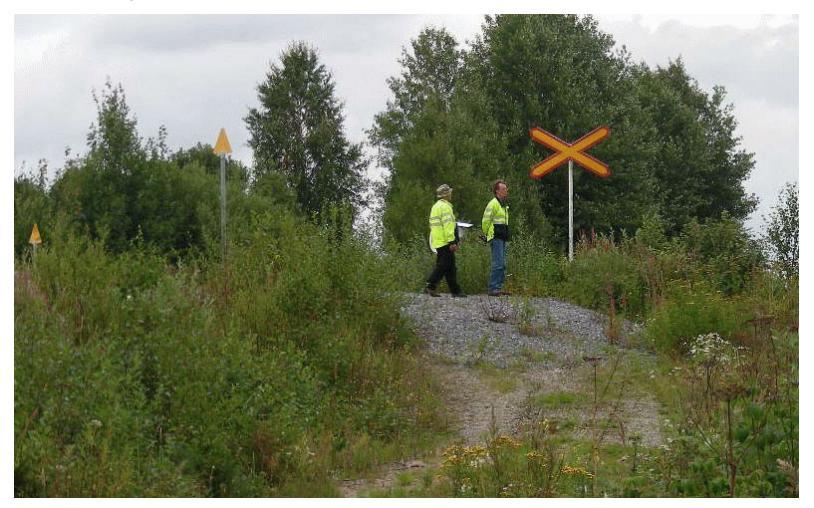
- Driving bans for certain types of road vehicles are feasible only when it is unlikely that such vehicles must use the level crossing.
- Level crossings can be removed only if traffic can use other existing or new routes, or the level crossing is not used at all (Fig. 8). Removal of existing level crossings also requires administrative procedures, which can be laborious.

Fig. (8). A desolate level crossing clearly not in active use.
