Attachment of Natural Lightning Flashes to Trees: Preliminary Statistical Characteristics

Abstract: Lightning attachment to trees was studied based on 37 trees that were struck in Finland in summer 2007 and 2008. The type and severity of lightning damage was correlated with multiple parameters related to the flash, the meteorological characteristics of the strike time, and the surroundings of the tree. Damage was classified into three categories: bark-loss (minor), wood-loss (extensive), and explosive (complete loss of tree material). Four statistically significant parameters were found. The absolute value of the peak flash current is strongly correlated with damage; also, an indirect argument suggests that positive flashes cause more damage than negative flashes. The amount of damage is inversely correlated with the rainfall in the previous three hours, indicating that a wet ground and tree surface protect trees against damage by providing a conducting path to the ground. The ground type also has a weaker statistically significant effect, with poorly conducting ground leading to more extensive damage. Old and rotten trees are statistically most likely to experience explosive dama

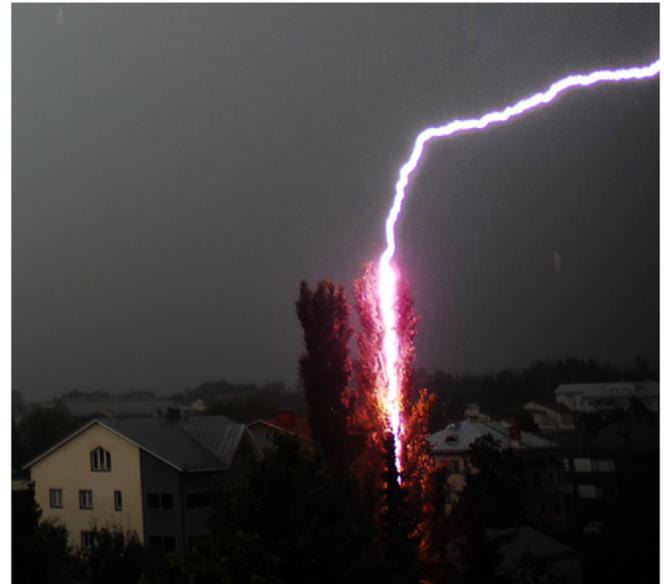
Fig. (1). Picture of lightning flash to nearby tree. No damage to the tree was observed. Picture is cropped from the full image shown in the Appendix. Photograph: Niklas Montonen.

One observer (Niklas Montonen) photographed a flash in Porvoo which hit a European aspen (*Populus Tremula*) less than 50 meters away. Fig. (1) is a cropped part of the full photograph. Based on location and timing, the flash could be uniquely tied to a -6kA flash with multiplicity 1. As in the case of [5], no damage whatsoever was observed to the tree, nor was any observed when the tree was rechecked in June 2008. As in [5], there had been a considerable amount of rain before the flash (15 mm in the three hours before the flash). According to the observer, the flash did cause a temporary break in cable TV service to the area.

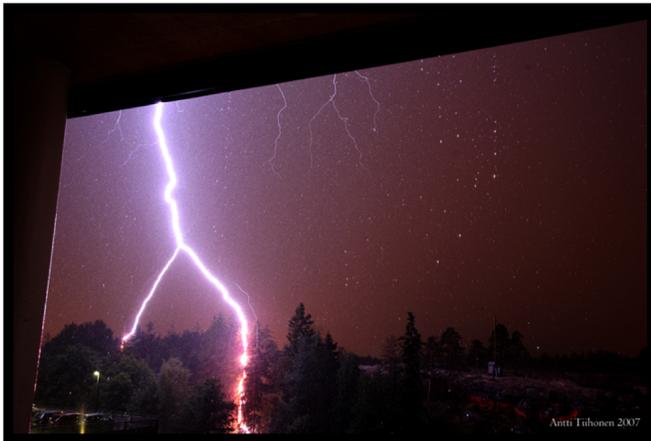
Fig. (2). Viikki case: Picture of three-stroke flash to trees. Photograph: Antti Tiihonen.

Another observer (Antti Tiihonen) caught a nearby flash in Viikki, Helsinki (Fig. 2). The flash was found to be a -13 kA flash with multiplicity 3. There had been about 15 mm of rain in the 24 hours before the flash, and both the ground and the trees would have been saturated with rain. The photograph shows a number of small-scale lightning phenomena which have not often been captured for natural flashes. The flash has at least one fork, which suggests that at least one of the subsequent strokes hit the ground several hundred meters from the others. An unconnected upward leader can be seen rising from the fir tree at the foreground. More weakly, a number of filamentary upward leaders can be seen to be associated with the stroke that is farther away. The return strokes have been overexposed, and it is not possible to see whether there is any fine structure in them. The struck tree in the foreground was found on the following day (Fig. 3). The tree with the upward leader could also be identified on the ground, but sustained no visible damage. The tree in the background that was also struck could not be identified with certainty, indicating that damage to it was small or non-existent. The fine structure seen in the photograph therefore did not appear to cause any visible

damage; even the return stroke caused only minor bark-loss damage.

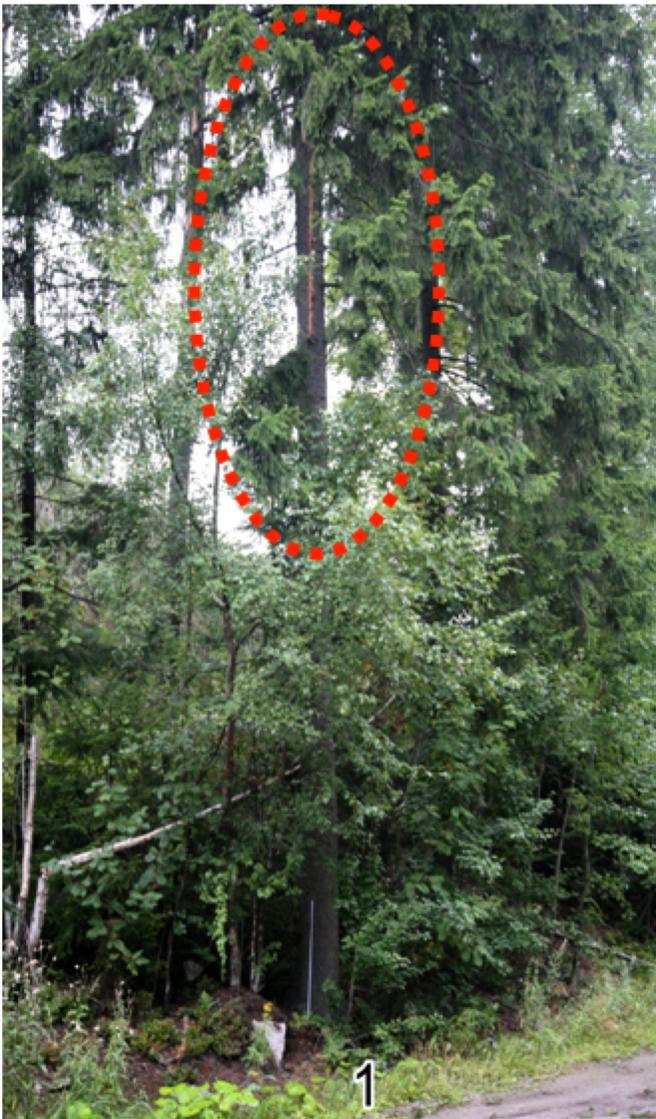
Fig. (3). Viikki case. Classical scar to the main struck tree above 6 meters. No damage to the tree with the attempted leader. Photo: Antti Tiihonen.

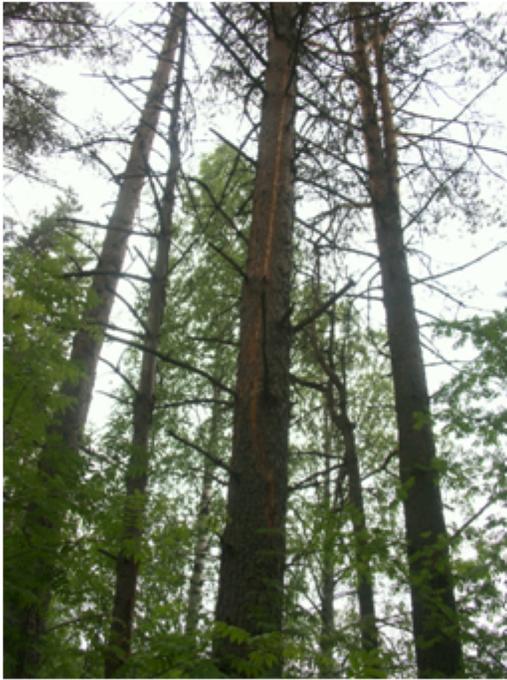
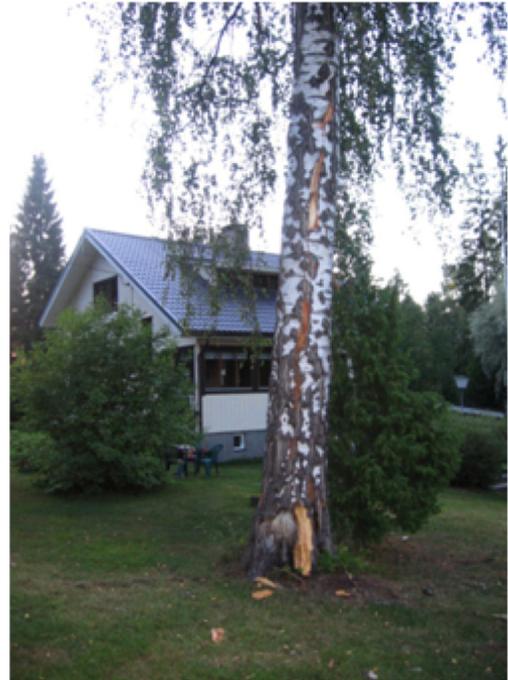
Fig. (4). Bark-loss damage in a fir (left) and birch (right). Photos Esa Tuunanen (left), Jussi Haapalainen (right).

Fig. (4) shows examples of bark-loss damage in an evergreen and a deciduous tree. Fig. (5) shows a somewhat more unusual bark-loss case in which long strips were torn away. The photo also shows a small furrow in the ground, as well as the vertical cracks described by [10]. In wood-loss cases, some inner wood is ejected as well, but the damage is still restricted to only part of the tree. This implies that current has partly penetrated into the inner wood, although the exact damage-causing mechanism may not be known. Fig. (6) shows a rather typical wood-loss case extending almost the full length of the tree. In explosive cases, the damage is so extensive that the entire tree mass has been blown apart. Fig. (7) shows a fir tree which was essentially demolished. There is some room for subjectivity in classifying individual cases, with the boundary between wood-loss and explosive being particularly fuzzy. However, each of the authors made the classifications independently for each case. Although there were some disagreements classifying between wood-loss and explosive damage, bark-

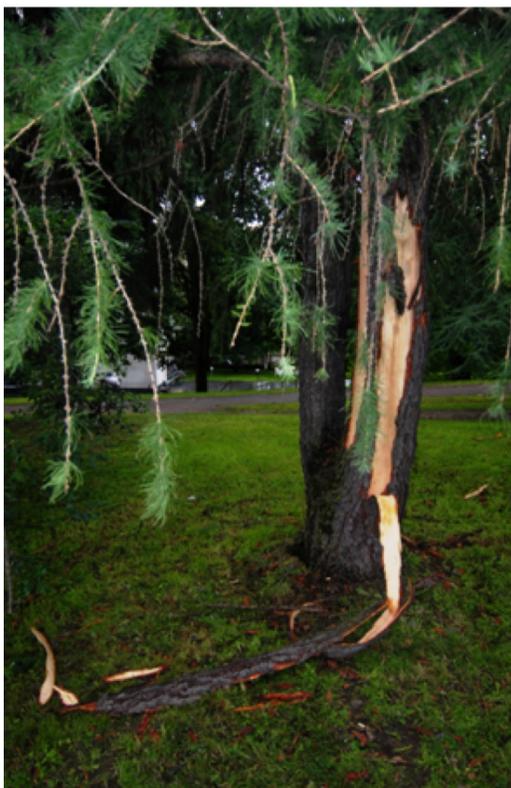
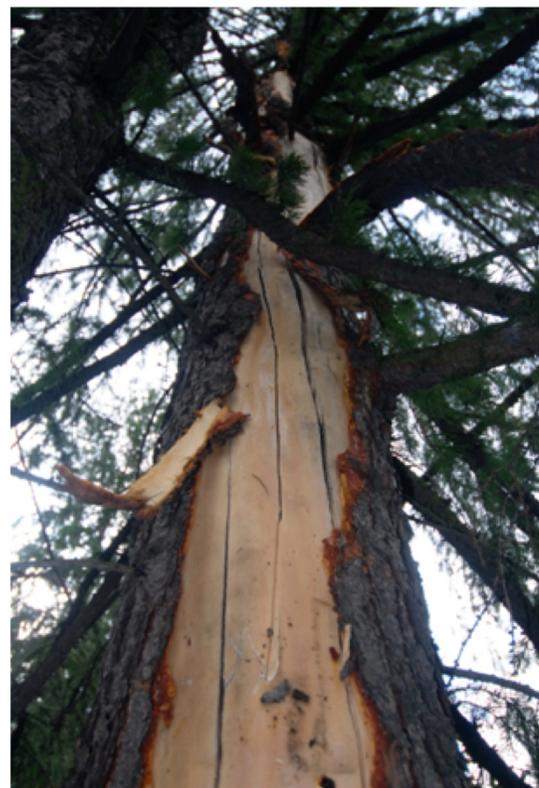
Fig. (5). Unusual bark-loss damage in a larch tree. A weak furrow can be seen in the ground. The tree also exhibits cracks along the grain. Photo: Eero Karvinen.

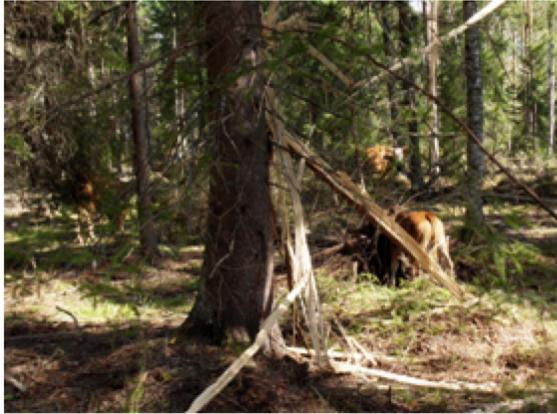
Fig. (6). Wood-loss damage to a fir tree. Photo: Matti Mäkelä.

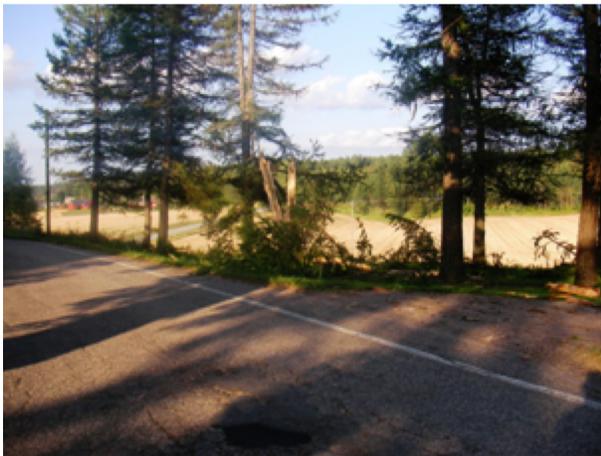
Fig. (7). Explosive damage to a fir tree. Photo: Mats Kommonen.

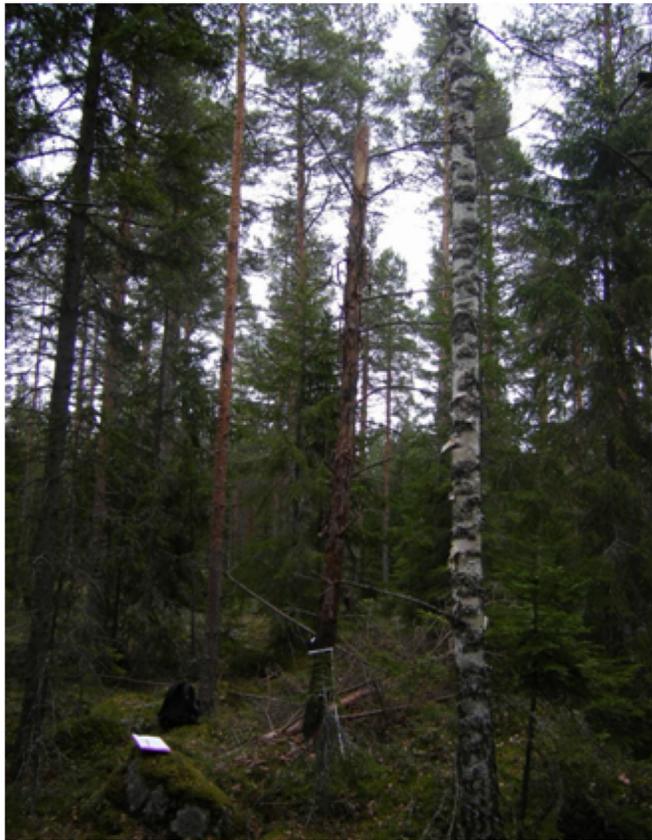
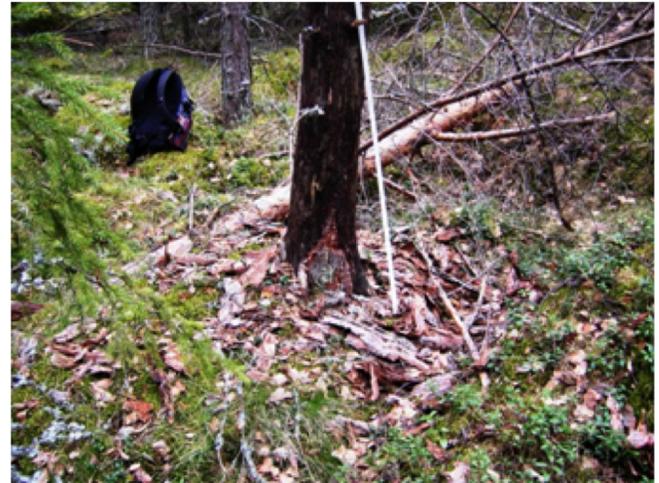
Fig. (8). An "anomalous" case. The bark has been disturbed by a strong impulsive force, but the mechanism cannot be identified as lightning with complete certainty. The lightning-detection network observed a flash at the location. Photo: Jakke Mäkelä.

loss cases and wood-loss cases were unambiguously separate. In the 2007 data collected by the “flash-based” method, a number of “anomalous” cases were found (Fig. 8). The mechanism causing the damage was clearly impulsive and the location fits with a flash observed by the lightning detection network, but cannot be identified as lightning

damage with any certainty. Experienced foresters consulted about the damage could neither rule out nor confirm the damage as being lightning-caused. These ten cases have been included in the data set, but analyzed separately.
