Environmental Impact of Beach Nourishment: A Case Study of the Rio San Pedro Beach (SW Spain)

Abstract: The beaches on the left bank of Rio San Pedro (SW Spain) are in a regressive state because of the human activities of recent decades. With the objective of minimizing the effects of the erosion, the Spanish Coastal Department (Ministry of the Environment) decided that the most suitable solution was to provide sand nourishment. Previously, an environmental impact study (EIS) was carried out on these beaches, and an environmental monitoring campaign was also completed during that nourishment. A new methodology to perform this kind of studies is proposed in the present report. Moreover, a form is proposed for establishing the degree of observance of the EIS. Additionally, discrepancies in opinions on the alleged environmental impact of the sand nourishment on the *Uca tangeri* (European Fiddler crab), a representative but not protected species that lives in the area of research, led to the development of a complementary study. Therefore, observations, experimentations and calculations were carried out on individuals of this species of crab. It was concluded that there was no signif

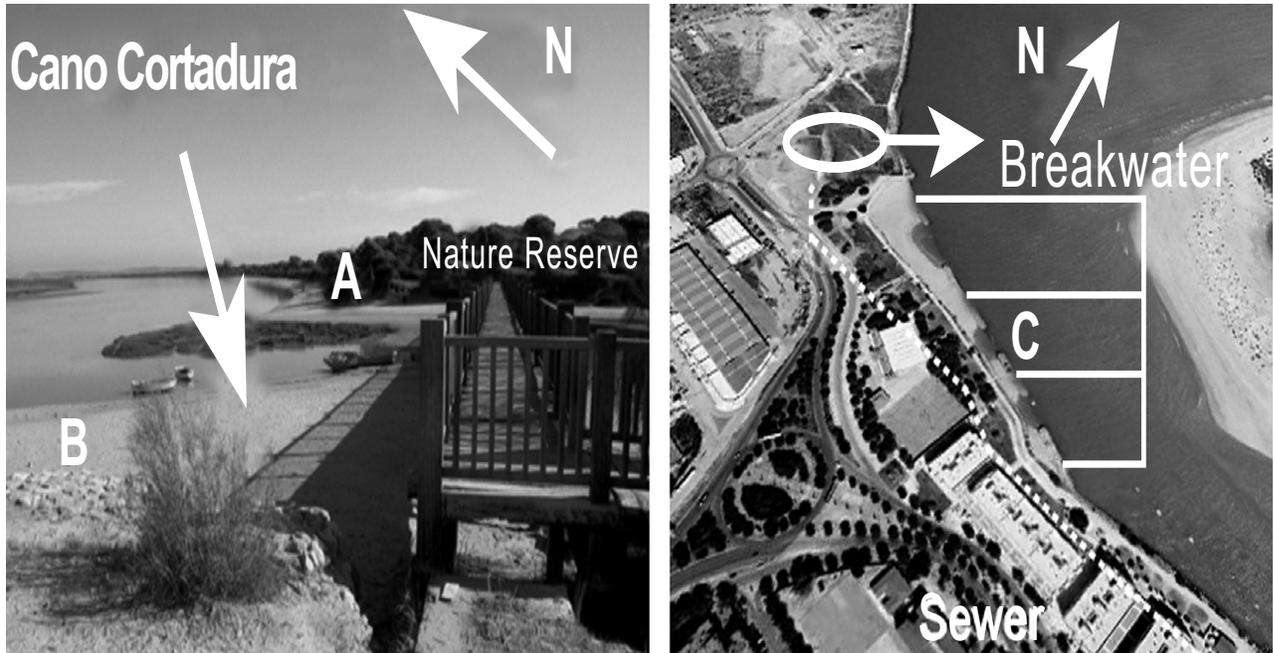
Fig. (1). The location of Cadiz in the Iberian Peninsula. The nourished beaches on the San Pedro River (A and B are upwards and downwards Caño de Cortadura; C is a pocket beach behind the detached breakwaters).

The area of study is located in Puerto Real, which is situated inside the Bay of Cadiz in the southwestern end of the Iberian Peninsula (about 36°31'N and 6°13'W) where low coastal areas with sand bars and tidal marshes dominate (Fig. 1).

An EIS of the area in question was carried out a priori, taking into account the area located inside the Cadiz Bay Nature Reserve. This area corresponds to the part of the beach situated opposite from the La Algaida pine wood (see Fig. 1).

Several samples were taken before, during and after the replenishment of the three beaches (Fig. 1) and from different profiles of the beaches, although a uniform pattern was always used. Each of the samples was sieved and the corresponding granulometry was obtained.

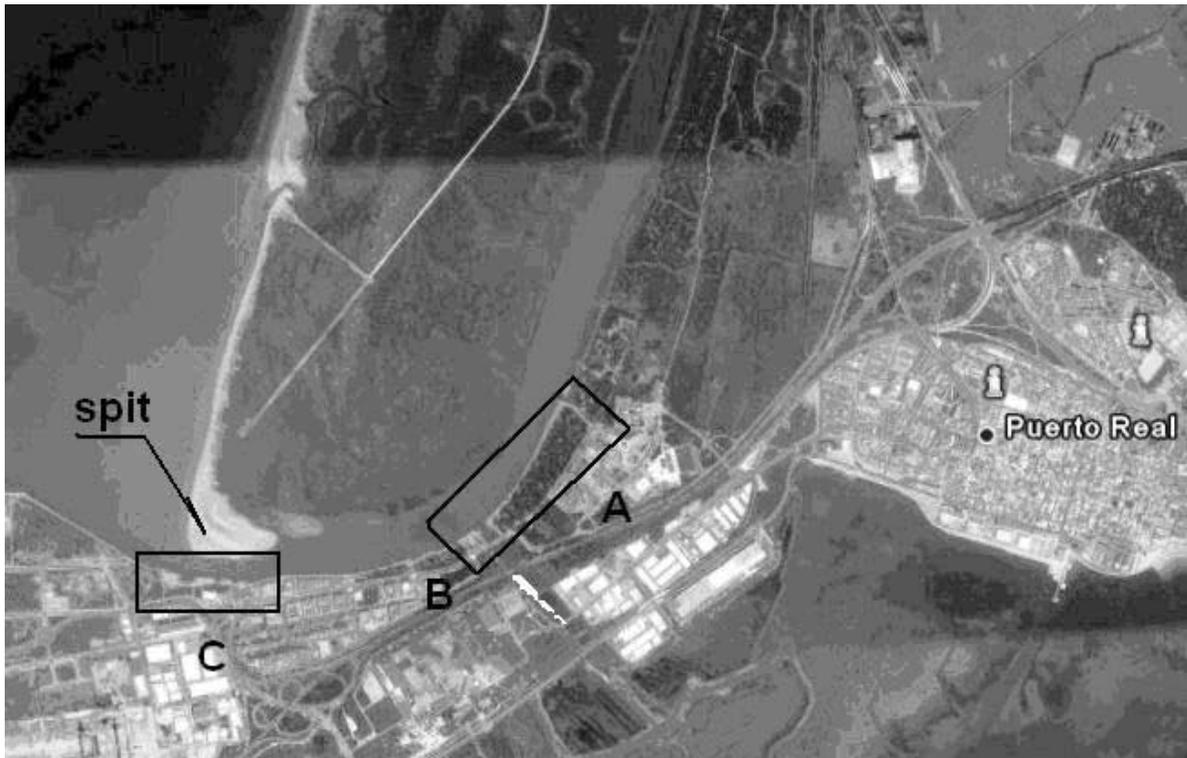
Fig. (2). An aerial photograph showing where the arrow-shaped beach is located. The nourished areas are framed in rectangles.

flood tide level; the current increases again and becomes a minimum once more at the low water tide. Moreover, the water stream is faster on the top surface than on the bottom and the center, and it is faster along the left bank than on the right shore. Note that the littoral dynamics have created a spit (an arrow-shaped beach) in the outside area (Fig. 2).

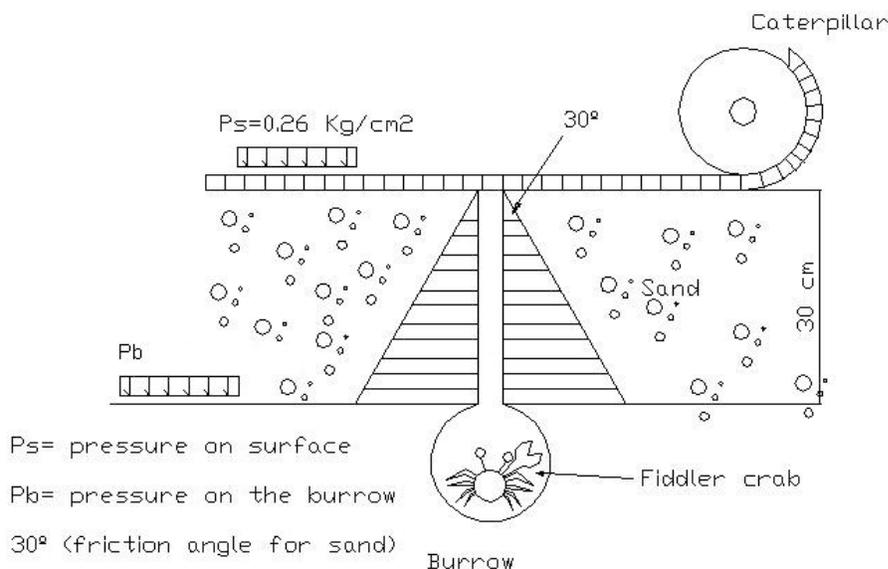
Fig. (6). The pressure over the burrow walls diminishes according to the internal friction angle of the sand. The fiddler crab only support the tidal water level pressure.

column of water during rising tides. The results indicate that the pressure produced by the column of water (0.4 Kg/cm²) during high water tide over a crab who lives buried at 30 cm deep is greater than the pressure experienced by the same crab during low tide as a bulldozer passes overhead. A bulldozer with two 3 m long by 0.5 m wide caterpillars and a weight of 8,000 kg was used to spread out the sand. This means that there was a pressure of 0.26 kg/cm² on the surface of the sand. As the crab hides into his burrow, which

is 30 cm deep, the pressure on the burrow walls diminishes according to the internal friction angle of the sand (Fig. 6). Therefore, the sand replenishment project could have been carried out with a bulldozer that weighted 4 times greater than the one used without endangering the *Uca tangeri*.
