# The Open Construction and Building Technology Journal

## Numerical Analysis of Historic Structural Elements Using 3D Point Cloud Data

Umut Almac\*, Isil Polat Pekmezci and Metin Ahunbay

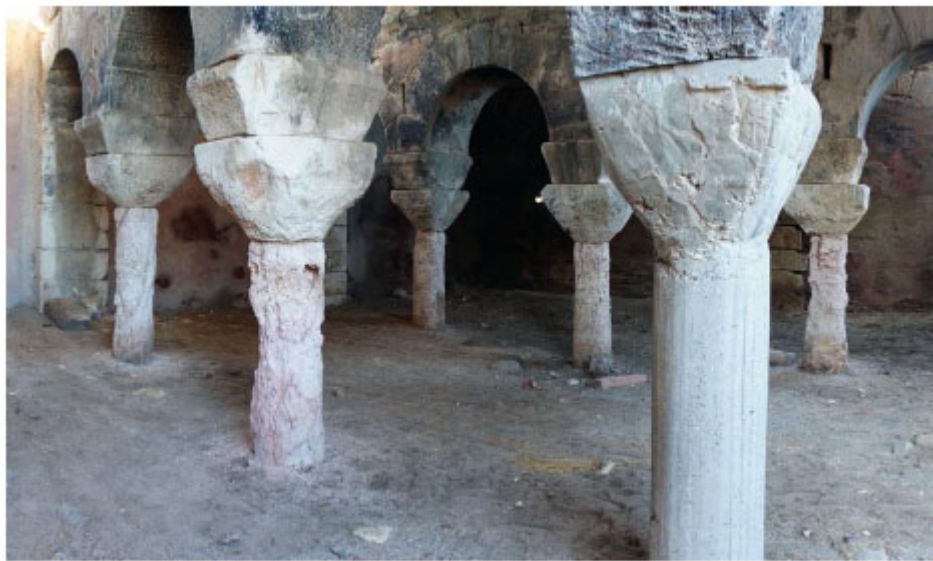
Fig. (1). The cistern of Hagia Thecla Basilica, interior space, 2013.

The columns supporting the upper structure originally had a diameter of approximately 45 cm (Figs. 1, 2). They are made of a pink calcareous stone. The columns have double capitals made of limestone (Fig. 1). It is not possible to make observations about the condition of the column bases and the floor, due to the thick layer of earth accumulated inside the cistern over centuries.

One of the columns (column 3) collapsed in the 1960s and was replaced by a concrete column [22]. This was an emergency intervention to stop further damage. The boundaries of the collapsed section can be distinguished easily by the new stones used for the repair (Fig. 1).

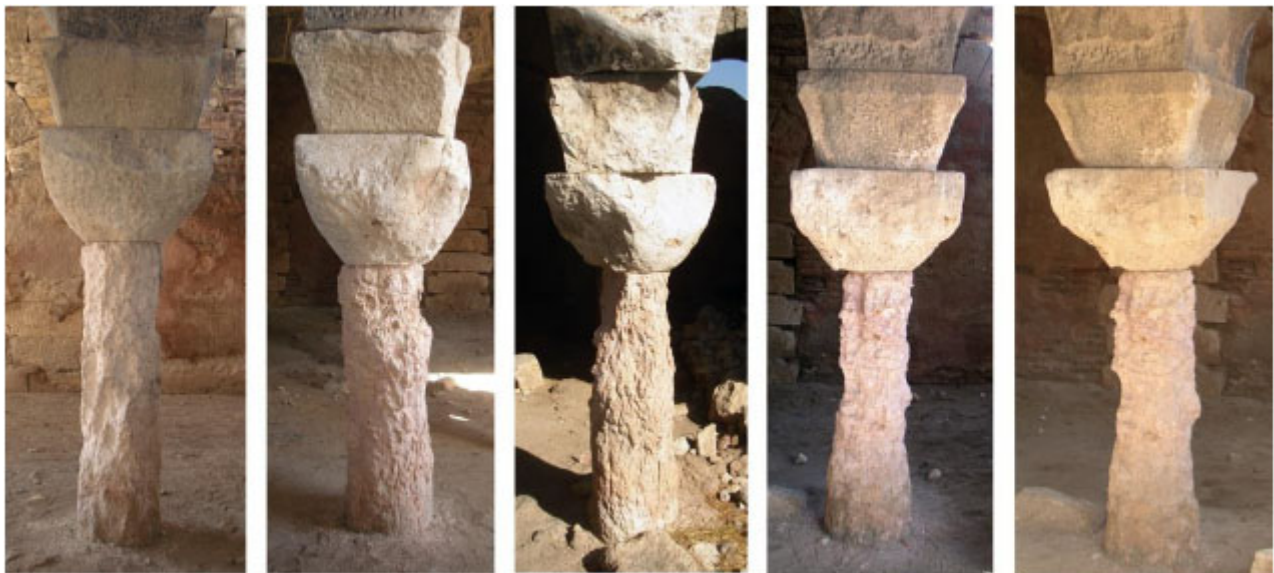
The most vulnerable elements of the cistern are the decayed stone columns. The cross sections of the columns have decreased remarkably (Fig. 5). The exterior surfaces are flaking due to physicochemical effects; the erosion continues. In addition to surface erosion with a non uniform pattern, there are deep cavities on the columns (Table 1).

Fig. (5). Decayed columns of the cistern (Column 1, Column 2, Column 4, Column 7, Column 8).

Column	Damages	Min. cross section area* (cm <sup>2</sup> )
Column 1	Non-uniform erosions.	1037
Column 2	Deep cavities and non-uniform erosions.	1231
Column 4	Severe and non-uniform erosions. Fractured and missing parts both on the columns and capitals.	800
Column 5	Relatively uniform erosions.	1355
Column 6	Relatively uniform erosions.	1181
Column 7	Severe and non-uniform erosions. Fractured and missing parts close to the connection with the capital.	827
Column 8	Severe and non-uniform erosions. Fractured and missing parts close to the connection with the capital.	1204

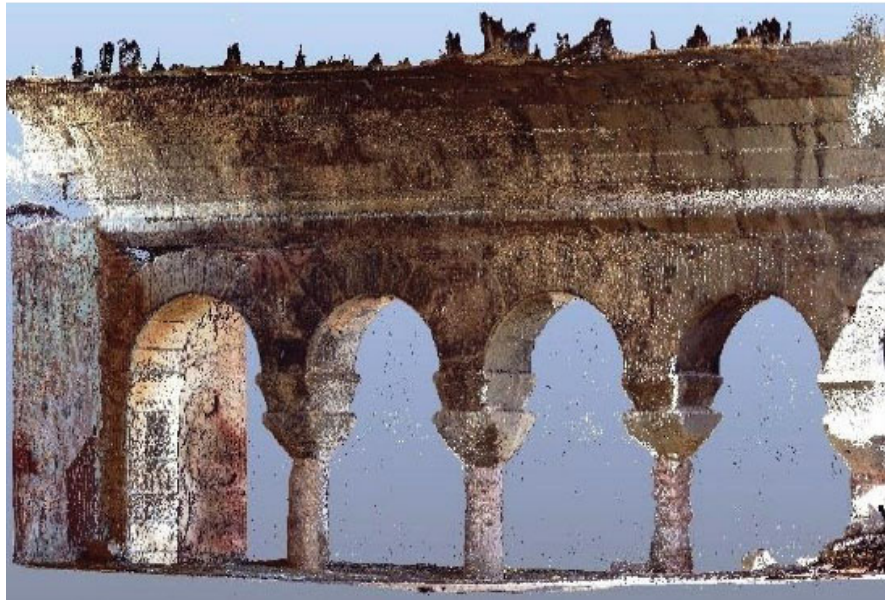
The software ‘FARO Scene’ was employed to register the point cloud using common control points visible in both scans [29]. Preliminary cleaning and cropping of the point cloud data of columns were also achieved through the same software (Fig. 6). Conversion of files into a compatible format to start with the solid model was the last step of the primary stage.

Fig. (6). An example from the point cloud data of the structure.
