The Open Construction and Building Technology Journal

The Effect of Boundary Conditions on the Behaviour of Pointed Masonry Barrel Vaults: Late Gothic Cases in Scotland

D. Theodossopoulos*, N. Makoond and L. AKL

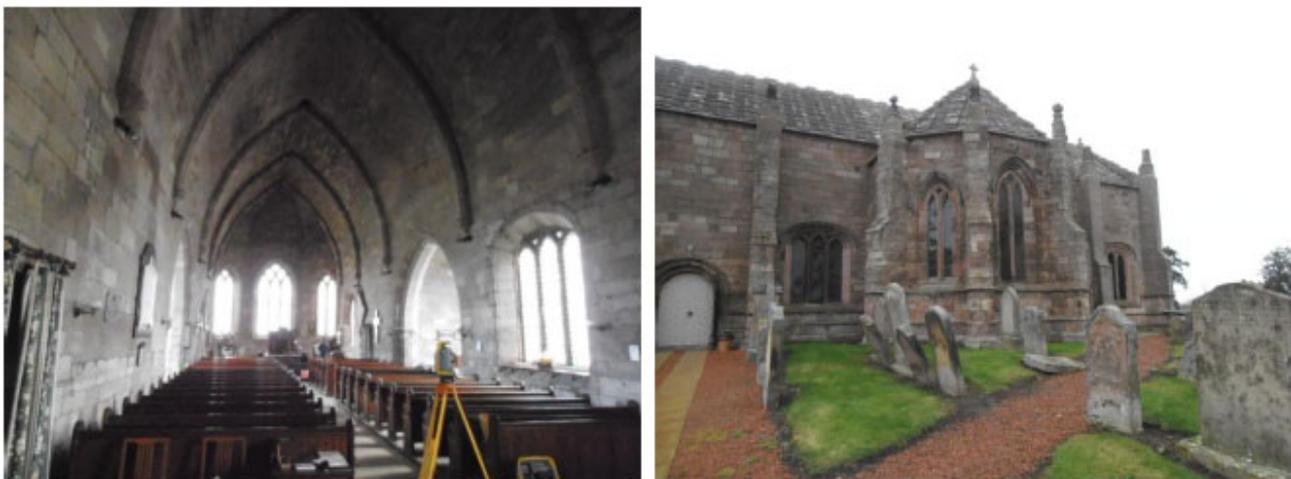
Fig. (1). The nave, flagstone roof and buttresses of Ladykirk church, Scottish Borders.

Containment of the thrust line within masonry is fundamental for the stability of a vault and regarding the support conditions, transverse bracing along the longitudinal edges against the thrust is more important than the integrity of the gables, as indicated at Almond Castle (complete lack of gables) or Dundonald Castle (gable wall eroded around the windows underneath the apex) [11]. The churches are braced with full pier buttresses, sometimes attached at an angle at the corners of the apse, which reduce to half at mid-height. In Ladykirk for example, the piers are 1.2m thick at their

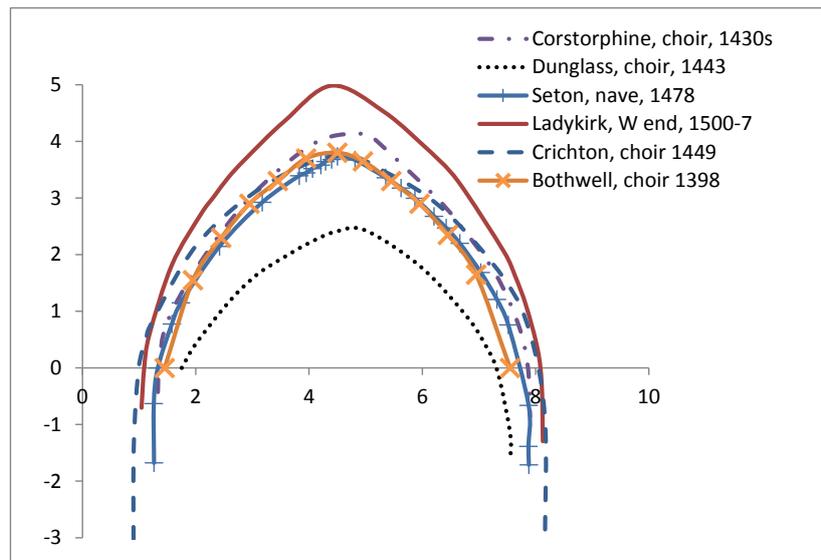
Fig. (2). Comparison of representative cross sections between five Scottish case studies of pointed barrel vaults.

The study of form from a survey of 5 major case studies [4] shed some light in the designers' choices and their relation to the construction process. The profiles in Corstorphine, Seton, Ladykirk (Fig. 1), Crichton and Dunglass are consistently pointed and there appears to be an underlying scheme of equilateral triangle that defines the overall dimensions of the vault itself (Fig. 2). The comparison of the profiles shows a slow increase in height, and Ladykirk in specific establishes a confident and safe design of pointed shells (6.5m span). Its normalised thrust was calculated as $0.374wR$ by thrust line analysis of the profile [4, 7] (w is its weight and R is the radius of the circular segments is made of), which is relatively low and well contained, and therefore has not caused any defects, in contrast to the visible cracks in Bothwell or the larger vaults of St. Salvator's (9 m span), which had to be taken down in 1773 [8]. In all cases, the construction is solid and of good quality ashlar finish, with almost no deviations of the pointed segments from their original circular profiles. When no deformation is observed in the supports, this quality shows the structural form is neither sensitive to the construction process (whether it progressed from the edge to the crown or end to end).

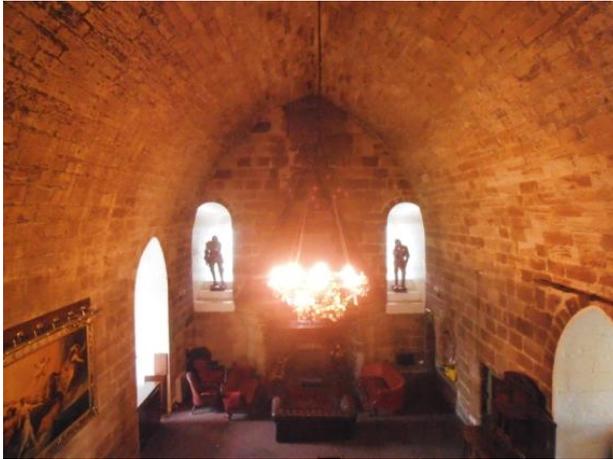
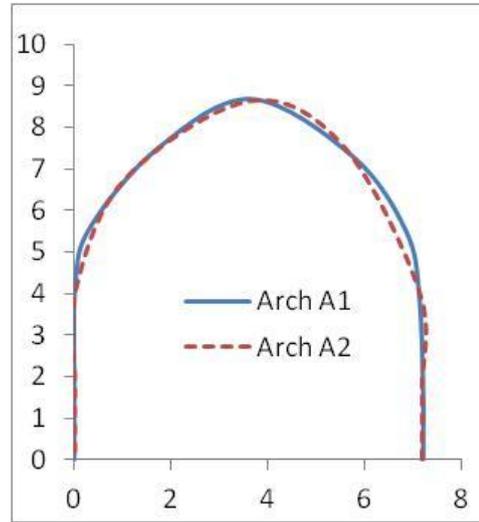
Fig. (3). The Great (Lower) Hall in Borthwick Castle (before refurbishment in 2013) and the geometry of each extreme section (more surveys can be found at [10]).

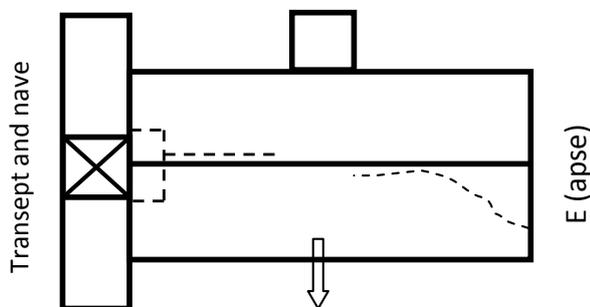
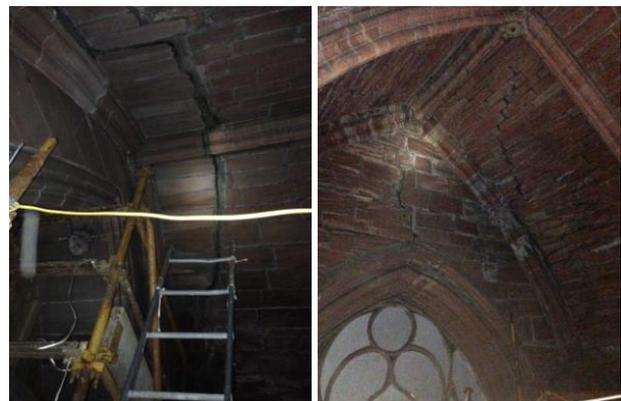
Fig. (4). Cracks pattern due to transverse outward movement drawn at the intrados of the choir in Bothwell church and the cracks next to the transept and apse [6].

Apart from the scale, a key difference with the model is the orthotropic nature of the masonry (Fig. 4), therefore a method used earlier to study the failure of Holyrood Abbey church [26] will be adapted here, using the same material properties here as well (Table 3). The orthotropic elastic modulus and bending strength were combined into a simplified version of a biaxial brittle failure criterion that controls the smeared crack approach, but the principles remain the same:

The orthotropic masonry increases the vault’s strength when the resulting deflections are compared to those of the isotropic model (Figs. 22, 23), as the stronger longitudinal direction resists the spread of failure. The supports displacement also compares well in terms of magnitude with those recorded for other gothic vaults [27], which tend to fail later however due to the stiffening effect of the transverse vaults (assuming that the construction quality and continuity of the vault along the ribs is good). Overall, the FE model is in good agreement with the deformation of the church and offers more insight on the sensitivity of the vault to the support conditions, as the combination of settlement and displacement can produce a pattern similar to Fig. (4)

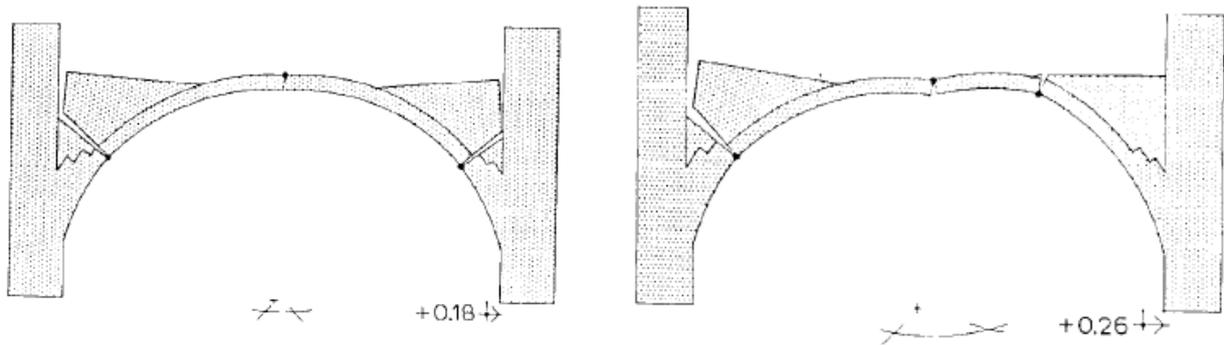
Fig. (5). The failure pattern of the vault model in the Cathedral of Sant'Angelo dei Lombardi due to supports spread (left) and the final failure pattern after the repairs (right) [14].

A major real case that offers insight to the failure from lateral movement is the lunetted brickwork cross vaults of Cathedral of Sant'Angelo dei Lombardi, which collapsed during the earthquake of Irpinia in S. Italy in 1980. One of the nave vaults was recreated in a full scale model spanning $L = 7.2\text{m}$ [14] and the effect of the horizontal component of the earthquake was simulated as a static spread of the abutments. The right-hand support was shifted outwards using hydraulic jacks until a 4-hinge failure [15, 16] occurred at 180 mm ($1/40$ of L) from a combination of three hinge lines at the arch with the spreading support, as shown in Fig. (5). Each part of the vault around the ridge was then repaired with a different technique: on the one section, the cracks were filled with a high strength grout, while in the other the masonry around the crack was rebuilt. The tests show the repairs are effective as the supports could be further displaced to failure at a total of 260 mm ($1/28$ of span), *i.e.* 45% more: the grouted portion became rapidly unstable while the rebuilt one developed the same crack pattern as before.

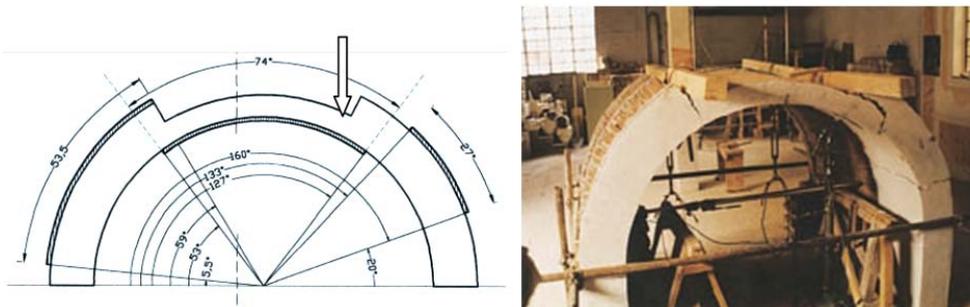
Fig. (6). Barrel vault loaded at quarter point (span $L = 2520\text{ mm}$): geometry and FRP reinforcement schematic, and failure pattern [17].

A further group of tests on barrel vaults demonstrated the effect of quarter-span point loading, with restrained supports. Plain tests on ribbed barrel vaults of circular profile spanning 2.52m [17] established the failure pattern, consisting of a downward longitudinal hinge at the load point and of one of opposite sign, symmetrically located Fig. (6), at a load of 4.95 kN (producing a 0.2mm deflection). Afterwards the vault was repaired locally at the faults with FRP, allowing the vault to carry a further load of 22.5 kN , or 4.5 times higher, reaching a 0.9mm deflection. When a new vault was reinforced with a regular grid and tested, its strength went beyond 60kN . In both reinforced cases, the failure occurred at positions similar to the unreinforced one but always around the FRP bands.

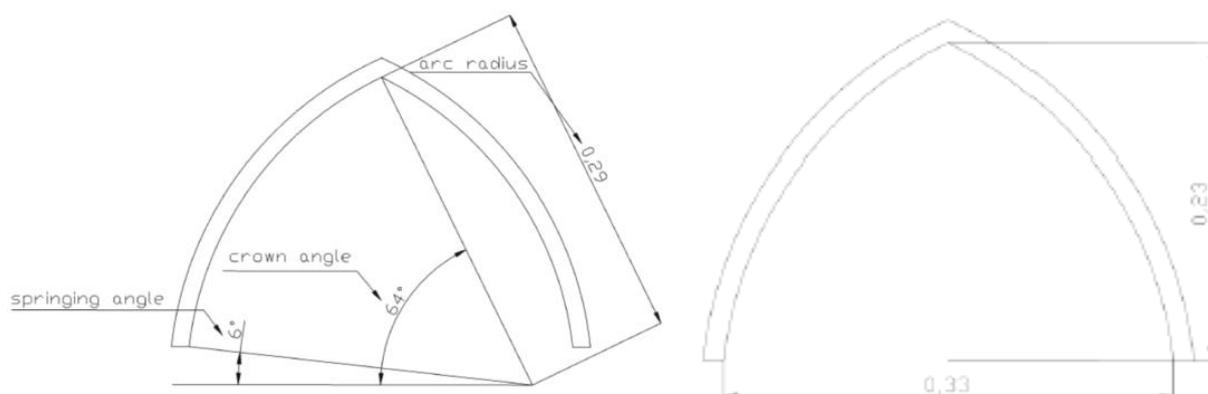
Fig. (7). Generating arch profile used for the models (all dimensions in m).

It was decided to find an arch profile from the survey data of 15C Scottish barrel vaults [4] that would represent their geometry and make a synthesis of their proportions (Fig. 2). A scale of 1/15 was chosen for the construction of the models, to enable a reliable repetition of several specimens of the same geometry, at a meaningful consistency and workable dimensions and set up. The representative arch profile chosen for these models has span to rise ratio $L/F=1.43$, a springing angle of 6° and a crown angle of 64° , (Fig. 7). The survey showed many vaults cover a length of 12m, so accordingly the models have a length of 0.8m.

Using the pointed arch profile in Fig. (7) a formwork was created and all barrel vault models were cast with two layers of scrim fibres (one layer in each direction in between 2 plaster layers), at a nominal uniform thickness of 15mm. All models and tests are summarised in Table 1, while Table 2 compares the maximum deformations measured at the crown at the point of failure.

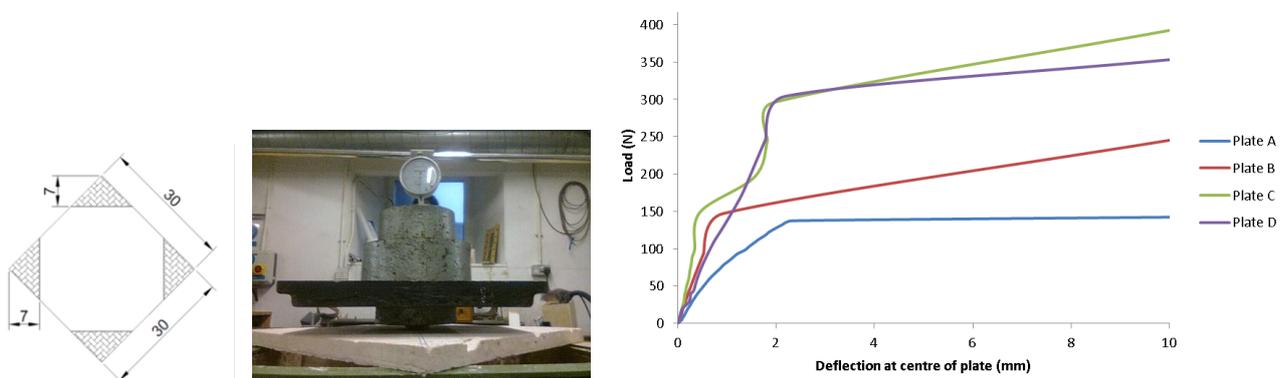
Fig. (8). Plate tests [6]: set up and deflection results. Plates A, B and C have the same thickness (15 mm) but 2, 4 and 6 layers of vegetable scrim fibres respectively. Plate D has 4 layers reinforcing a 17mm thickness.

Deflections were measured against the applied load and are plotted in Fig. (8): although Plate A appears to reach a plastic “plateau” at a smaller load, the elastic region seems to have a more gentle gradient and the material behaves more closely to a linear elastic perfectly plastic material with much less anomalies than the other plates. Plate A therefore simplified the understanding of the material’s behaviour and was chosen as the material of the model. Combining analysis with Finite Element (that assessed stresses at the plate) with the deflections and load recorded, Young’s modulus for the material was assessed approximately as 525MPa and the yield stress was approximated to 0.63MPa.

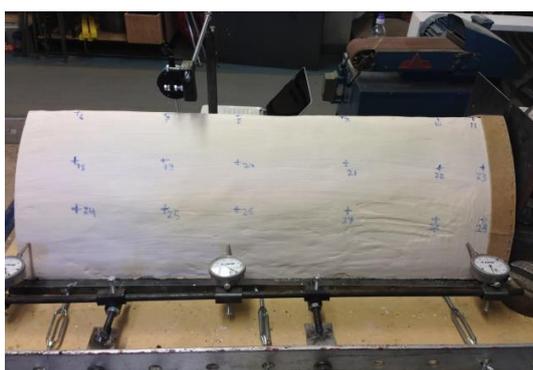
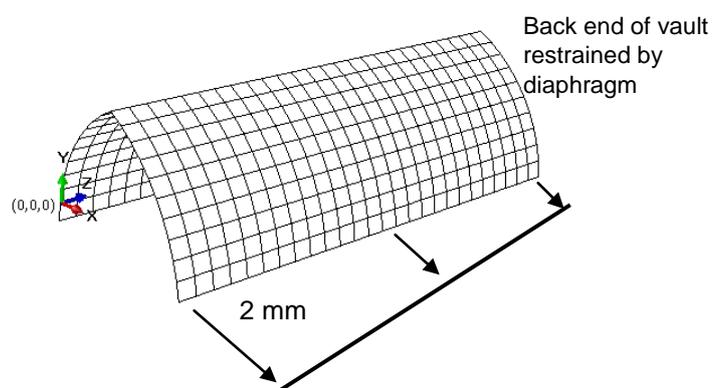
Fig. (9). The set up of the tests.

It was important to be able to impose a spread at the supports of the vault in a smooth and controlled manner without interfering with its response. Metal plates were bent in an angle shape and were attached at the edges of the barrel vault. Turnkeys were fixed on the plates and were used to spread out the supports uniformly if turned at the same time or asymmetrically. Since there were almost no deformations under the maximum uniform dead load that could feasibly be applied, no tests included additional dead loads aside from the self-weight of the vault. The tests confirmed

Dial gauges were set up to measure the spread exactly. The symmetrical spread was applied by turning all the turnkeys on either side of the vault at the same pace. The asymmetric, right-hand-side spread was applied linearly along the edge (Fig. 9): if the back edge was spread by only half a turn, the middle turnkey would have to go through one whole turn and the final turnkey at the front edge by 1.5 turn. This action corresponds approximately to a 2mm spread of the right hand side at the front end, or tip of the edge of the vault.

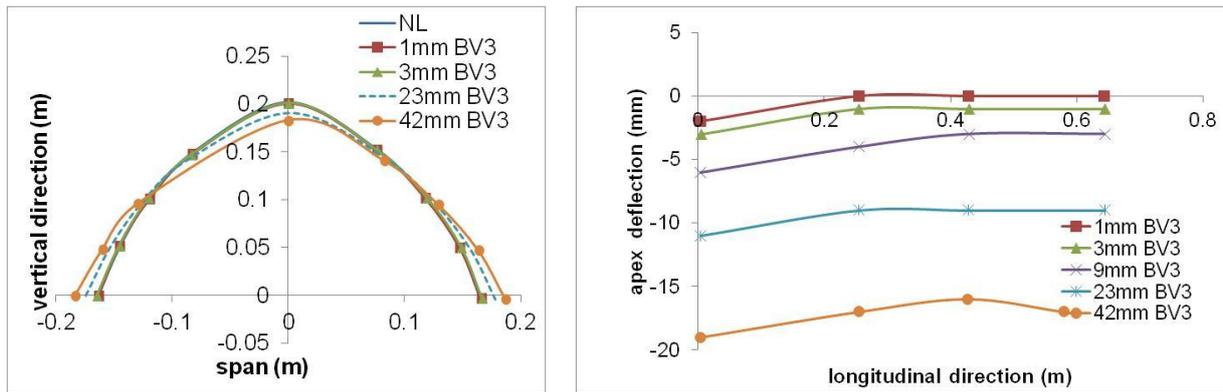
Fig. (10). Symmetric spread BV3: the front end (in m) and deflection along the apex (from free front end to the wall at the back).

Fig. (10) shows points on the vaults that were monitored using the Leica TPS1200 Total Station. The raw data recorded were translated into Cartesian coordinates using a transformation matrix set up into a spreadsheet by Katherine Primavesi and Jenny Gilbertson [22] so that the front profile lies on the x-y plane and the z-axis is the longitudinal one.

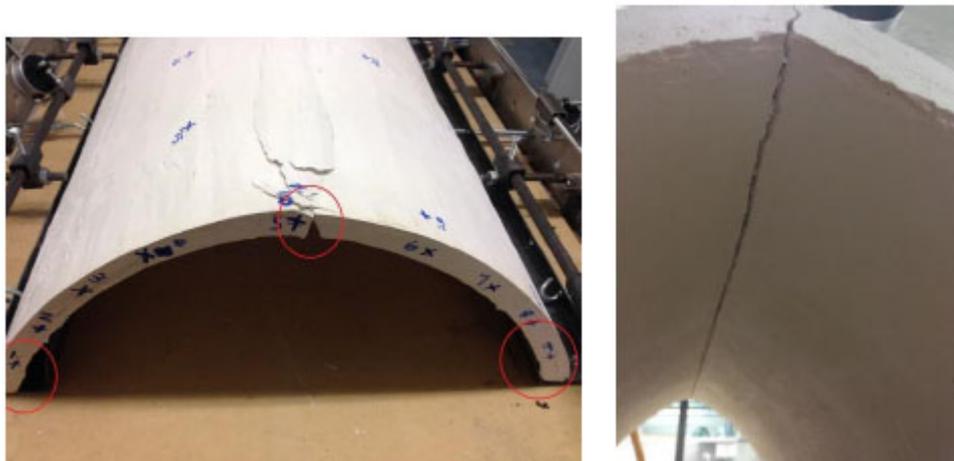
Fig. (11). Location of hinge-lines at BV3 (extrados and intrados).

Tests on vault BV3 imposed a symmetric spread which can be considered as the datum of all the tests (Table 1). The vault could withstand 21mm of spread on each side (total 42mm), causing the apex to deflect by 18mm at the front profile (Fig. 10). These graphs clearly indicate that as the vault is spread outwards, the top portion of the vault deflects downwards whereas the lower portions expand outwards [15, 16]. A crack is formed perfectly along the intrados of the apex, which propagated gradually (Fig. 11), eventually becoming a hinge line and completing the failure pattern as a four-hinge mechanism.

This graphic-statics analysis is predominantly a two-dimensional approach of “slicing” the 3D structure into 2D sections and confirms when some of the cracks form Figs. (11, 13, 14, 16, 19), but not the failure of the entire vault. This method was further developed into Thrust-Network Analysis, a three-dimensional computational method which produces lower-bound solutions of masonry vaults with complex geometries [23], and it would be worthy investigating its application at a further stage. A continuous shell analysis is a more straightforward option to assess the load-sharing and the tests were used to validate a homogeneous FE macro-model (Fig. 17). This would then serve to explore the strength of key examples of barrel vaults to supports spread and the effect of some design aspects.

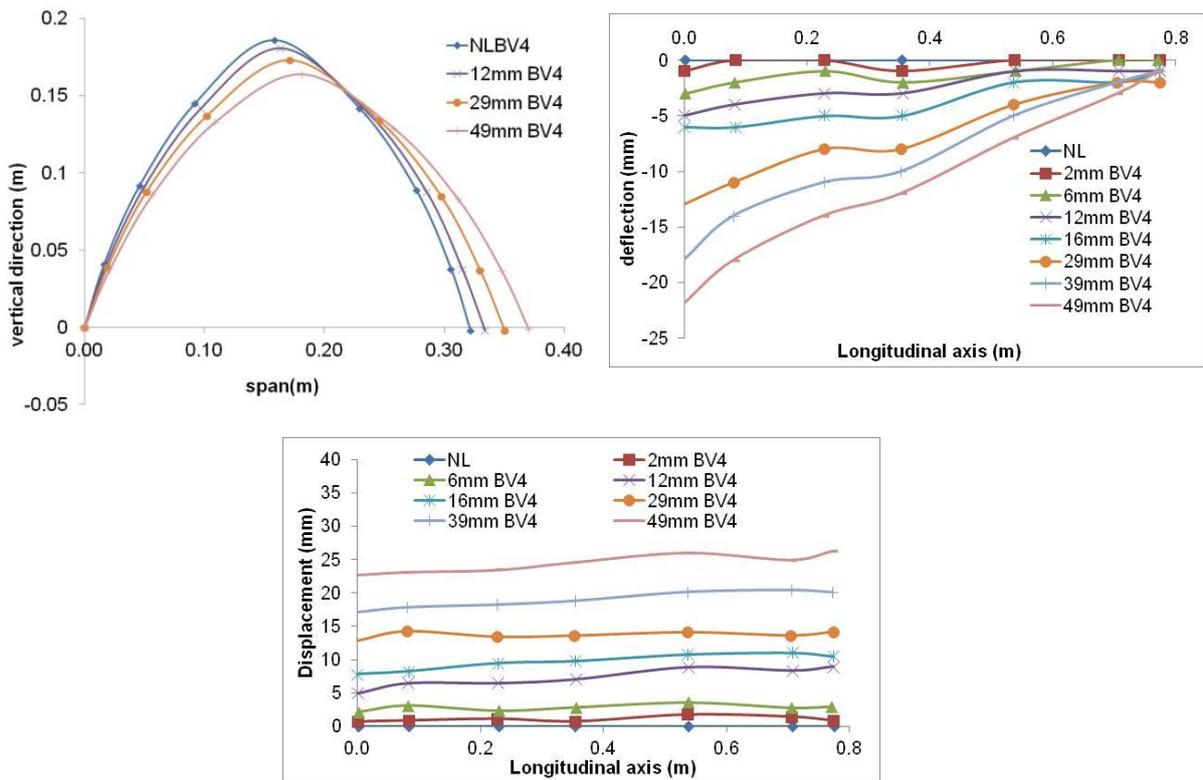
Fig. (12). Test BV4: the front end; deflection and lateral displacement of apex.

As perfectly symmetric spread of a vault’s springings rarely occurs, the discussion was framed with an asymmetric spread that increases linearly on one edge, while the back end was fixed with a wooden diaphragm wall (test BV4). The right hand side of the front end ultimately undergoes a total outward horizontal displacement of 49 mm (Fig. 12), or 1/7 of span whilst the crown displaces horizontally (x direction) less, 22.7mm (or 1/14 of span) and deflects 22mm. Apex deflection is as expected, the vault deformed almost linearly towards the front end as it was restrained at the back (wall). The horizontal displacement of the apex however occurred at the same rate and the diaphragm wall at the back end seems was not capable of withstanding such spread, contrary to the vertical constraint.

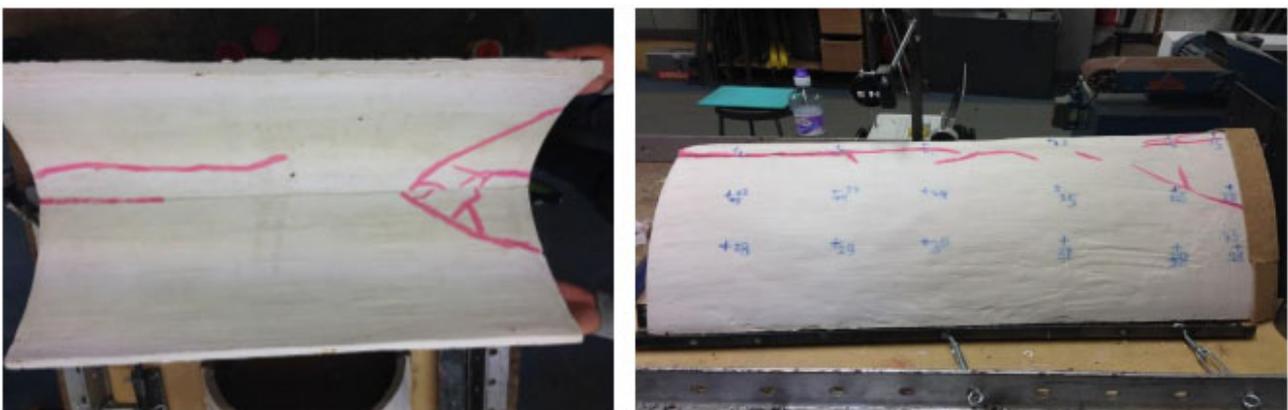
Fig. (13). Test BV4 Crack pattern at intrados and extrados. Maximum movement is applied on the front end (left-hand side in these photos).

Unlike the symmetric spread BV3, a clear hinge line no longer forms throughout the apex or across the length of the vault, instead two cracks appeared at the intrados at the front end of the vault, one at the crown and one on the left hand side (Fig. 13). A crack also formed at the back end of the vault on the extrados. The cracks at the front end eventually spread to the extrados: the crack at the apex propagates more on the extrados whilst the one on the left hand side propagates more on the intrados. The ones at the back end propagate at a similar rate and they almost meet forming a diagonal failure pattern (Fig. 13). This shear type of crack is justified by the differential spread of the front end.

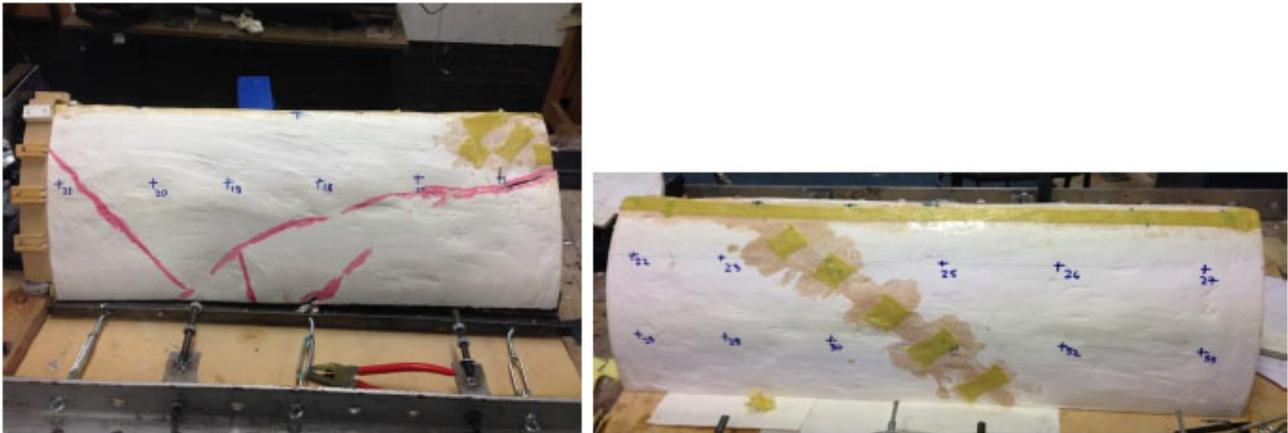
Fig. (14). Left hand side view in BV6 and right-hand side view of BV6R (the side of displacement application).

The principal crack at this limit state runs once again diagonally and is clearly appreciated at the extrados, but this time closer to the front end (Fig. 14) when compared to test BV4. At the front end, the crack starts from the left of the crown at a similar location to where the crack started at BV4 and then spreads diagonally but at an earlier stage, in a shear pattern due to the differential spread. The deflections across the vault show some interesting patterns: the

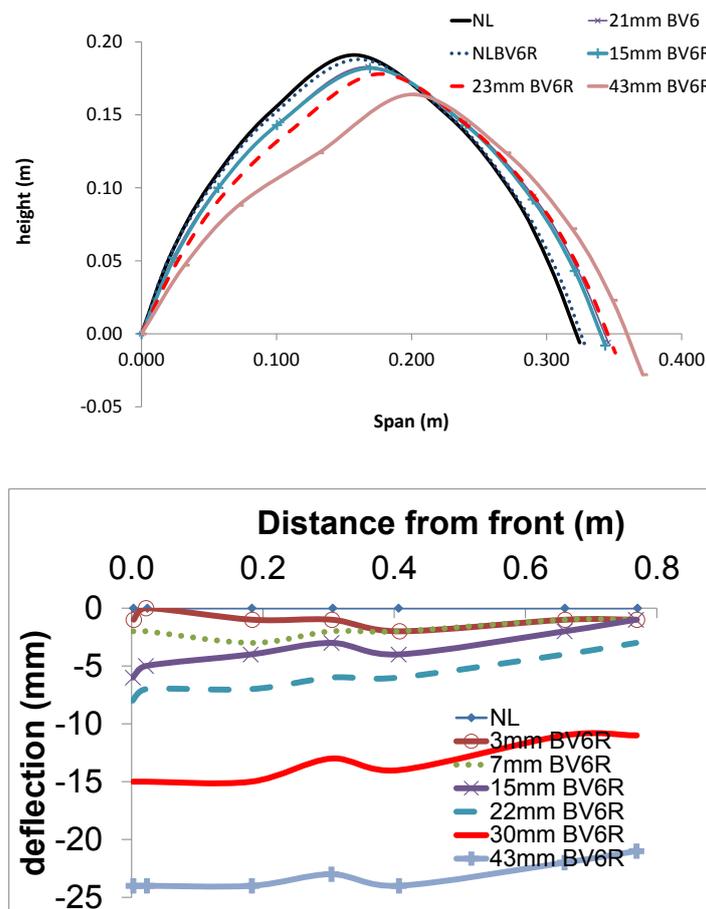
Fig. (15). Front end and deflection of the apex during supports spread, combining tests BV6 and BV6R.

increments till cracks formed (BV6) before repaired with FRP and was then tested again to failure (BV6R test). The displacement was removed before the repair and the vault almost returned to its original form (vd. profiles NLBV6 and NLB6R in Fig. (15)). The key contribution of the repair is that the vault became reinforced, as the spread at failure went from 22mm (unreinforced) or 1/15 of span to 47mm or 1/7 of span, *i.e.* almost doubled its capacity (Fig. 15).

unreinforced vault deflects heavier closer to the front end, but a detachment from the back diaphragm wall also develops, slowly. After reinforcement, the tests BV6R show the vault can take significant more spread, but the vault detaches clearly from the diaphragm and starts behaving like an unsupported barrel vault, as the horizontal displacement of the apex is almost constant across its length (Fig. 15). Most probably, it was the lower parts of the reinforcement, around the spandrels that were more effective in changing this pattern [17].

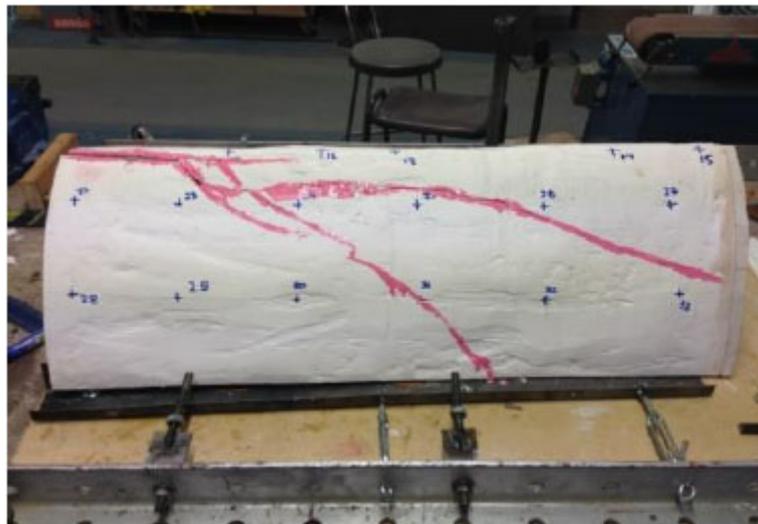
Fig. (16). Crack pattern due to asymmetric spread on a vault model fixed on a diaphragm at the right end made of the same plaster (Test BV7).

To assess the strength and contribution of the diaphragm wall, asymmetric spread was once again applied on one side but with a diaphragm wall made of same material as model (test BV7). The first cracks that were produced were visible at the front end around the apex and propagated only a short distance along the apex, deviating towards the right hand side (Fig. 16). As the vault was spread further, two small diagonal cracks became visible at the intrados of the right hand side of the vault. One stems from the bottom of the vault similar to the previous diagonal cracks (BV6). The other crack stems from the back wall, just below mid- height of the vault. This crack proliferates onto the back diaphragm wall where it propagates downwards and a detachment of the plaster wall starts there.

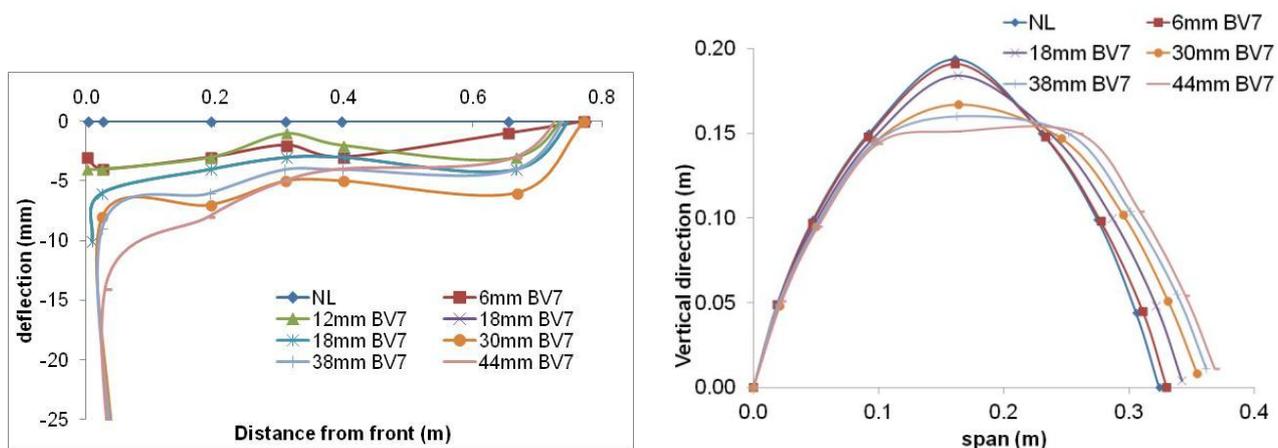
Fig. (17). Test BV7: deflection of the apex plotted against tip displacement and the front end during the asymmetric spread.

Heavy deformation of the front end (Fig. 17) is associated with quite severe cracks and splitting of the vault there around the apex, and this may have been due to insufficient reinforcement (scrim fibres) at this area. This distortion however dies away quickly within the vault, which shows that this fault may be local and the vault have enough redundancies to maintain some geometric integrity. In fact, the rest of the vault spreads outward almost uniformly, except for the diaphragm wall around its crown that does so much less.

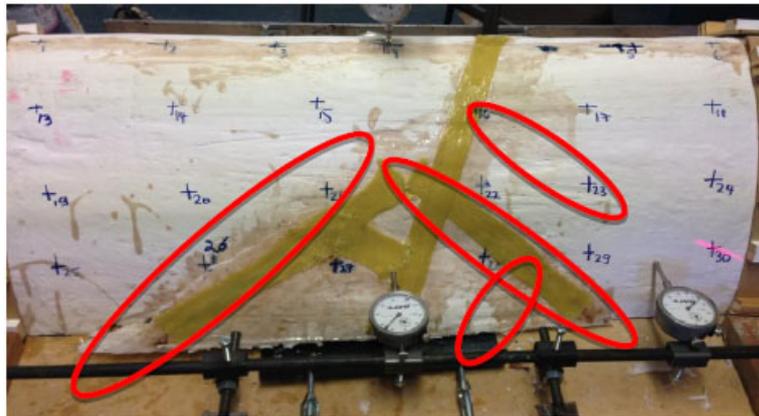
Fig. (18). Centrally-spread vault BV5 after FRP repairs.

The final test was to apply a central symmetric spread only, fixing the vault with two wooden diaphragm walls on either end (test BV5). After the formation of cracks, the vault was repaired as in BV6 (test BV5R). Although the vault was spread uniformly, cracks are formed only on the right hand side of the vault, at $2 \times 5 \text{ mm} = 10 \text{ mm}$ and the effect of the spread is very localised in that area Fig. (18). Repairs were applied at $2 \times 8 \text{ mm} = 16 \text{ mm}$ and permitted 10mm more of spread. Two cracks starting from the springing level around the centre of the left hand side of the vault were the first visible extrados cracks. The final cracks at the intrados form on both sides, around the central areas that are spread. As the extrados of the haunches was reinforced, this proved to be effective in resisting better the imposed displacement, similar to the reduction of thrust experienced by De Lorenzis [17].

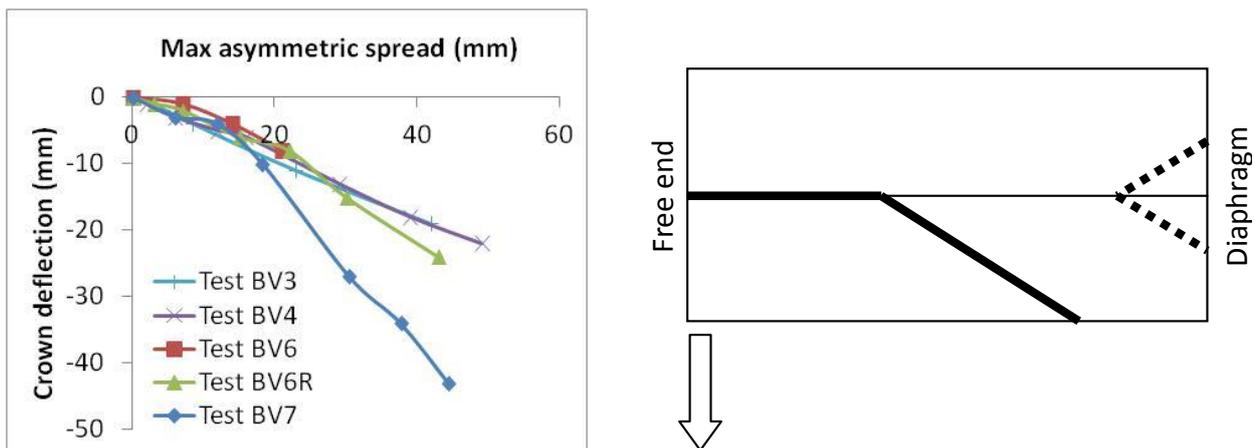
Fig. (19). Crown deflection of the tests on plaster models and their FE simulation against tip (maximum) spread, and crack pattern for asymmetric supports spread (continuous line is crack at extrados, dotted is intrados).

All tests were concluded when the structure was considered to have become unstable or a mechanism and the stages of the impending failure have been recorded. In order to link the observed crack patterns and the deflections measured, the crown deflection was plotted against spread (Fig. 19), showing that apart from the symmetric spread BV3, the asymmetric ones exhibit a non-linear pattern due to the presence of the cracks and the gradual failure, when read with the crack pattern in Fig. (19).

The discussion of the tests showed that plotting the deflections of the crown of the front end is quite representative of the behaviour of the model, so it will be used to validate the FE model. Regarding asymmetric movement, the FE model was spread linearly along the right-hand side edge only. The correlation of the deflections of the front end crown (Fig. 21) is satisfactory, especially for tests BV4, BV6 and initial stages of BV6R, except for the case of BV7 where as was mentioned heavy crack and separation occurred at that point (Fig. 17), possibly due to a local material fault as was discussed earlier. The plot of the plastic hoop stresses S11 at failure (Fig. 21), which indicate the smeared cracks, also correlates with the crack pattern observed in the asymmetric spread tests, which develops after a tip spread of 11mm (or 1/30 of span) and can be considered as the yield point of the model. The differences in deflection after that point can be attributed to the physical split of the tests models, which the continuous shell FE model cannot reproduce to the same extent. Similarly, the difference with test BV6R can be attributed to deformations that may have been embedded after the repairs, causing higher deformations.

failure eventually develops as geometric instability (Fig. 19), and the orthotropic masonry bond in these vaults shift the patterns significantly and increase their strength (Figs. 22, 23) as parts of the cracks spread slower, producing instability of the entire vault later.

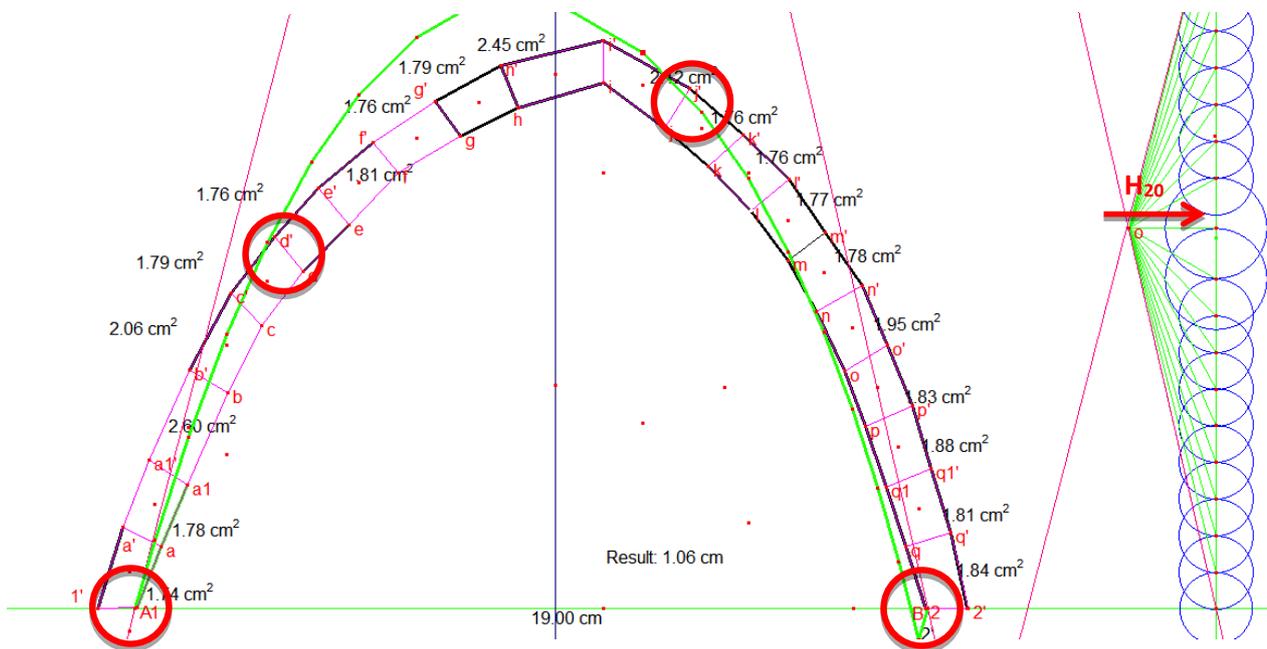
Fig. (20). Simulation of asymmetric spread of the right-hand support, in an arch with the same dimensions as a cross section of the tested vaults. The capacity of the arch is surpassed at a 20 mm spread, where 4 hinges form.

The configuration of the model is changed to mimic an arch being spread; this is done by moving the right abutment outwards first. The rest of the points are then moved accordingly to maintain constant thickness of the arch and the voussoirs. When a 20 mm spread is applied, the line of thrust is not contained on the left-hand side, which results in the formation of two hinges on either side of the crown and two more at the intrados of the abutments where two hinges (Fig. 20). This results in failure of the 2D arch and a capacity of 20 mm spread (1/16 of span).

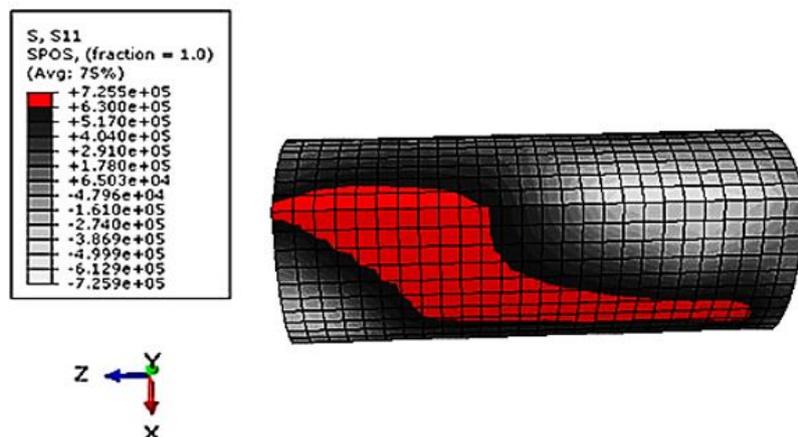
Fig. (21). Hoop stresses at the intrados of the FE model at failure from asymmetric support movement. The light (red) areas indicate plastic failure and the spread of (smeared) cracks.

Variation of the diaphragm wall stiffness or even its removal increased slightly the deflections. This together with the close values of the asymmetric tests (Fig. 21) confirms that once cracks have formed, especially along the apex, the failure of the vault is in essence geometric. The shear cracks along the middle of the vault are due to the continuity of the vault, and therefore can only be captured by 3D limit-state tools.

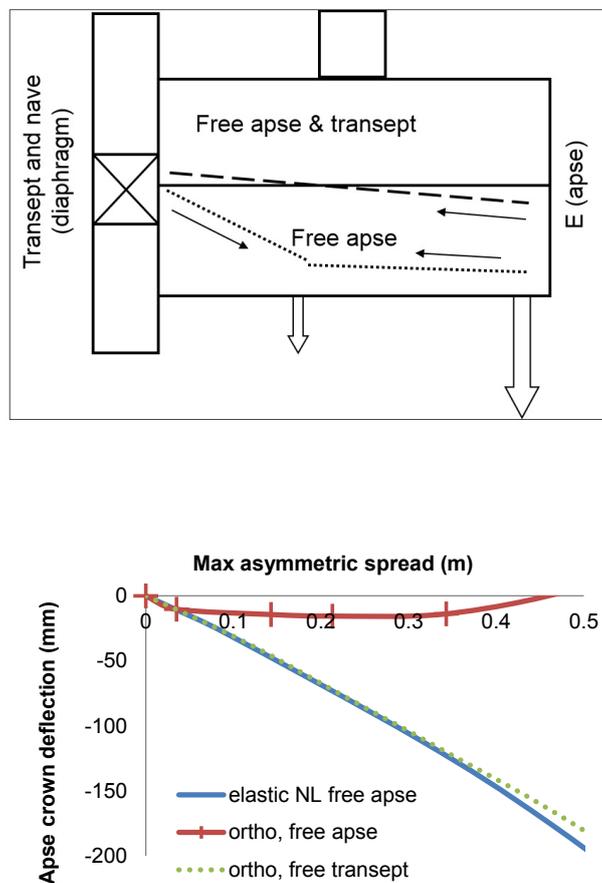
Fig. (22). Failure mechanism and crown deflection against tip (maximum) asymmetric horizontal movement of the supports in the Bothwell FE model for the two options of support conditions, showing propagation of failure.

The asymmetric support movement presents some interesting trends. When a diaphragm is considered at the transept and the apse is free, the principal yield line forms slowly at 0.34m of spread (or 1/18 of span 6.1m), producing a crown deflection of 14mm (Fig. 22). The process is slower however when both ends are free: the first cracks appear at 0.22m along the apex causing a larger deflection (76mm) and then they spread slowly to the centre, when they form a continuous yield line that marks failure at 0.88m (1/7 of span). This impression of higher redundancy of the free vault is false though as the pinned vault does not deform as heavily, but on the other hand the free vault gives ample warning of the incoming failure, even though with heavier and possibly unrecoverable deformations.

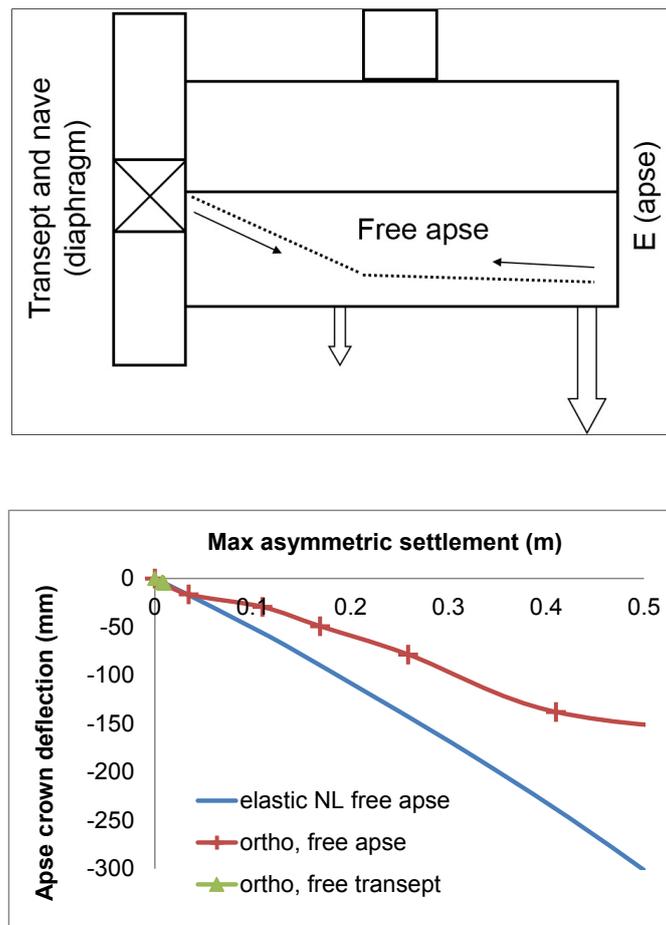
Fig. (23). Failure mechanism and crown deflection for asymmetric settlement of the supports in the Bothwell FE model, for the support conditions considered here, showing the direction of the spread of failure.

A similar observation on the role of the supports can be made for linear settlement applied along one edge only of the vault (Fig. 23). For the vault with diaphragm at the transept and free apse, the yield line forms slowly at 0.62m max settlement (deflection -156mm), while at the one with both free ends the yield line forms too slowly to be meaningful, probably due to the immediate bracing effect of the applied horizontal constraint along the edge.
