Design Provisions for An Easy Intervention in the Future Life of a Structure. The Case of the Post- Byzantine Timber-roofed Basilicas of Troodos Area in Cyprus

Marios Pelekanos*

Department of Architect Engineers, School of Engineering, Frederick University, Nicosia, Cyprus

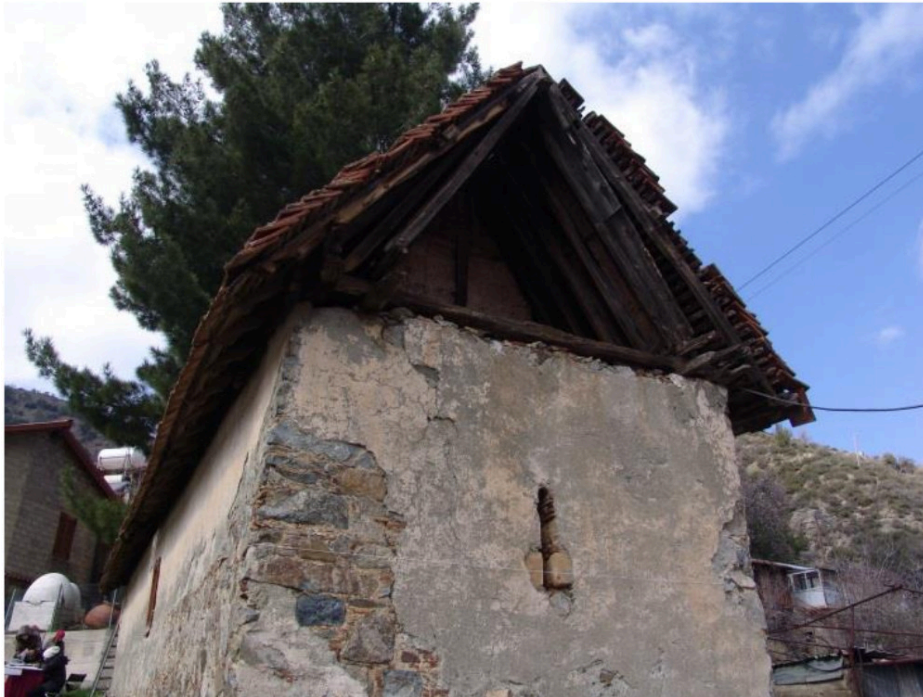
Fig. (1). The single-aisled basilica of Saints Sergios and Vachos, at Kalopanayiotis village. East façade (Photo M.Pelekanos) [4].

The island of Cyprus presents a distinctive type of basilicas with a wooden roof, which were built from the mid 15th to the late 19th century AD. According to researchers, this type seems to be unique in the European and Mediterranean area and probably worldwide too. There are more than 130 churches of this type, all of them located within the boundaries of the Troodos Mountain Area, which is the highest of the two mountain regions in Cyprus. As far as typology is concerned, 75% of the churches are single-aisled (Fig. 1), and another 20%

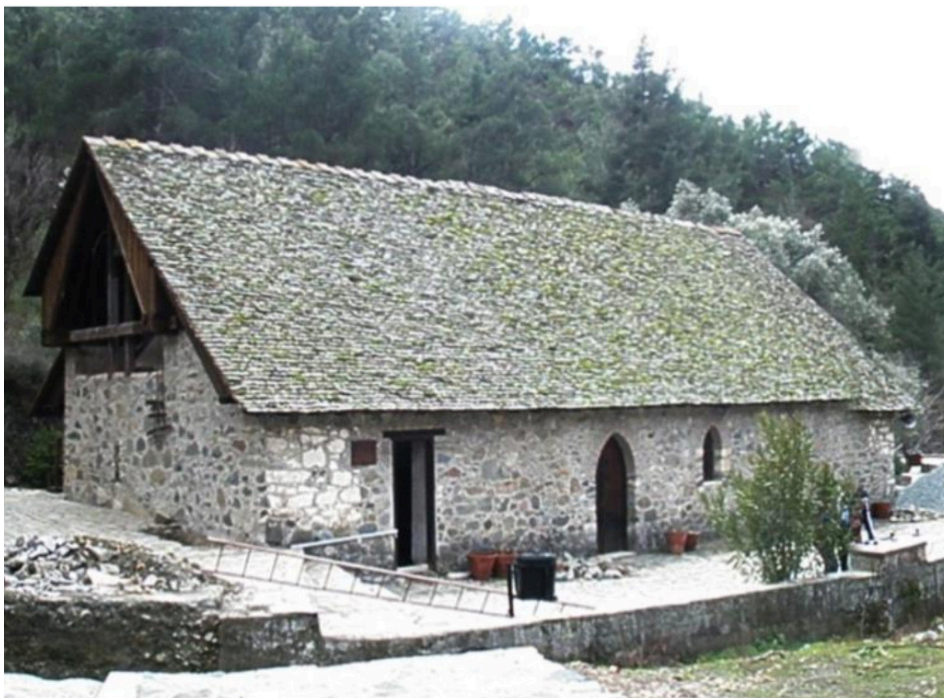
Fig. (2). View of the three- aisled basilica of Panayia, at Kourdali village from the North- East (Photo M.Pelekanos). [3].

are three-aisled (Fig. 2). There are also six cases of two-aisled churches (5%), all of them being the result of an extension of a single-aisled church.

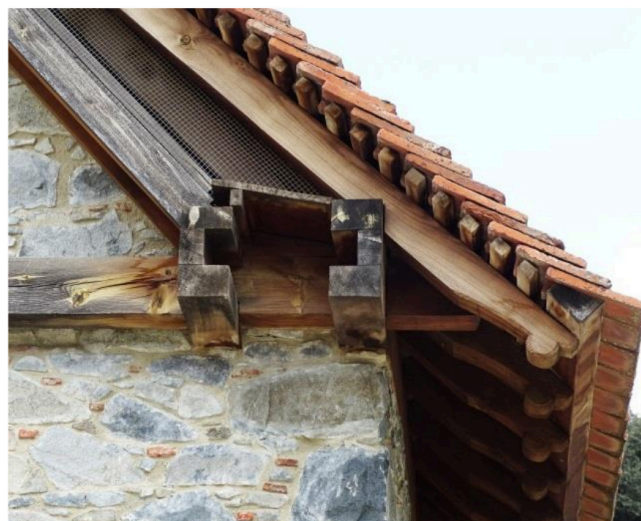
Fig. (5). Church of Panayia at Moutoullas village. Detail of the connection between the timber roof and the south wall (Photo M. Pelekanos).

The bearing walls of these basilicas are constructed of the volcanic stone of Troodos. The long walls, to the north and south, which bear the load of the roof, are usually short, about 2.5- 3.0 m (Fig. 5). The west wall rises to a pointed triangular shape, up to 6 meters in single-aisled and almost 8 meters in three-aisled basilicas. To the east, there is the apse of the sanctuary, which sometimes is clearly visible from the exterior as a half of a cylinder with half of a dome on top, and in other cases, it is fully inscribed in the general rectangular shape of the church.

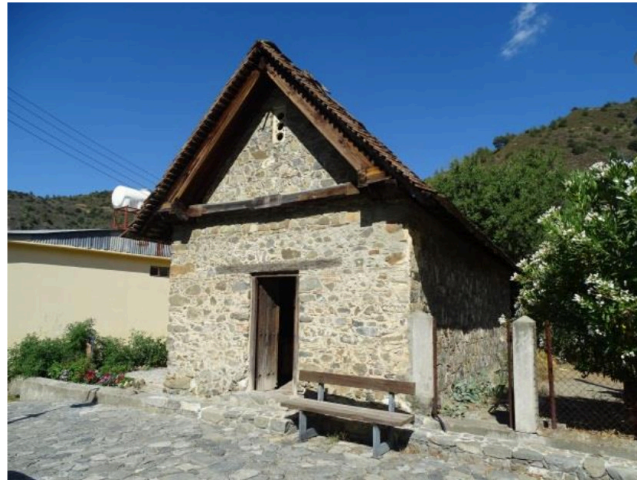
Fig. (6). Church of Ayioi Andronikos and Athanasia at Kalopanayiotis village. West Entrance (Photo M. Pelekanos).

The openings are few, usually a main door to the west and another one, or in some cases two, on the long walls, a narrow window high up on the west wall and a small slot-opening over the apse of the sanctuary (Figs. 6 and 7). The interior surface of the masonry is coated with plaster and, in many cases, it is decorated with high-quality frescoes (Fig. 8). The foundations of the bearing walls are usually very shallow, and in some cases, where there is an inclined terrain, they are founded at different levels (Fig. 9).

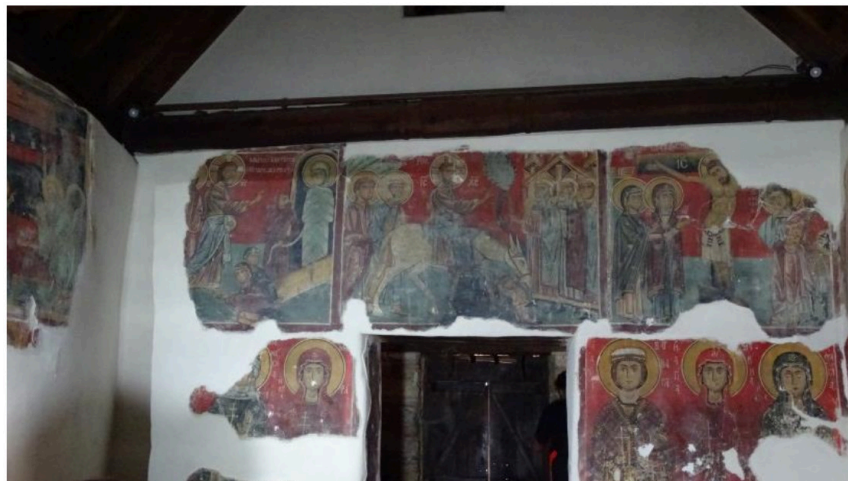
Fig. (7). Church of Panayia at Moutoullas village. The west entrance, now leading to the Narthex which was built at a later stage (Photo M. Pelekanos).
