# Seismic Mitigation of a Historic Masonry Building

**Abstract:** This work presents an analysis of different proposals of rehabilitation of a masonry building, built around the beginning of the XX century for public schools, in the highest seismic risk zone of Argentine; and which was closed down after Mendoza's Earthquake in 1985. The building has masonry walls of artisanal ceramic bricks and wood-framed roof but it does not have lateral ties. Currently, it gives evidence of structural pathologies due to various seismic events and the lack of maintenance by water losses. The work was developed in two stages, one in 1999, and the other one in 2010. At each stage, the evaluation of pathologies was carried out. Studies of the soil and the characterization of materials used were also conducted. As a reference, the effect of vibrations generated by the traffic was measured. With the parameters obtained, the structure was modeled through finite elements in order to verify the status of damage and the behavior of the proposed rehabilitation (reinforced concrete or steel structure). The technique of rehabilitation accepted by the heritage experts is the reversible type, in order to avoi

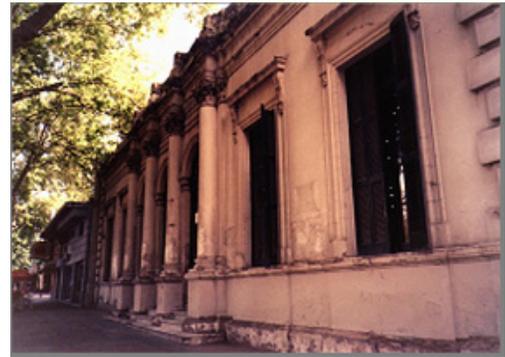
Fig. (1). State of the facade in 1999.

The building is designed specifically for school purposes (Fig. 1); it has one level on a cloistral diagram or central square playground (Fig. 2), surrounded by galleries where the classrooms doors open to the main front. There is a second playground with another block of classrooms and a third one with sanitary services.

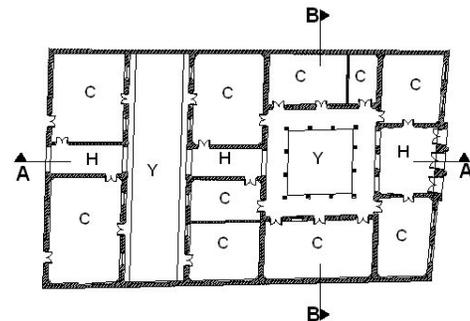
Fig. (2). Floor plan (C: classroom, H: hall, Y: yard).

tive institution; thus, in 1999 it initiated the proper studies which continued during 2010. Fig. (2) presents the actual floor plant and Figs. (3) and (4) show vertical sections of building.

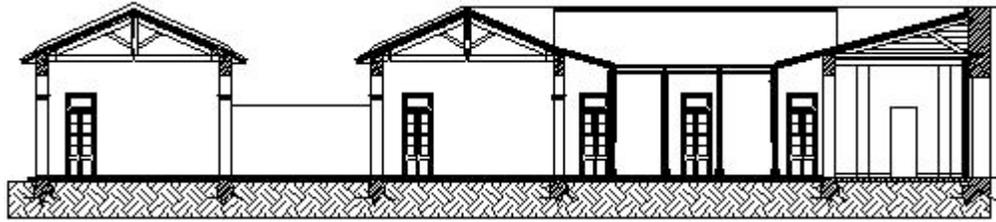
**Fig. (3).** A-A Vertical section of the building.

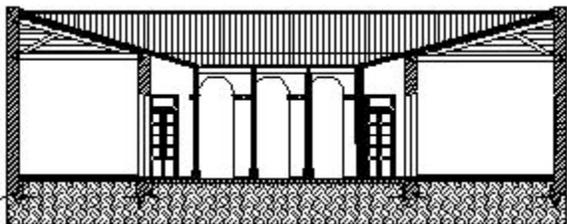
**Fig. (4).** B-B Vertical section of the building.

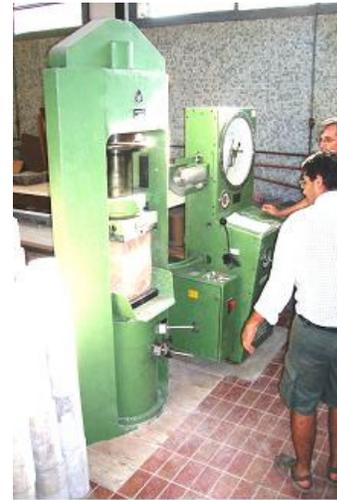
**Fig. (5).** Test set-up of the compression test.

The artisanal solid clay-brick unit masonry was identified, with its physical and mechanical properties (density, porosity, compressive strength in Fig. 5). And the ultimate capacities under simultaneous loads of compression and shear were evaluated in laboratory tests with specimens extracted from the building (Fig. 6). Table 1 resumes the obtained results.

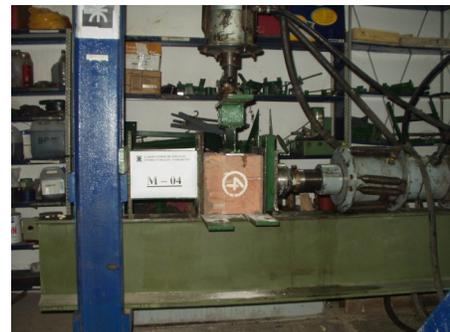
**Fig. (6).** Test set-up of combined compression and shear test of masonry.

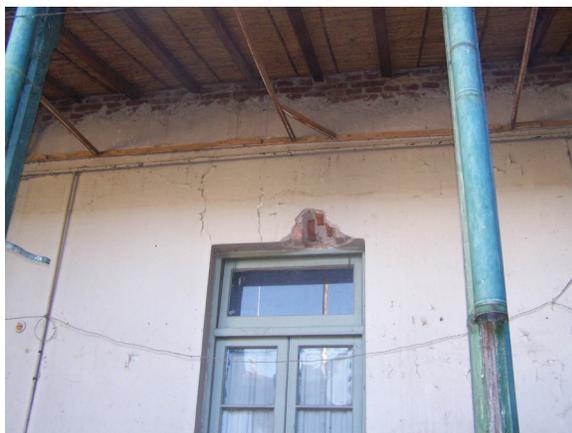
**Fig. (7).** Prospecting over openings.

The prospecting situated in the lintel did not indicate presence of reinforcement ties in the masonry structure (Fig. 7). Only tighteners in the centered zone of the principal hall were present, superficially situated as product of the first intervention to conform a tie-system of the building, but non enough to avoid the damage causes by seismic loading (Fig. 8).

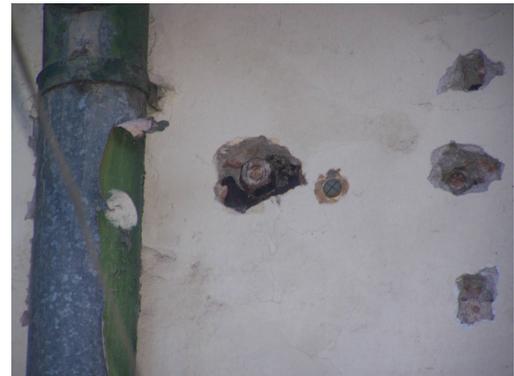
**Fig. (8).** Detected tighteners.

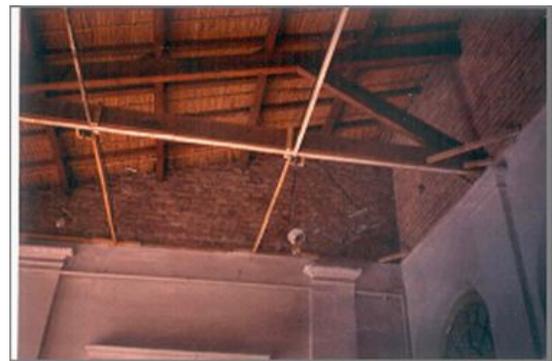
**Fig. (9).** Cracking of tympanus (1985).

An exhaustive exploration of the building pathologies was done, evaluating the damage during the decade between the first study and the last. One of the damages of the masonry owe to the Mendoza Earthquake of 1985, with cracks in the tympanum at 45 ° (Fig. 9), and the separation of the

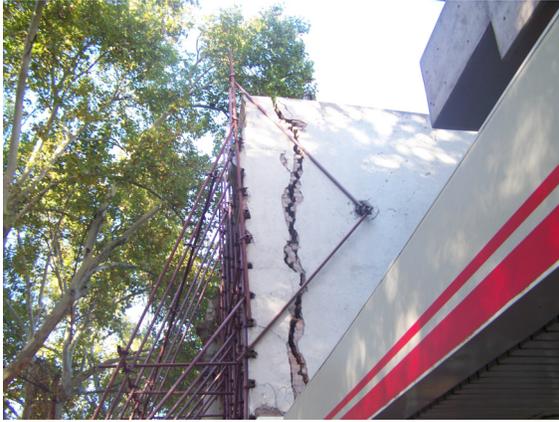
**Fig. (10).** Cracking of façade (2010).

facade afterwards 2005 and 2006 earthquakes (Maldonado WHE 2008) [5] (Fig. 10).

The observed damages in the building correspond not only to the problem of 1985 Mendoza Earthquake and the later important earthquakes but also to the lack of support capacity of the soil. The diagnostic indicates the need to reinforce the structural foundation system as a consequence to avoid displacements without compatibility with the unreinforced masonry structures (Fig. 10).

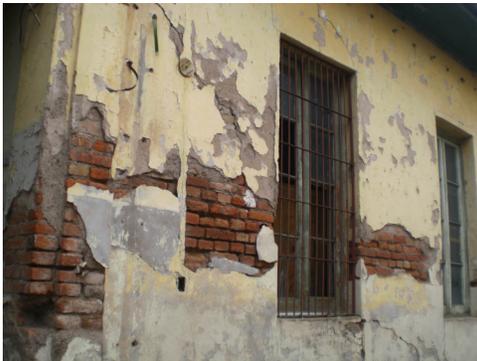
**Fig. (11).** State of masonry walls.

Besides, some leach at floor level and at mid-high level in masonry walls, as a result of the absence of underlayment on the continuous footing and due to the modification of vent conditions by replacing the existing wood strip flooring for ceramic floor and the presence of several layers of oil-painting on the masonry walls, which prevent the evaporation of moisture (Fig. 11).

The soils study detected permanent losses in the plumbing and drainage of rains, with the consequent increase of the moisture and cracking of masonry by settlements due the type of soil (CL) and the contribution of water by the use of facilities (Figs. 11, 12, 13 and 14).

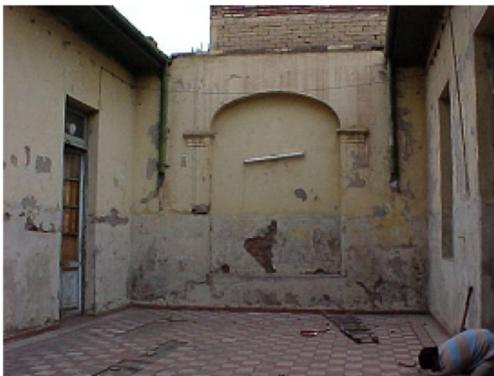
**Fig. (12).** Modifications of ventilations.

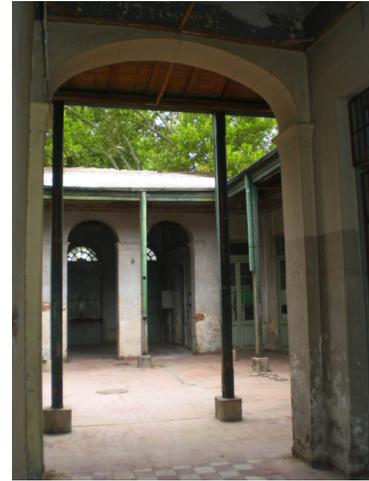
**Fig. (13).** Settlements of the soils.

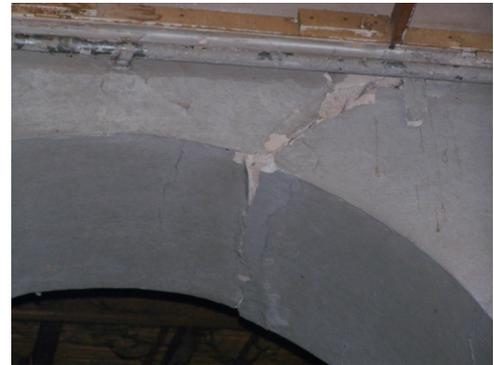
**Fig. (14).** Cracking of arches.

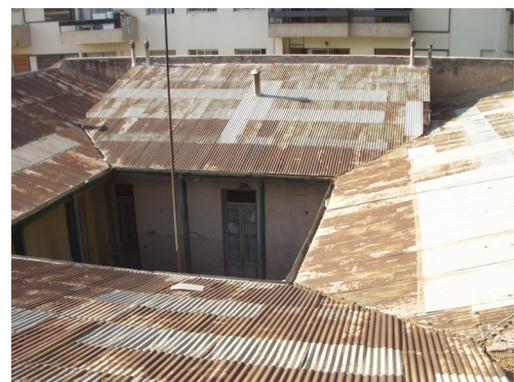
**Fig. (15).** View of the sheet roof covering.

The study of environmental vibrations measured the effect of the diurnal traffic at different levels: floor and roof (Fig. 15) in 19 and 8 points respectively detecting an important transmission in all the masonry structure (Fig. 16).

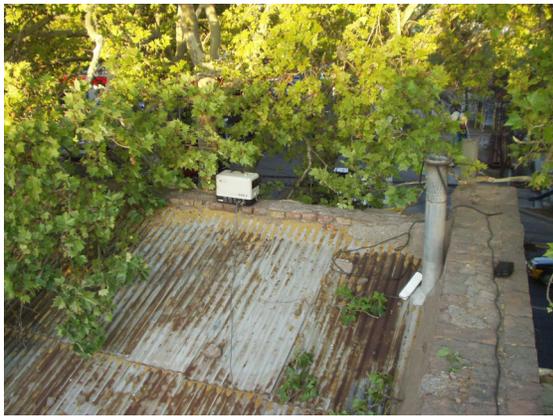
Fig. (16). Location of accelerometer.

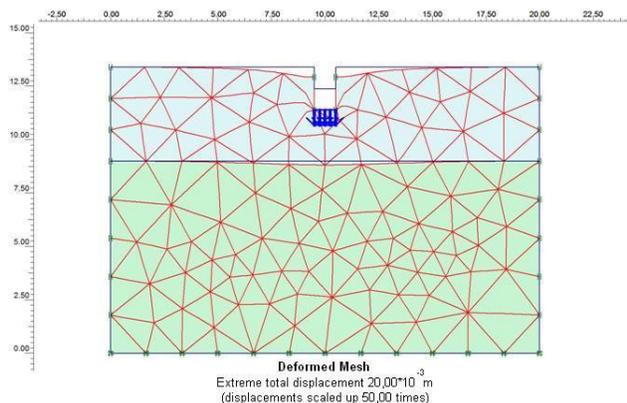
Fig. (17). Deformed finite element mesh of soil.

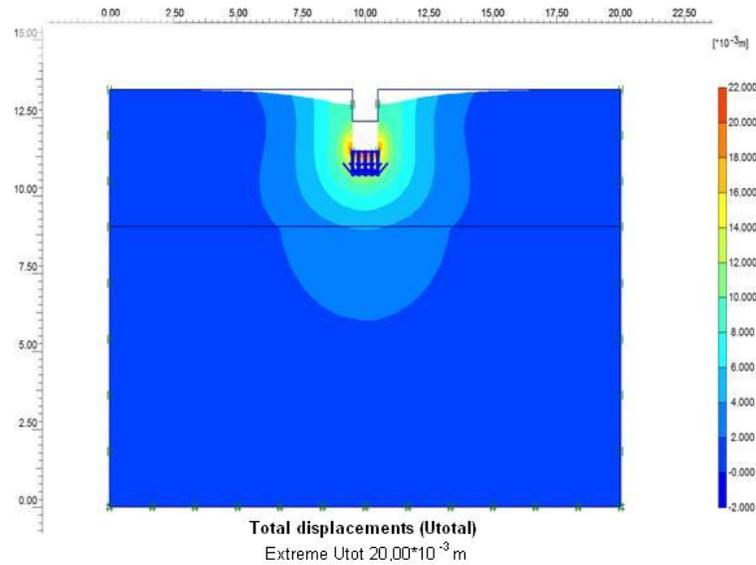
**Fig. (18).** Variation of the deformations in the soil profile.

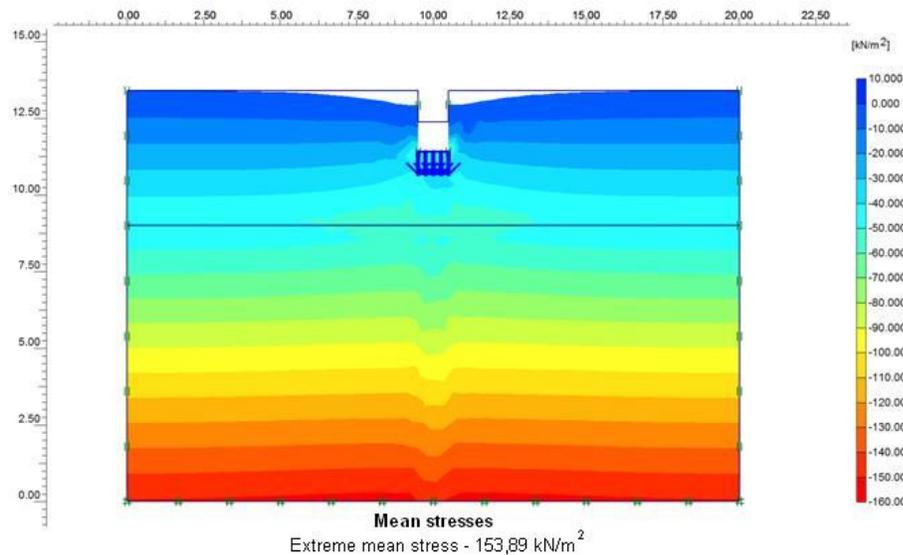
**Fig. (19).** Variation of the stresses in the soil profile under footing.

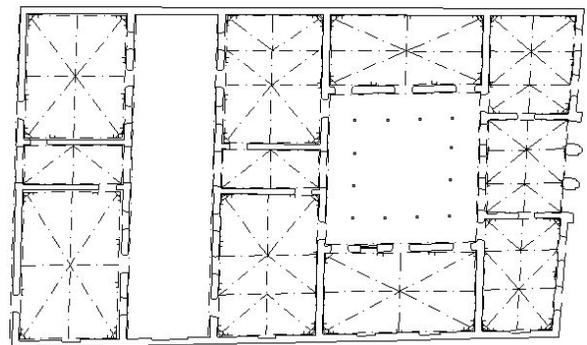
Fig. (22). Schematic upper truss reinforcement and columns.

- To arm a metallic truss in the top of the building, to tie in both directions the masonry walls by means of metallic beams anchored to the walls and metallic profiles, trussing the space to cover. This metallic truss is situated in such a way that the suspended ceiling does not leave it in evidence and allows it to be used for pipes of installations (electricity and conditioned air, Fig. 22).

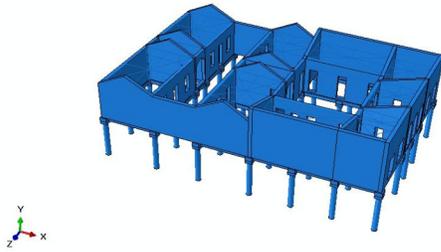
Fig. (23). Model of building.

The structural computation has two branches: one of them is the formulation of a non linear finite element model, using isoperimetric elements with 8 nodes (3D), with constitutive models that simulate the non linear behavior of the masonry in order to verify the structural performance under distinct loads and conditions, already considering the existing damage of the structure with the settlements of foundations (Fig. 23) (Abaqus 6.4 2004) [11].

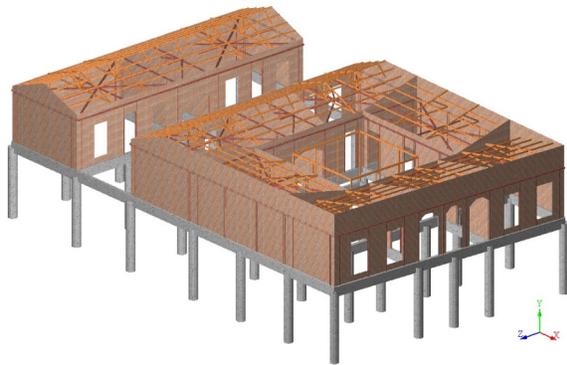
Fig. (24). Structural model of rehabilitation.

The other branch is the structural analysis, in linear form, by means of finite elements software (SAP 2000) [12], which allows the design and verification of the proposed solution with different structural elements. The resistant structure of the building consists in thick masonry walls and columns. The roof covering is resolved by means of metallic truss that bear a wood framing and cane. To represent it some plates and bar elements were used, considering that these would properly simulate the structural appearances of interest in this study. It is very important to specify that the model only includes the structural aspects (Fig. 24).

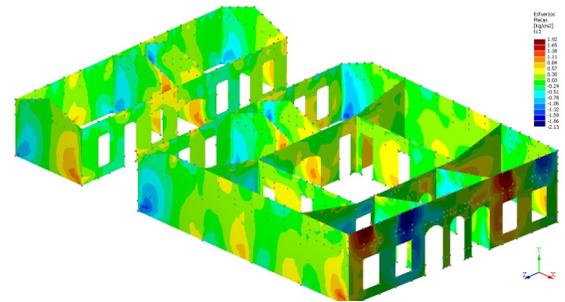
Fig. (25). Maximum stress in plates due to dead loads.

Fig. (25) can be considered as a representative result of the numerical study. The concentration of stress is associated to the intersection of shear walls and to the points of application of loads, points that will have to be reinforced locally, whereas the rest of the masonry walls are under maximum tensional stress. The existing structural system, particularly the masonry walls, maintains a level of stress under its capacity.

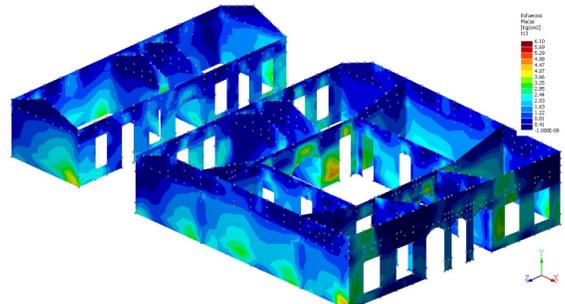
Fig. (26). Combined loads stress.

Fig. (26) presents the maximum stress for the combinations of loads that include the seismic load.

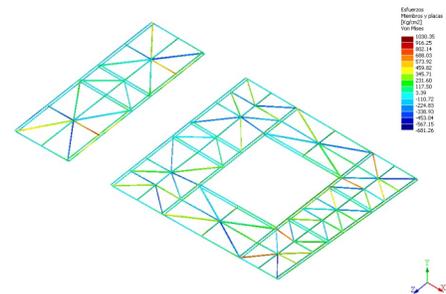
Fig. (27). Stress of truss at ceiling level.

The upper truss fixed to the structure as indicated previously, is subjected to stress under its capacity as shown in Fig. (27).
