Seismic Behavior of the San Pietro di Coppito Church Bell Tower in L'Aquila, Italy

Abstract: In the present paper, a non-linear numerical study on the 13th century masonry bell tower of the church of San Pietro di Coppito is described. The aim is to have an insight into the causes at the base of the partial collapse suffered by the structure during the L'Aquila earthquake in 2009. To this aim, two different numerical analyses have been performed namely non-linear static (pushover) and limit analysis. In both cases, the same full 3D detailed FE model of the structure is adopted, changing the seismic load direction and assuming different distributions of the equivalent static horizontal load. When dealing with the FEM incremental analysis, a commercial code is utilized assuming for masonry a smeared crack isotropic model. For limit analysis, a non-commercial full 3D code developed by the authors is utilized. It provides limit good estimates of limit loads and failure mechanisms, to compare with standard FEM results. From numerical results, the role played by the actual geometry and by the masonry mechanical characteristics of the tower is envisaged, as well as a detailed comparison

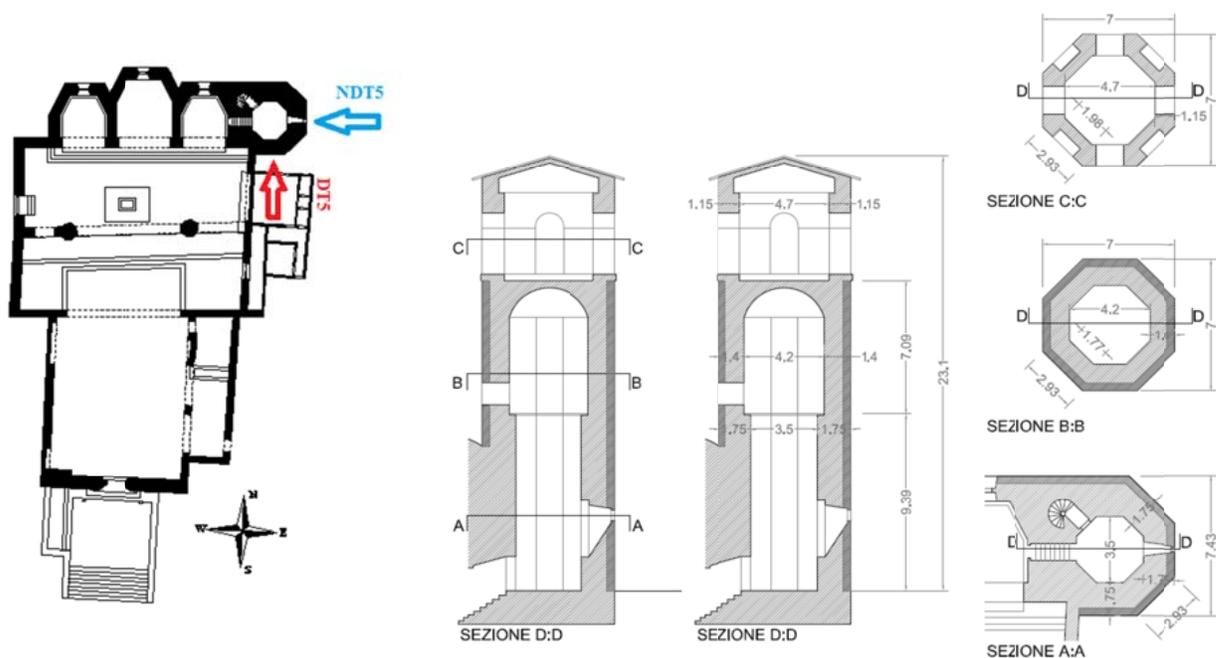
Fig. (2). Plane view of the church and bell tower sections

The structural system of the church, Fig. (2), is constituted by a single nave with a single lateral corridor, which is at the base of a strong structural asymmetry. Furthermore, the transept is divided into two parts with different longitudinal plan-altimetric configuration.

On the right side of the church -very complex both for the symmetry and structure- there is a bell tower, built near the apse and transept. It exhibits an octagonal hollow cross section and inside there is an unusual spiral staircase that goes up to the belfry. The bell tower is 25 meters high; the radius of the circle which circumscribes the outer perimeter is about 8.14 m) so the slenderness of the tower is about 3. The walls of the stem are made up of two interconnected layers built by rough-hewn blocks. The thickness is around 1.75 m (Fig 2) until the height of 12 m, while the thickness reduces, up to the belfry, to 1.4 m (Fig 2). The thickness of the external leaf made with bigger and more regular stones is approximately of 40 cm. Between the stem and the belfry a concrete curb 30 cm thick and built in recent years is present. The belfry is built using less thick masonry walls (1.15 m) with niches and equi-spaced windows. After the earthquake occurred in April 2009, in direction NW-SE (Fig 2), the belfry collapsed on the side of the church, devastating completely the roof of the transept. Also the stem of the tower has suffered the seismic event, showing evident shear cracks. The size of the crack is serious, but did not cause the collapse of the structure. Some documents show that during the

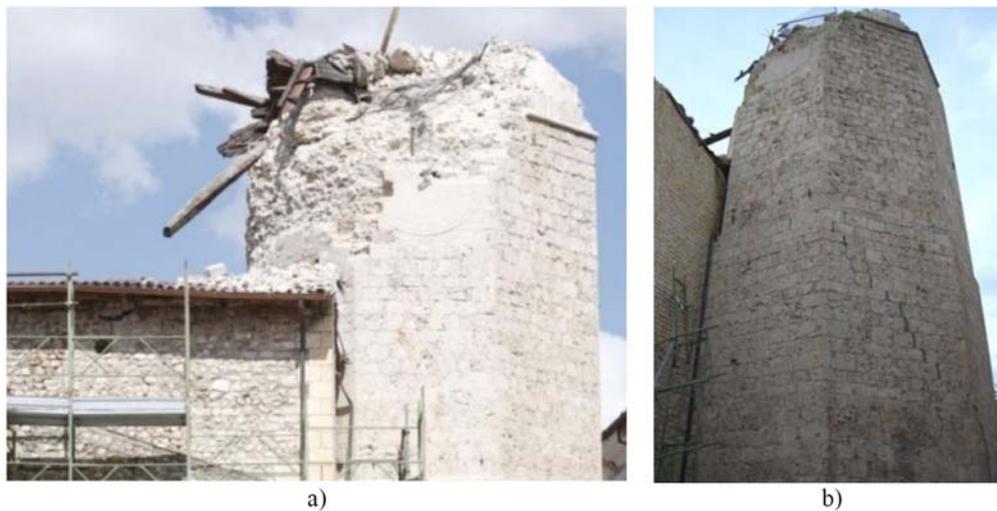
Fig. (3). Photographic documentation of the collapse of the bell tower: a) detail of the interconnection between external walls and inner nucleus b) detail of the interconnection between the tower and the church.

The walls made by rough-hewn blocks have generally very irregular external surfaces and there is almost lack of connection between external walls and inner nucleus, as demonstrated by the photographic documentation reported in Fig. (3a). As a matter of fact, the collapse of the upper part of the structure put in evidence the actual distribution of blocks along the thickness of the wall and the interconnection between external and internal leafs.

The bell tower is connected to the contiguous church, having in common an irregular contact surface (Fig. 3b). In particular, the common edge is constituted by a rectangular flat portion of the tower facing the transept up to a height of about 13.5 m and by two faces looking towards the apse, up to a height of about 11 m. To properly take into account such interconnection, suitable displacement constraints along X

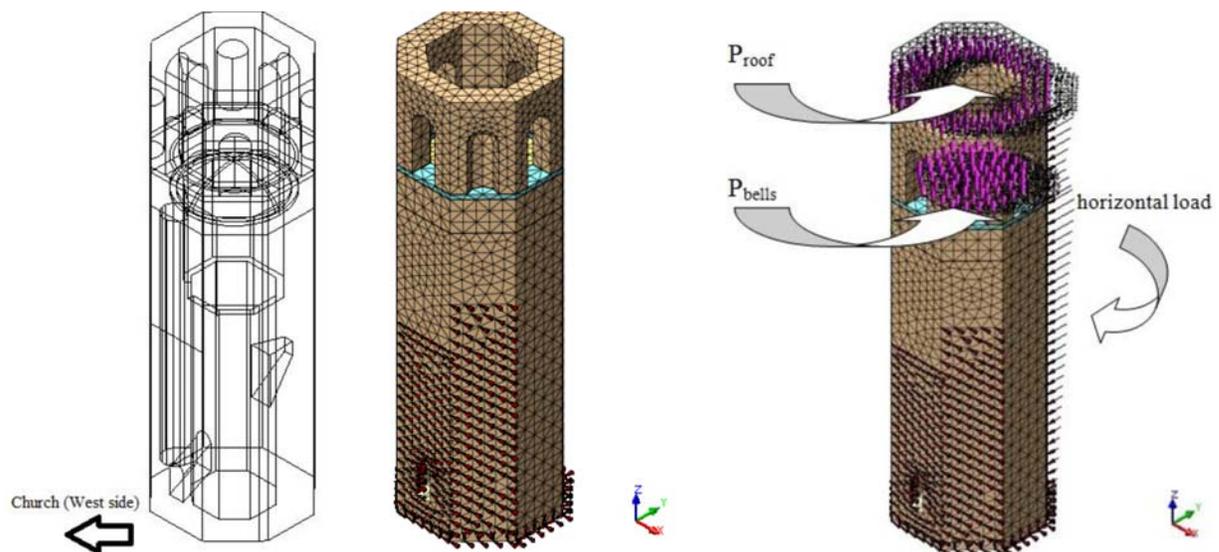
Fig. (4). Left: Axonometric view of the tower. Center: FE discretization. Right: schematization of extra-loads (except self-weight) applied to the model.

and Y direction in the FE model, Fig. (4), are inserted.

From existing documentation, it is known that a wooden roof was present, but neither geometric surveys nor existing drawings that allow identifying the exact morphology are at disposal. Hence, in what follows, a distributed vertical load equal to 16 kN/m² is applied to the numerical model. Conversely, it is known that there were two bells, one with a diameter of about 80 cm and the other with a diameter of 30 cm. The weight of the bells is determined using literature data for bells having the same diameter. In particular, it is assumed a weight equal to 4 kN and 1.30 kN for the bell with a diameter equal to 80 cm and 30 cm respectively. An additional load equal to 1 kN is assumed for the knocker. Finally, it is supposed that bells were supported by a suitable steel frame. Vertical pressure representing the roof weigh is applied in correspondence of the head of the walls of the belfry, while bells weight is applied to the model by means of vertical pressures on elements belonging to the extrados of the dome infill, as shown in Fig. (4).

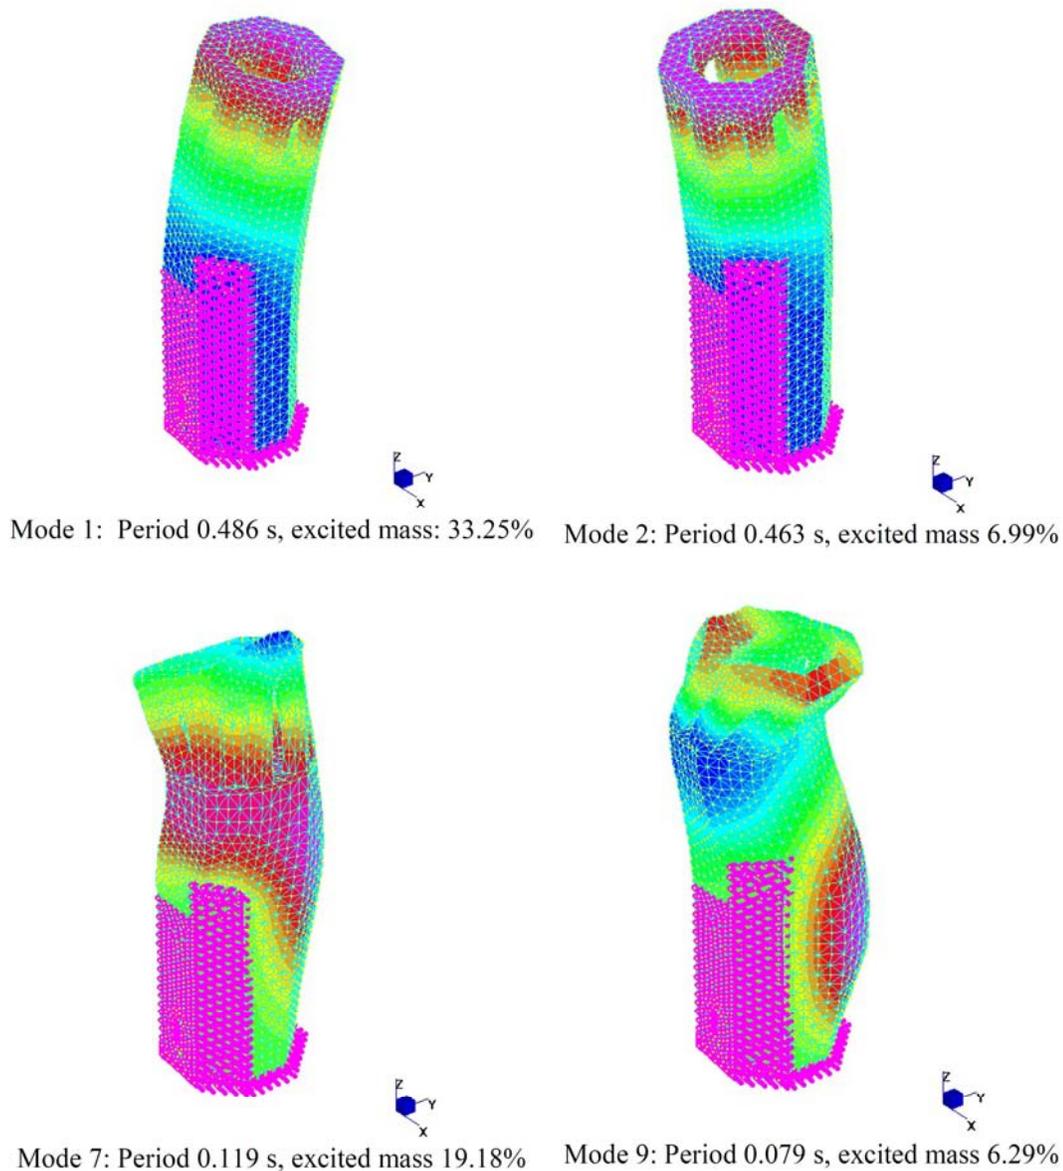
Fig. (5). Modes in X direction.

Periods and excited mass in X and Y direction from modal analysis, together with the activated mass percentage are listed respectively in Table 4 and Table 5. Only modes with excited mass greater than 5% are reported, moreover the corresponding modal deformed shapes are depicted in Fig. (5) and Fig (6). It is worth noting that the largest excited mass in X direction corresponds to the first mode and represents the 33.25% of the total mass, whereas in Y direction corresponds to the second mode and it is equal to 30.65%. The low values of excited mass corresponding to the first mode in Y direction are due to the presence of the constraints simulating the connection to the church, that does not allow the movement of the lower part of the tower where a large part of the mass is concentrated.

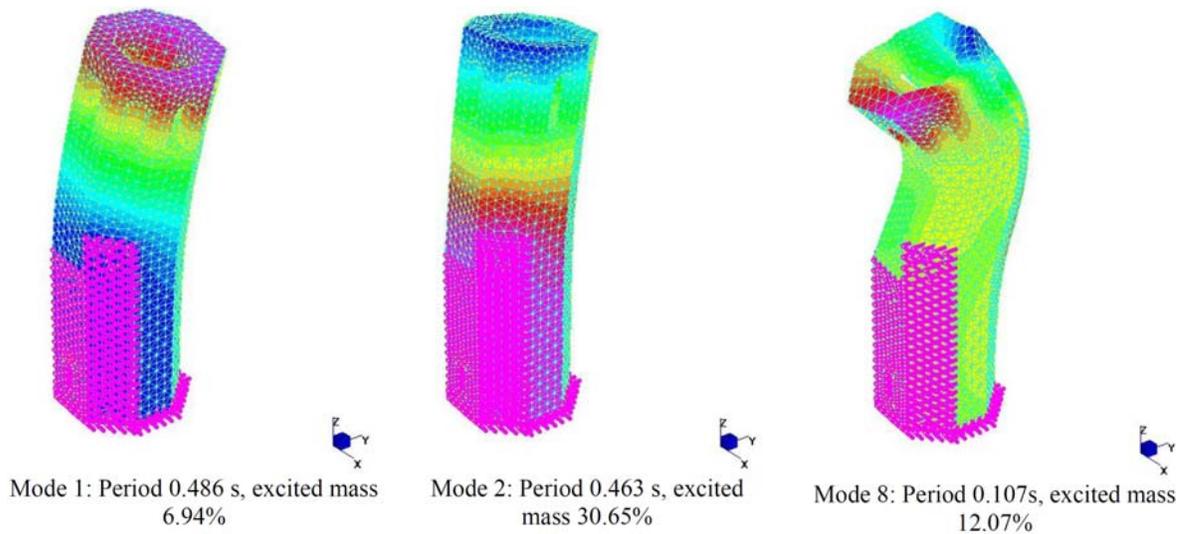
Fig. (6). Modes in Y direction.

The resulting response conveniently represents the behavior of the structure during the earthquake, in particular mode 8 deformed shape along Y direction (Fig. 6), may be regarded as representing conventionally the collapse mechanism of the belfry.

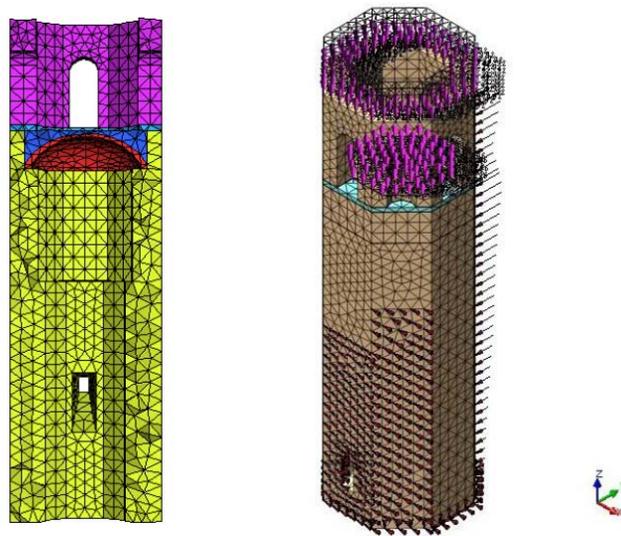
Fig. (7). FE models used for limit and incremental non linear analysis (23594 elements and 5909 nodes).

For both non-linear and limit analyses, 23594 four noded tetrahedron elements and 5909 nodes are used. The mechanical properties adopted for the pushover analyses are reported in Table 3. When dealing with limit analyses, approximately the same peak values of tensile and compressive strength utilized for pushover are adopted as limit strengths, as indicated in Table 6. More in detail, within limit analyses computations, tetrahedron elements are supposed infinitely resistant and plastic dissipation is allowed exclusively on inter-

Within both approaches, two horizontal loads distributions along the height are comparatively analyzed, as illustrated in Fig. (7). For the sake of simplicity, loads are assumed applied on the external edges both in the X and Y directions. While authors are aware that a rigorous approach would require the application of a distributed horizontal load element by element, this could result very tedious within a commercial environment and it is therefore avoided. Con-

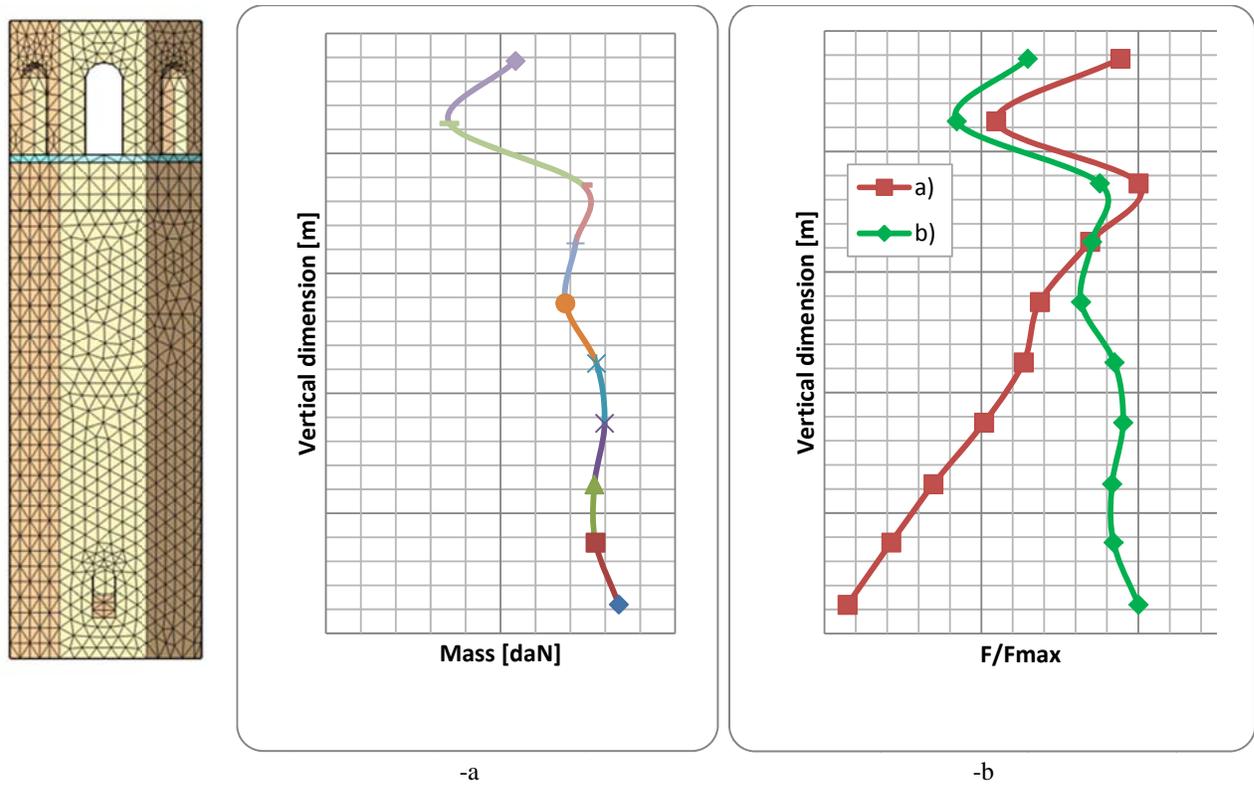
Fig. (8). -a: Distribution of masses along the height.-b: Distribution of forces a) curve corresponds to G1 case and b) curve to G2 case.

Italian Norms [24] when dealing with the non-linear static analysis prescribe the evaluation of the load carrying capacity by means of two configurations of horizontal forces: the first provides a distribution of forces derived by the assumption of a linear variation of acceleration along the height (G1) while for the second it is assumed a constant ac-

celeration (G2). As prescribed by the Instructions for NTC 2008 [17] the first distribution of forces of Group 1 and Group 2 can be applied independently of the participating mass activated by the first mode. The distribution of masses along the height is depicted in Fig. (8-a) whereas in Fig. (8-b) the corresponding distributions of forces in the hypothesis of linear (G1, curve a) and constant (G2, curve b) acceleration are represented. In Fig. (9) and Fig. (10) push-over curves obtained for X and Y direction (both positive and negative verse) under both load distributions hypotheses and limit analysis collapse loads are represented. Good agreement is found between the two alternative models regarding failure loads, the comparison giving a good confidence on the numerical collapse loads so evaluated.

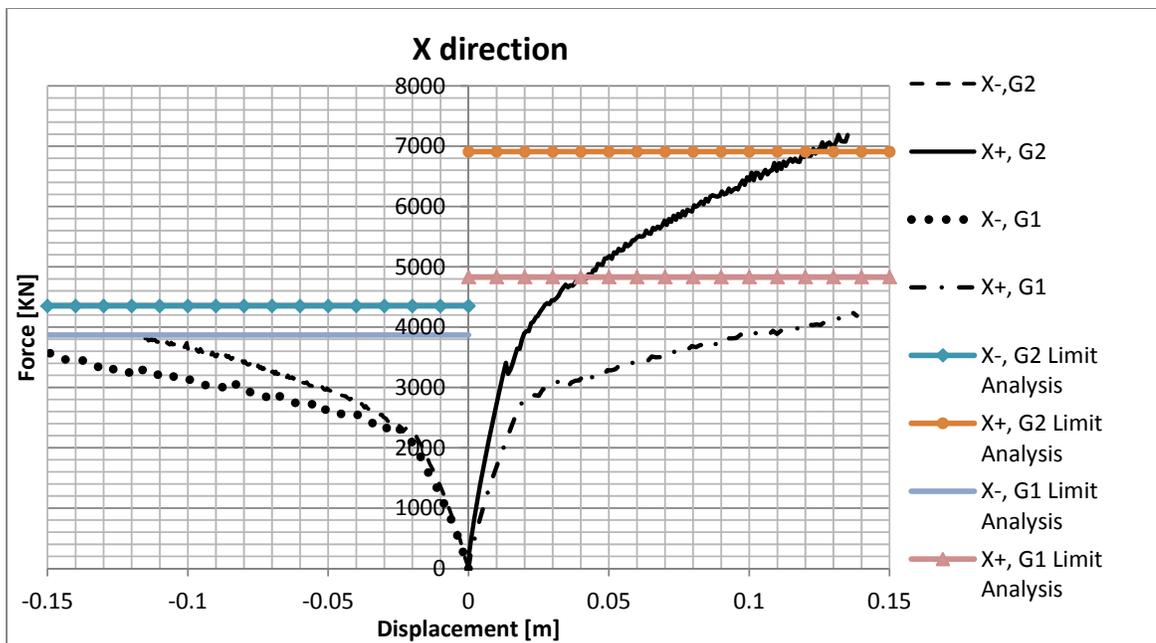
Fig. (9). Force-Displacement curve for X- direction.

From simulations results, it is interesting to notice that the curve with lower peak, for X direction, is that relative to the distribution of forces G1 and negative direction, while for Y direction the curve with lower load peak is again that

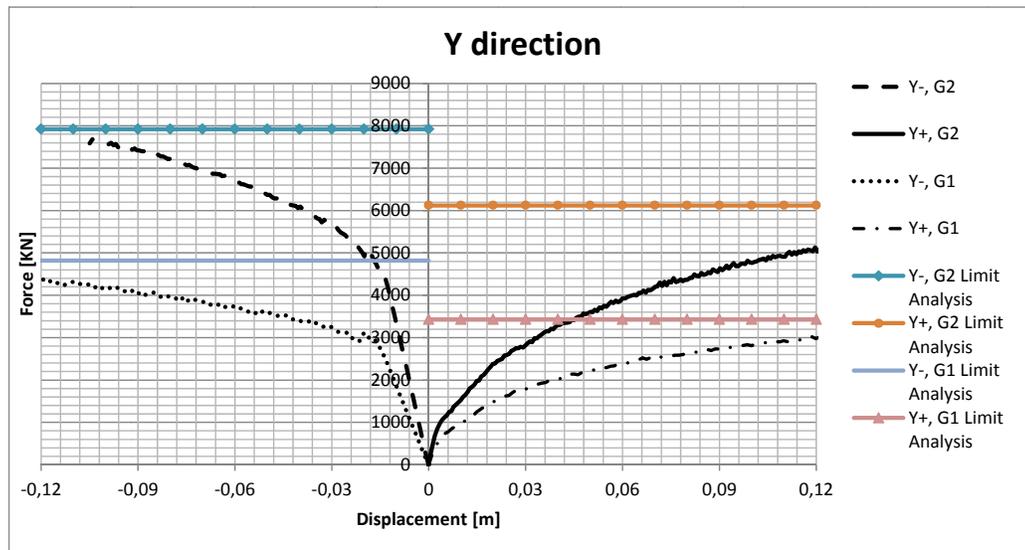
Fig. (10). Force-Displacement curve for Y- direction.

relative to the distribution of forces G1 but positive direction.

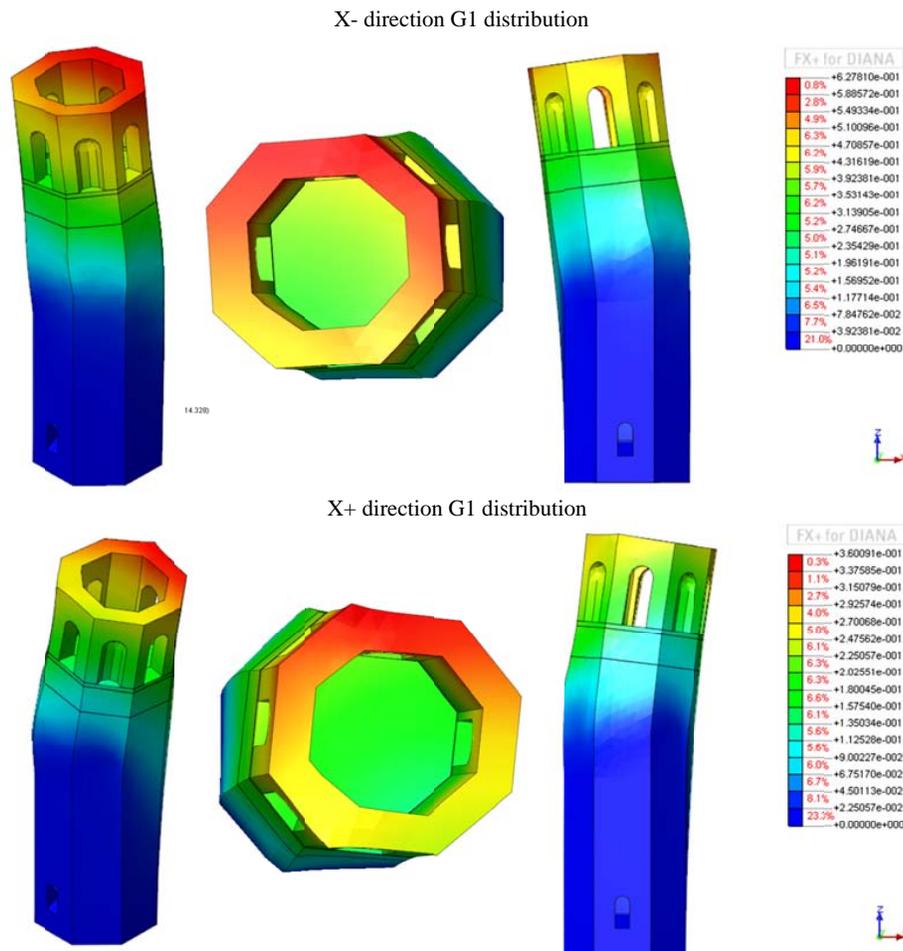
Fig. (11). Deformed shapes at peak provided by the commercial code. X direction.

shapes provided by both limit analysis and incremental non-linear code, reported in Fig. (11), Fig. (12) (incremental code) and Fig. (13) (limit analysis) especially for what concerns the failure mechanism.

It clearly involves the lower part of the structure, with the formation of a well-defined inclined cracked surface departing from the upper portion of the constrained vertical edge and proceeding deeply from the top to the bottom, up to the base, thus activating much more mass with respect to both G1 case and the contrary direction (X- and Y+ respectively).

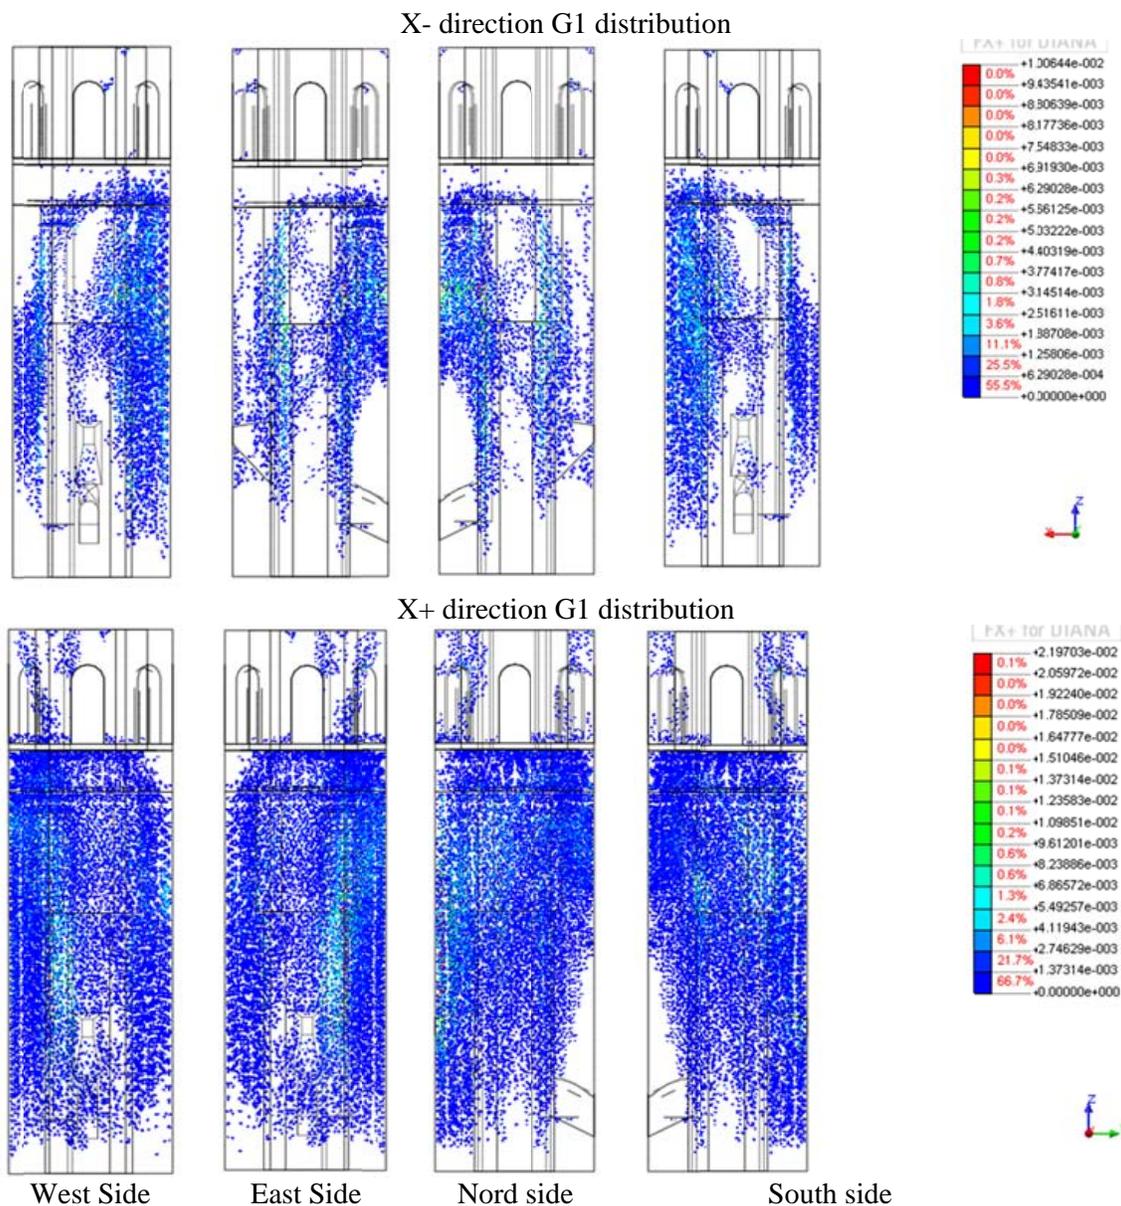
Fig. (14). Numerical crack patterns, X direction, G1 distribution

In figures from Fig. (14-17) crack patterns provided by DIANA program and referred alternatively to X and Y direction and G1 or G2 load distributions respectively are repre-

sented. As already pointed out, crack patterns provide a good insight into the actual failure mechanism active in the considered load case. The failure mechanisms is rather well de-

finned in each case, with a clear formation of an inclined failure surface and a rigid body movement of the upper part with respect to the lower around a cylindrical hinge belonging to the cracked surface.

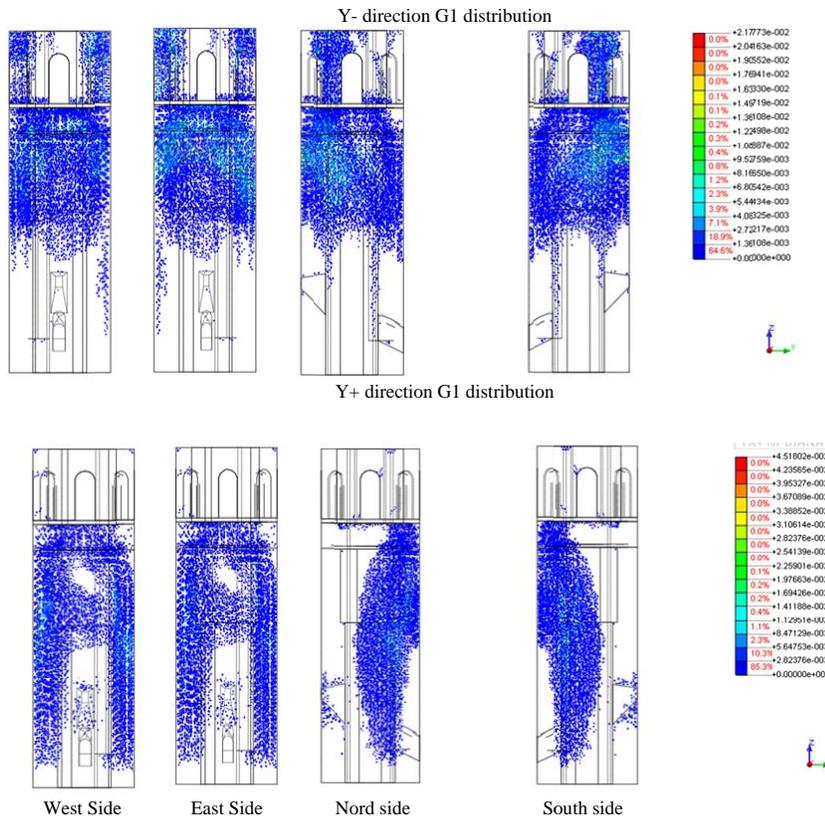
Fig. (16). Numerical crack patterns, Y direction, G1 distribution.

The un-collapsed lower part of the tower shows also an evident inclined lesion on the east side, which is compatible with the numerical crack pattern on the east side obtained when an earthquake in Y direction Fig. (16) is applied.

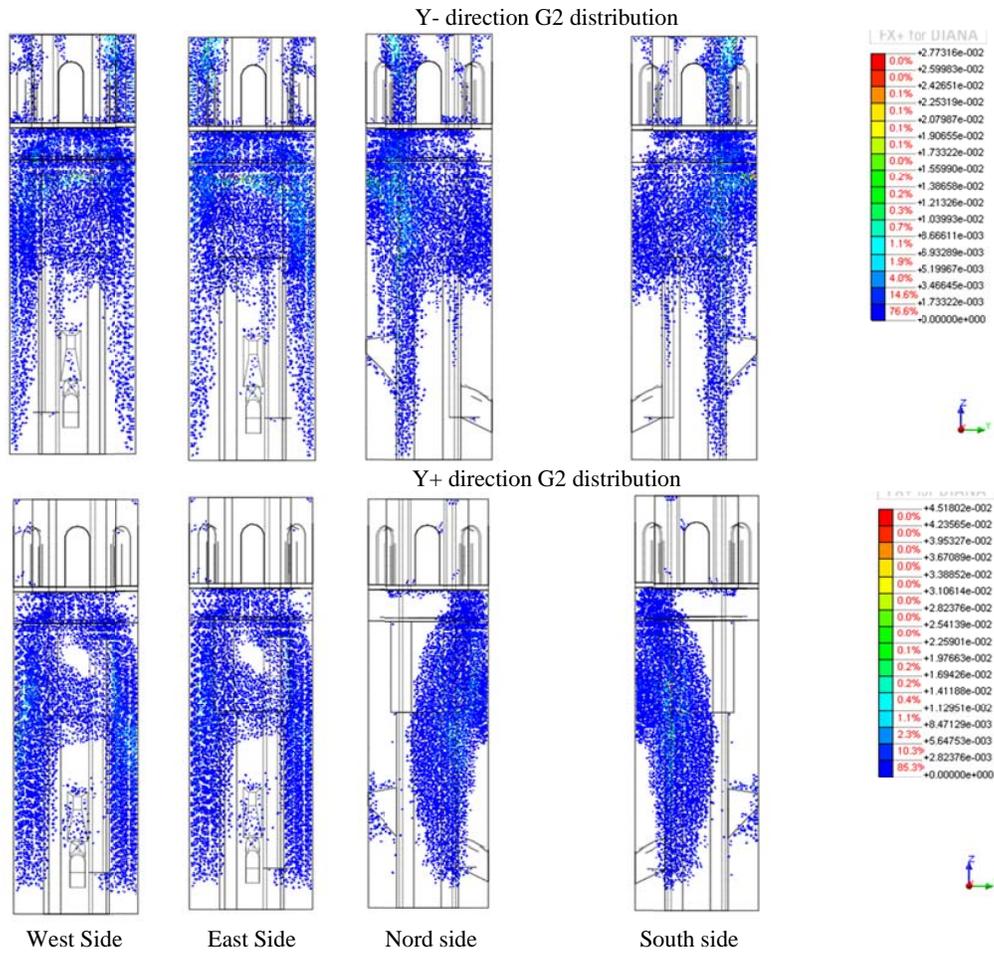
Fig. (17). Numerical crack patterns, Y direction, G2 distribution.

In several cases, a non-negligible concentration of cracks may be appreciated at the base of the belfry and diffusing in the central and lower part. Such a numerical result seems to

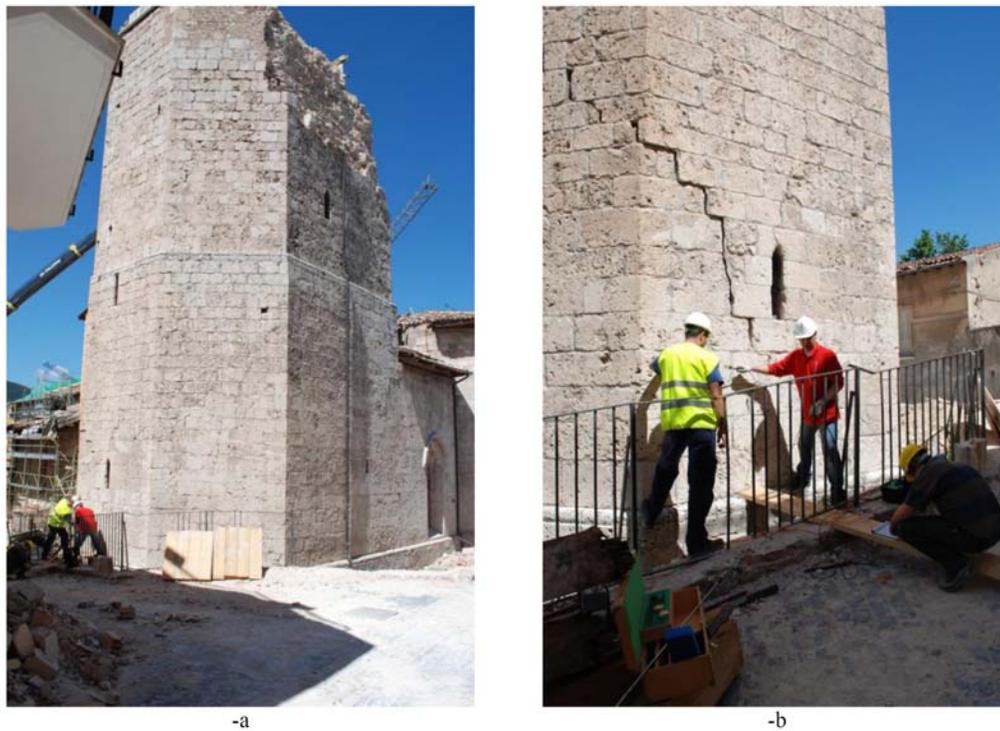
Fig. (18). -a: The tower after the L'Aquila earthquake (2009) and (-b) vertical cracks near the base

reflect quite accurately the behavior exhibited by the tower during the L’Aquila earthquake (2009), Fig. (18). Indeed, how it is possible to notice, the belfry results completely collapsed. From a detailed in-situ survey of the damages of the lower part and the ruins of the upper part, it appears clear that the failure mechanism associated to the partial collapse

was a full detachment of the belfry from the lower part of the tower in correspondence of the concrete curb.

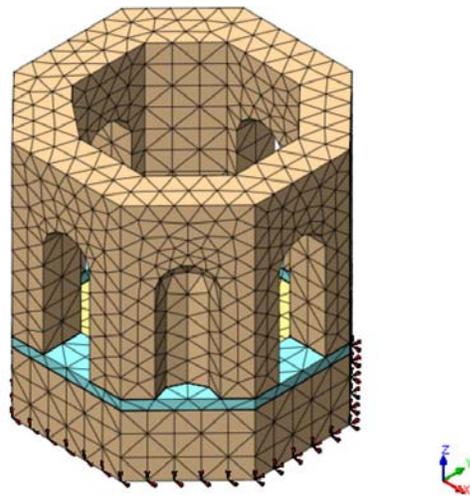
Fig. (19). FEM model of the belfry.

From post-earthquake surveys, it has been hypothesized that the collapse of the belfry was due to a failure mechanism associated to sliding and tilting of the upper part, probably caused by the presence of the concrete curb immediately under the belfry. In order to investigate such issue numerically, a further FEM model has been arranged using the same commercial code (DIANA 9.4.3 [22]), and modeling only the belfry of the tower, but introducing interface element between the belfry and the curb and between the frame and the

curb. Immediately under the curb, an additional small portion of the tower has been modeled, this latter assumed rigidly constrained at the base Fig. (19) The aim of the simulation is to reproduce both sliding and overturning of the upper part and compare the corresponding collapse acceleration to that required by code of practice specifics. The mechanical properties assumed for interface elements are reported in Table 7.

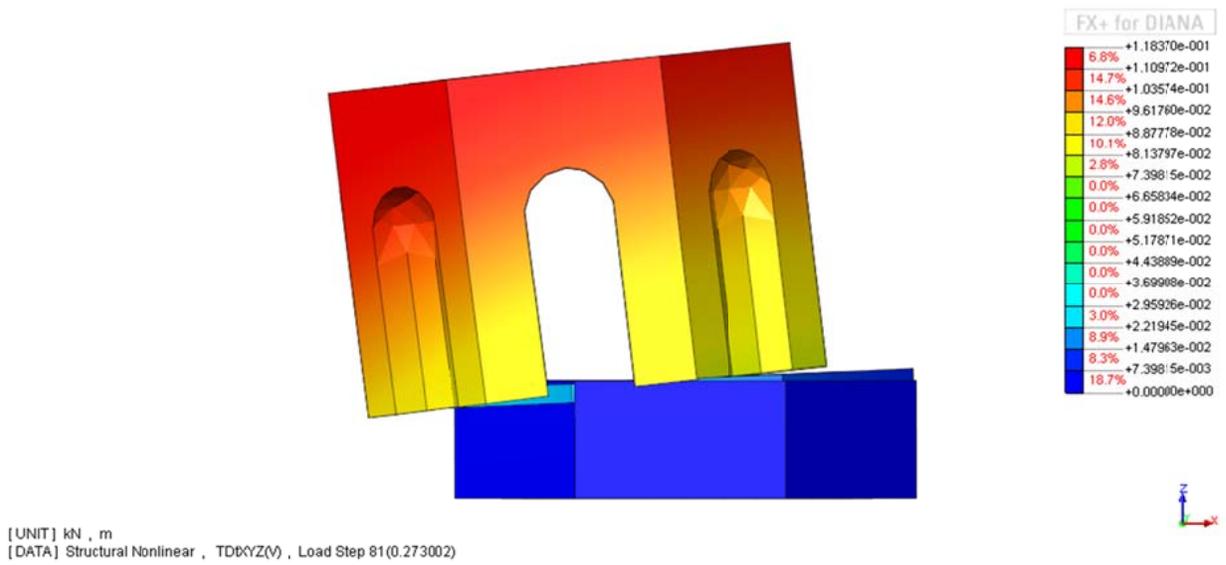
Fig. (20). collapse mechanism of the belfry.

The resultant deformed shape at failure is represented in Fig. (20). As can be noted, a sliding of the upper part with rotation of the belfry is present at failure, a collapse mechanism compatible to that observed during the seismic event.

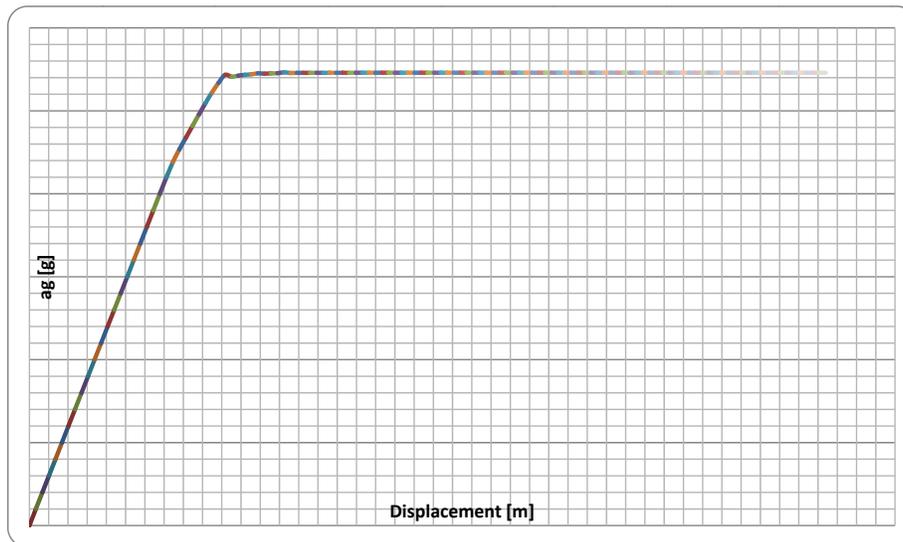
Fig. (21). Belfry mechanism. Curve representing horizontal displacement vs horizontal acceleration.

Having a look into the pushover curve (maximum horizontal displacement vs incremented horizontal acceleration), it can be noted that the collapse multiplier for the acceleration Fig. (21) is the following:

$$c=0.28 \tag{1}$$

$$a_0^* = \frac{c \cdot g}{e^* F_c} = \frac{0.28 \cdot g}{0.95 \times 1.35} = 0.22g \tag{2}$$

Comparing Equation (2) with Equation (3), it can be seen that the collapse mechanism of the belfry is not verified according to the Italian norms.
