# The Open Dentistry Journal

## CASE REPORT

### Chronic Submerged Implant Infection Treated with Immediate Implantation and Guided Bone Regeneration: A Case Report

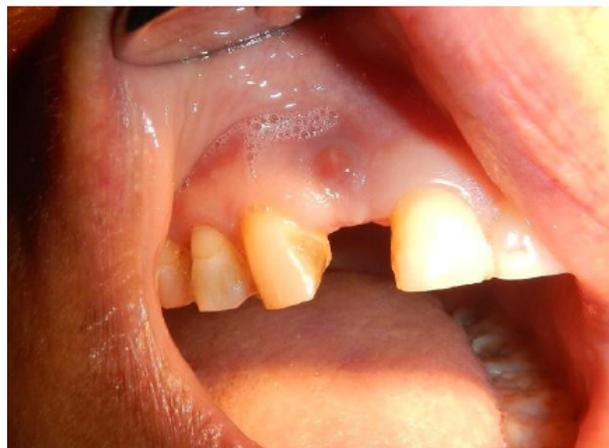
The patient was a 45-year-old woman with no history of any systemic disease, and she was not a smoker. The patient presented to our facility complaining about the sinus tract at the site where an implant was placed 4 months prior at the upper

right lateral incisor (Fig. 1). The implant was placed by another dentist, and the sinus showed pus discharge one month after implant placement. The patient was treated with antibiotics every time the sinusitis appeared, which disappeared after antibiotic treatment and reappeared after a period of time. The patient refused to continue treatment with the previous dentist; thus, she was referred to our clinic for further treatment. An orthopantomogram was taken to detect any osseous lesions or sites of bone resorption, and crestal bone resorption was found (Fig. 2). The decision regarding implant removal and replacement along with guided tissue regeneration was discussed with the patient. Written consent was obtained from the patient for the surgery and the publication of her data. Under local anesthesia, a three-sided flap was elevated, and all of the infected granulation tissue around the implant was removed. The implant was removed without bone removal using a ratchet with a forward movement (insertion torque); then, reverse torque was applied to remove the implant from the socket. The implant started to rotate when low torque was applied (15 Ncm), and examination of the implant after removal showed that the implant surface had not attached to the bone (Fig. 3). Through irrigation with normal saline, curettage was performed in the socket (Fig. 4). A new implant with an aggressive design (Dentium, SuperLine) was placed and immediately demonstrated good primary stability (45 Ncm). The implant placement was the same as that immediately after tooth extraction, engaging the palatal bone and the apical area. Several threads of the implant at the crest were exposed buccally (Fig. 5). Decortication and perforation of the labial bone with a burr were performed to identify the bleeding point on the bone. The GBR technique was performed using a resorbable collagen membrane (GENOSS, Gyeonggi-do, South Korea) and a hydroxyapatite-B tricalcium phosphate (HA 70% +  $\beta$ -TCP 30%) bone graft (GENOSS, Gyeonggi-do, South Korea). Periosteum scoring was performed at the base of the flap, and tension-free closure was achieved. The antibiotic treatment consisted of amoxicillin/clavulanate 625 mg and metronidazole 500 mg, and Ibuprofen 400 mg was administered for pain. The sinus tract infection disappeared after one month of healing (Fig. 6). Second-stage surgery was performed after six months; when the flap was raised, new bone was observed to have formed around the implant buccally (Fig. 7). The cover screw was removed, and the healing abutment was placed. After one month, an impression was made with the closed-tray technique and sent to a laboratory for the fabrication of a metal crown fused to porcelain. The crown was placed on a straight abutment (Fig. 8) and cemented with zinc phosphate cement, and the occlusion was checked. Post-implantation radiographs show the proper prosthetic setting and crestal bone level (Fig. 9). The patient was motivated to maintain good oral hygiene.

**Fig. (1).** Chronic infection with sinus discharge at the site of 12 submerged implants. The implant was placed 4 months ago.

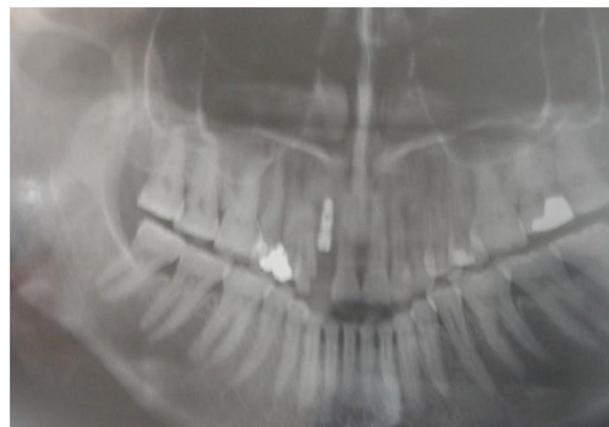
**Fig. (2).** Orthopantomogram taken to detect the status of the implant and the adjacent teeth. The radiograph shows some crestal bone resorption around the implant and normal adjacent teeth and structures.

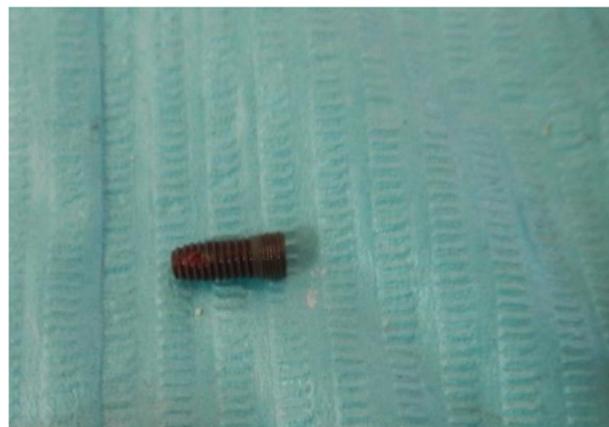
**Fig. (3).** Failed implant removed with low torque using a ratchet. There was no bone attached to the implant, and the implant was designed with shallow grooves and more parallel threads.

In contrast, in another study [8], the failed implant was immediately replaced with a wider and longer implant. In our case, we chose to remove the implant because it was not yet loaded, and there was no prosthesis to lose. In addition, the implant was not very stable and thus had a high chance of losing stability after loading. The implant was removed by

applying torque to the implant with a ratchet in the insertion direction and then applying reverse torque, which is a very safe procedure for removing a failing implant while maintaining the surrounding bone (Table 2).

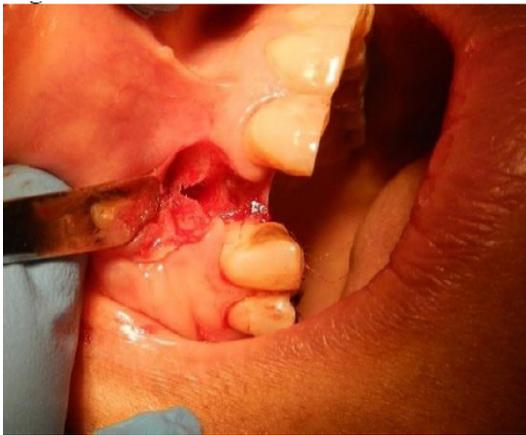
**Fig. (4).** The site after conservative implant removal with no bone destruction. The site was curetted to remove any fibrous or infectious tissue residue.

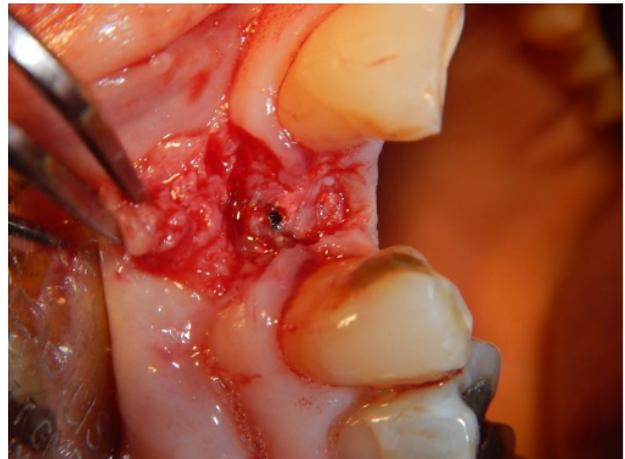
**Fig. (7).** Exposing the implant site after 6 months shows newly formed bone around the implant and was no signs of infection.

In the current study, the second implant was placed in the infected site with bone resorption; however, the bone was still able to integrate with the new implant. In addition, new bone formed closely around the second implant and the dehiscence through the GBR procedure.

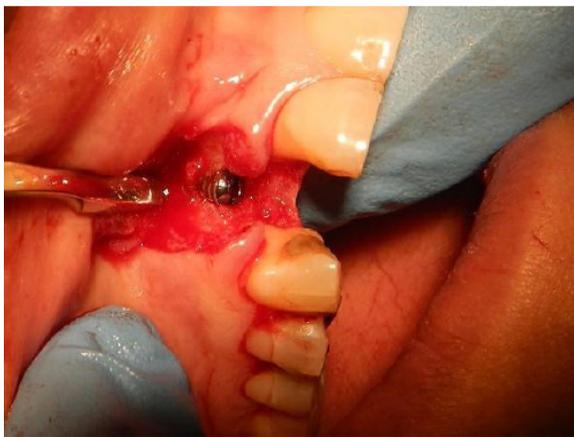
**Fig. (5).** The new implant was placed with good primary stability; the new implant was longer and engaged the palatal bone. The proximal and palatal views show that the implant is below the crestal bone, while the labial view shows that the implant threads remain exposed.

In the current case, we used a second implant with the same diameter as the failed implant but with a different design (aggressive), and we placed the implant more palatally using the same technique as used for the immediate implant (Table 2).

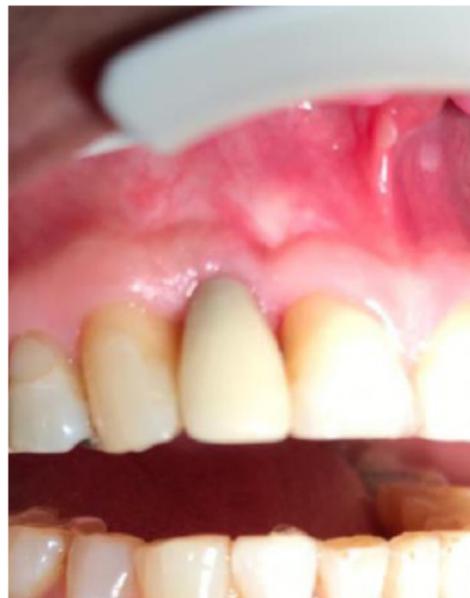
**Fig. (8).** Porcelain fused to a metal crown was cemented with zinc phosphate cement.

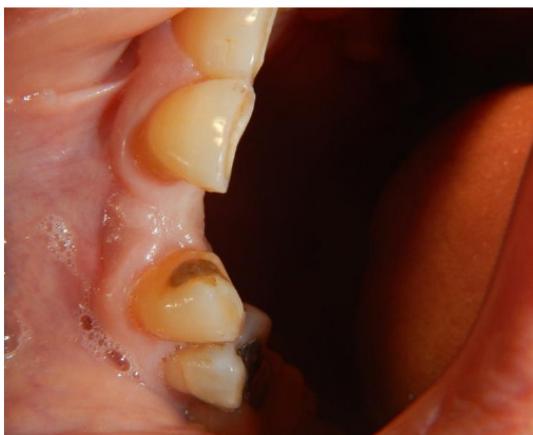
**Fig. (6).** After one month of healing with no signs of infection, the implant site is completely healed with normal tissue.

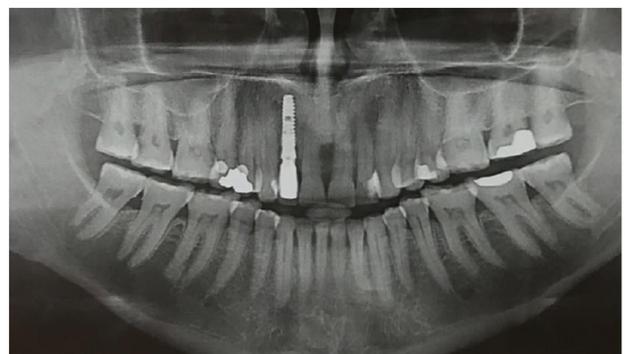
**Fig. (9).** Post-implantation radiograph showing crestal bone level stabilization and proper adjustment of the prosthetic parts.
