The Open Dentistry Journal

RESEARCH ARTICLE

Evaluating the Failure of Resin-based Materials on the Proximal Cervical Dentin

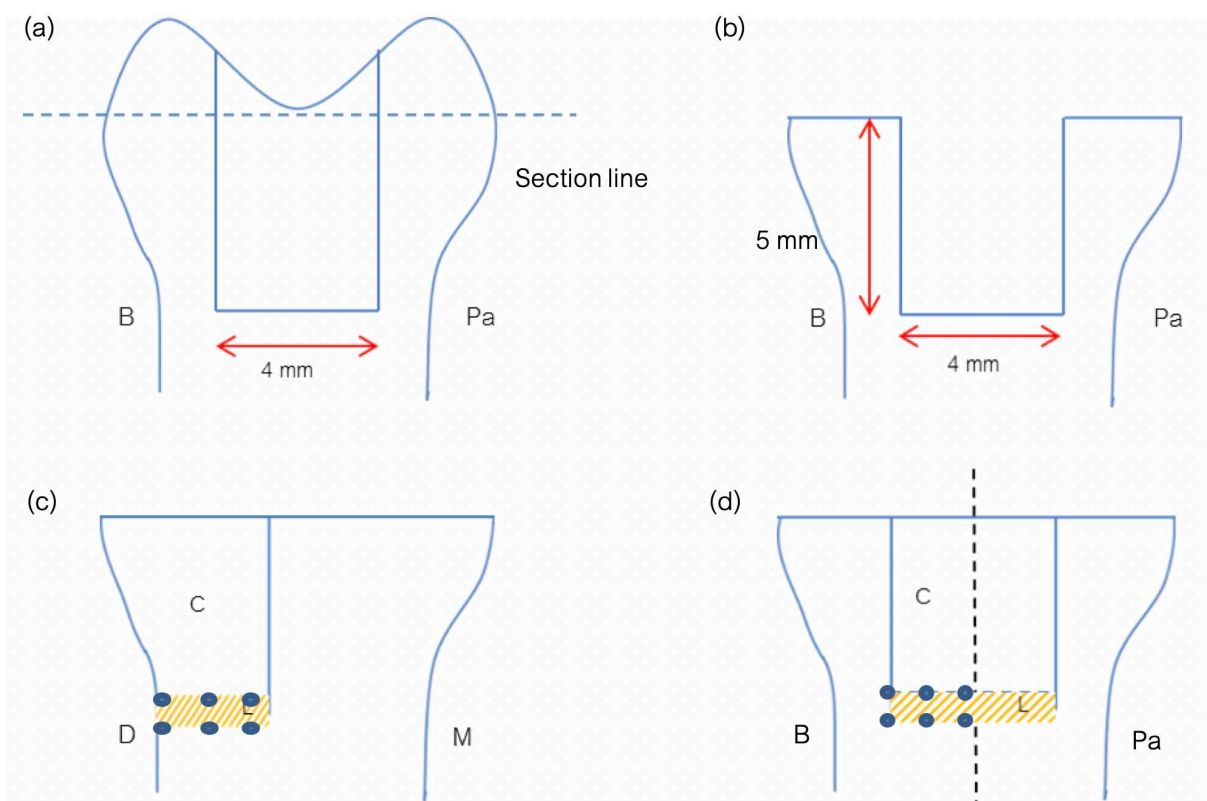
Fig. (1). The schematic drawing of sample preparation. The schematic drawing horizontally sectioned at the occlusal surface (a), cavity preparation after horizontally sectioned at the occlusal surface (b). Dots locate the gaps at liner-dentin interface and liner-resin composite interface of internal surface (c), and external surface (d). (C=Resin composite, L=Liner material, B=Buccal aspect, Pa= Palatal aspect, D=Distal aspect, M=Mesial aspect)

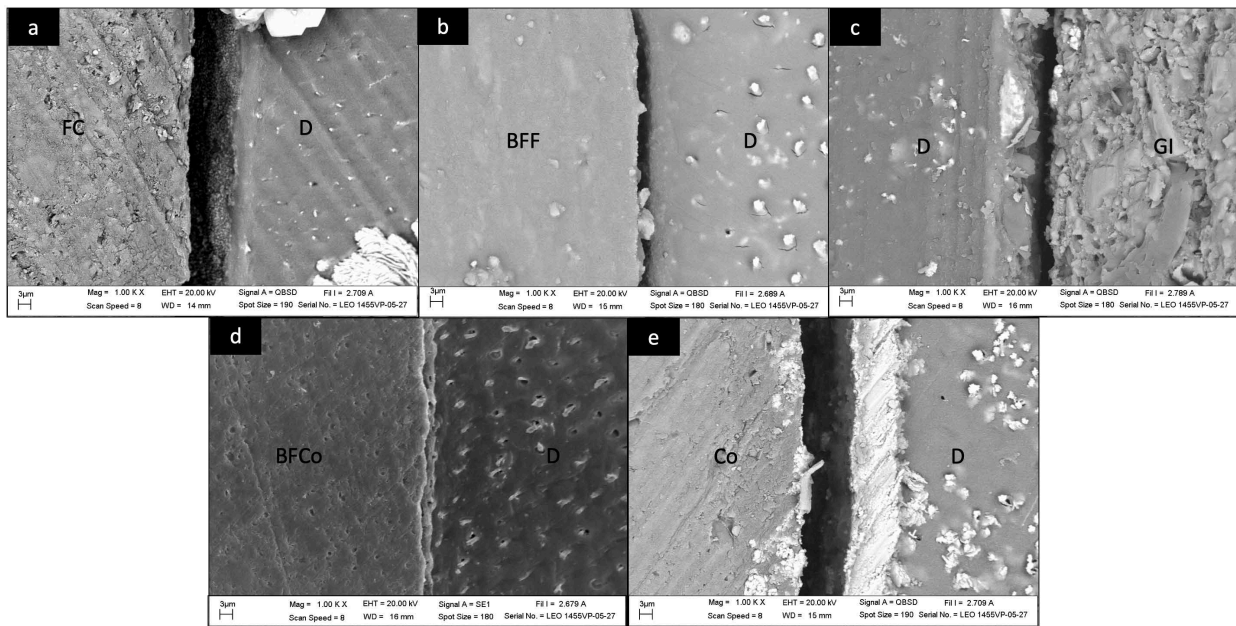
Fig. (2). These SEM micrographs (1000x) show gap formations at the cervical dentin on the external surface among the five groups. The gap formations occur between the hybrid layer and the restorative materials. (D=Dentin, FC=conventional flowable resin composite, BFF=bulk fill flowable resin composite, GI=resin modified glass ionomer cement, BFCo=high viscosity bulk fill resin composite, Co=conventional nano-filled resin composite).

Gap formations were found at the cervical dentin on the external surface between the hybrid layer or the modified hybrid layer (Group III) and the restorative materials (Fig. 2). The hybrid layer was still in contact with the cervical dentin. The width of the gaps varied, depending on the material used, as shown in Table 2.

Group III had the largest gap width (1.63 μm) ($p < 0.05$), followed by Group V (1.28 μm) and Group I (1.27 μm). Group II presented a significantly smaller gap width (0.68 μm) compared to Group V ($p < 0.001$). Samples in Group IV did not show any gap formation at the cervical dentin on the external surface.

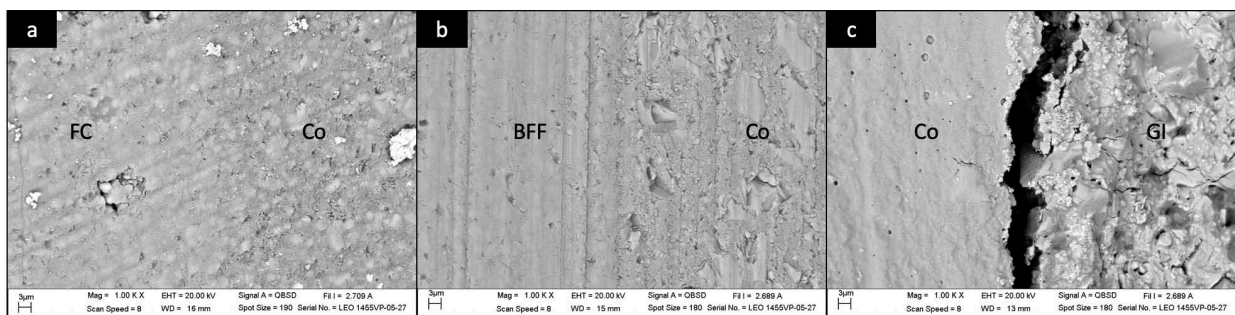
Fig. (3). These SEM micrographs (1000x) show the junction between the lining material and the resin composite on the external surface. Gap formation was found only between the resin modified glass ionomer cement and the conventional nano-filled resin composite. (Co=conventional nano-filled resin composite, FC=conventional flowable resin composite, BFF=bulk fill flowable resin composite, GI=resin-modified glass ionomer cement).

Gap formation between the lining materials and the conventional nano-filled resin composite on the external surface was found only in Group III (Fig. 3). The width of the gaps is shown in Table 3.

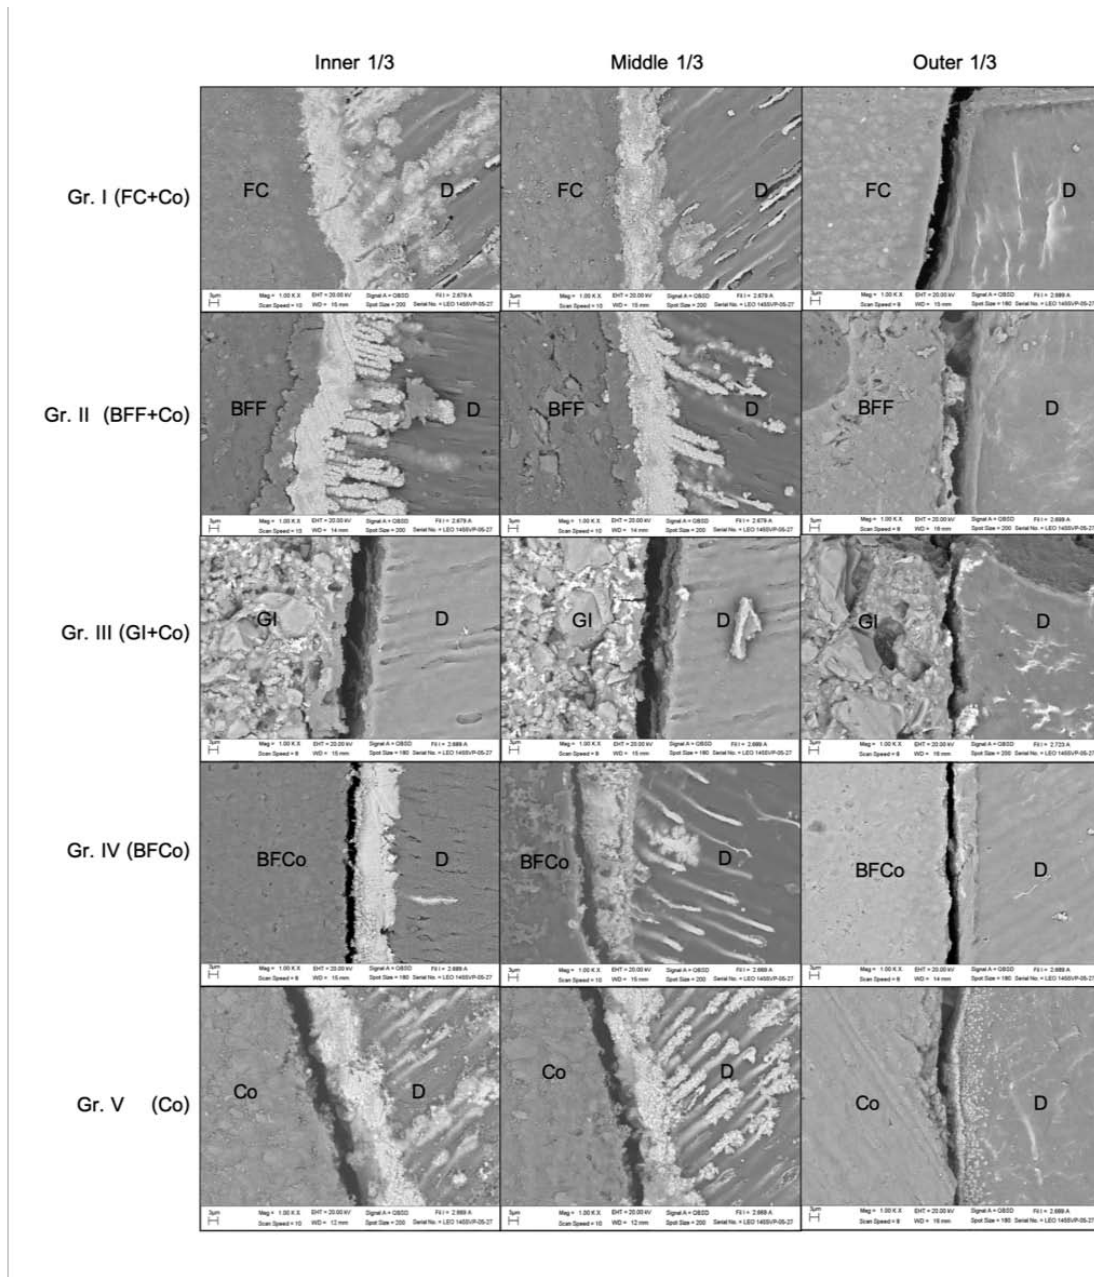
Fig. (4). These backscattered SEM micrographs (1000x) show the pattern of the silver nitrate deposition and the gap formation on the internal surfaces. (D=Dentin, FC=conventional flowable resin composite, BFF=bulk fill flowable resin composite, GI=resin modified glass ionomer cement, BFCo = high viscosity bulk fill resin composite, Co=conventional nano-filled resin composite).

The SEM micrographs in Fig. (4) show the hybrid layer, the pattern of silver nitrate deposition and the gap formation on the internal surfaces. The inner and middle areas of the gingival wall showed thicker hybrid layers and thicker silver nitrate deposition compared to the outer area. In Group III, all samples presented a modified hybrid layer, which was clearly thinner than the hybrid layers of Groups I, II, IV, and V.

Group I and Group II shared similar patterns of silver

nitrate deposition and gap formation. At the inner and middle areas, the silver nitrate was deposited on the entire width of the hybrid layer and on the resin tags penetrating the dentinal tubules. At the outer area, a thin layer of silver nitrate formed within the hybrid layer and gaps occurred between the hybrid layer and the restorative materials.

Group IV and Group V shared their own similar patterns of silver nitrate deposition and gap formation. The silver nitrate was deposited discontinuously on and within the hybrid layer. Gaps were formed between the hybrid layer and the layer of restorative materials in all three areas.

The SEM micrographs of Group III show the modified hybrid layer. The silver nitrate was deposited on and within the modified hybrid layer and on the resin modified glass ionomer cement. There was a gap formation between the glass ionomer material and the modified hybrid layer in all three areas.

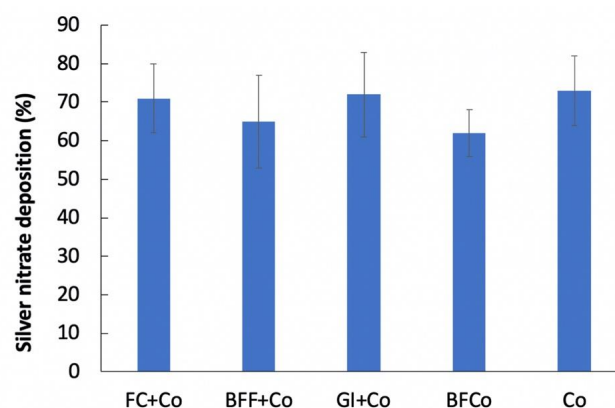
**Fig. (5).** The mean silver nitrate deposition at the cervical dentin on the internal surface, expressed as a percentage of the total length.

The distances of the silver nitrate depositions along the gingival wall are shown in Fig. (5), expressed as percentages of the total length. Group V (control) had the largest silver nitrate deposition (73.26%), followed by Group III (72.56%), Group I (71.46%), Group II (65.01%), and Group IV (62.66%). There was no significant difference in the distance of the silver nitrate deposition among groups ($p > 0.05$).

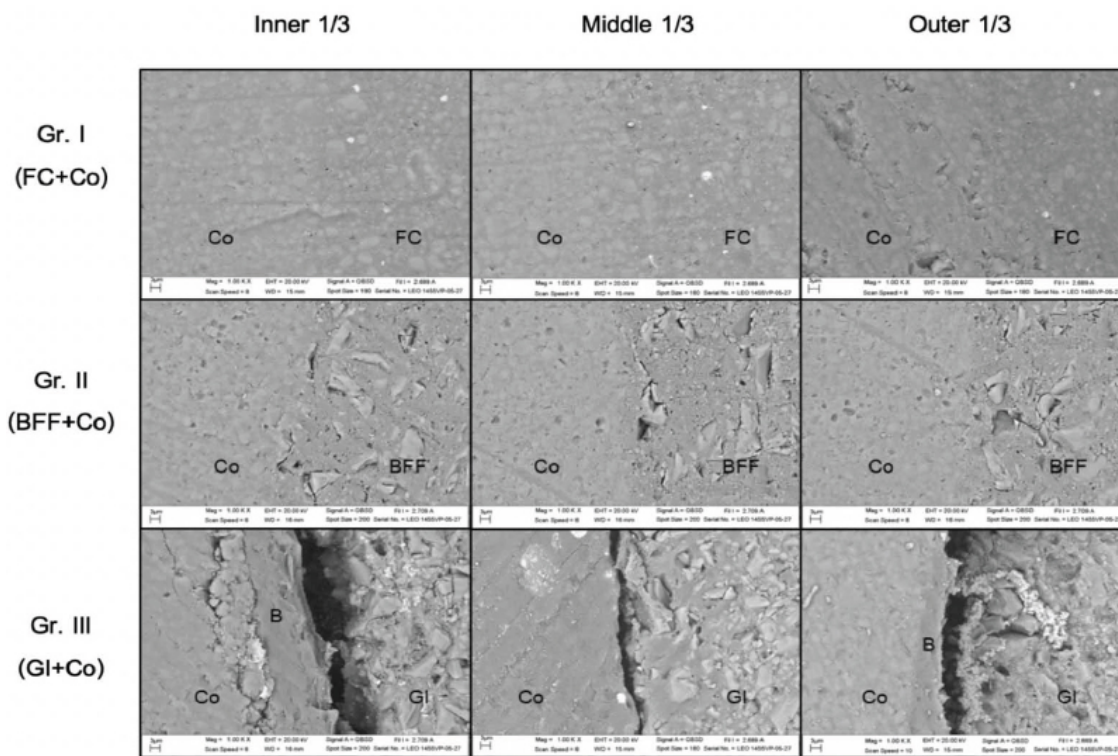
Fig. (6). These backscattered SEM micrographs (1000x) show the gap formation or lack thereof at the lining material-resin composite interface on the internal surface. Gap formation is visible between the resin modified glass ionomer cement and bonding layer at all three areas. (FC=conventional flowable resin composite, BFF=bulk fill flowable resin composite, GI=resin modified glass ionomer cement, Co=conventional nano-filled resin composite, B=bonding layer)

Groups I, II, and III had lining materials (flowable resin composite, bulk fill flowable resin composite, and resin-modified glass ionomer cement, respectively) underneath the nano-filled resin composite restorations. The SEM photographs of Group I and Group II showed no gap formation between the respective restoration materials of that

group. (Fig. 6). In contrast, gap formation was found in Group III, with the largest gap in the outer area (1.03 µm). The size of the gap was not significantly different among the three areas ($p > 0.05$) (Table 6).
