The Open Orthopaedics Journal

LETTER

Long Term Survivorship of a Severely Notched Femoral Stem after Replacing the Fractured Ceramic head with a Cobalt-Chromium Head

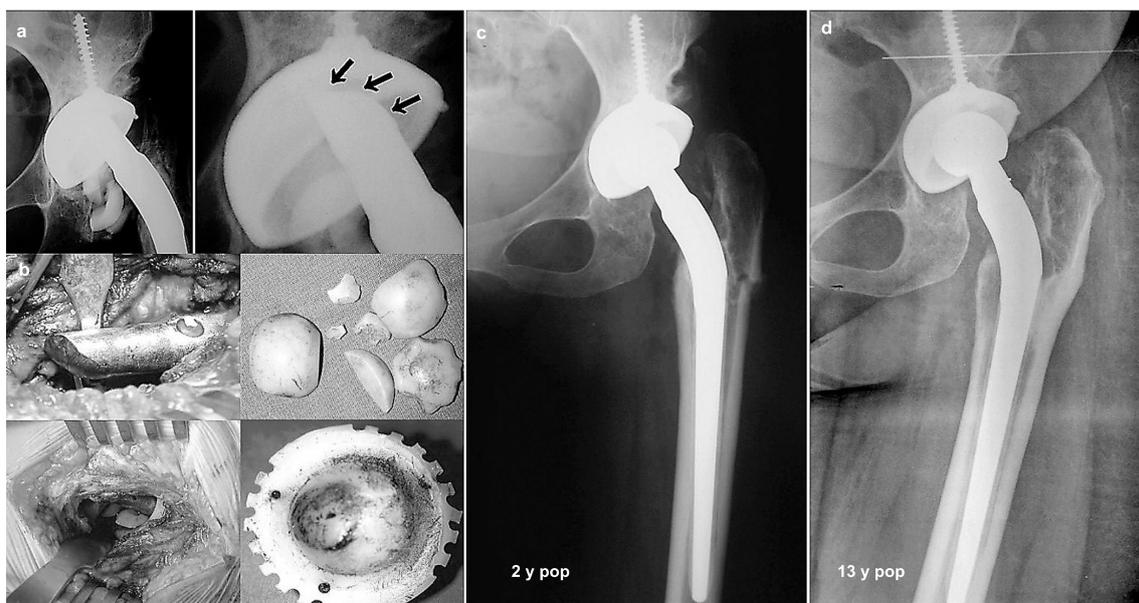
Fig. (1). (a). Plain hip x-ray demonstrated multifragment ceramic head failure associated with severe notching of the cone (arrows), (b). intraoperative findings at revision operation showing diffuse metallosis, multifragmented ceramic head, notching of the cone and severe polyethylene insert wear, (c). follow up x-ray at 2 years and (d). final x-ray 13 years after revision operation.

Details of the case have been presented earlier [8] but in brief it is about a 40-year-old woman, weighted 60 Kgr, who underwent an uncemented left total THA in 2001 for secondary degenerative osteoarthritis in a dysplastic hip. All the components had been manufactured by Mathys Medical Ltd., Switzerland, and consisted of a size 14 uncemented stem with 12/14 taper, a 28-mm small ceramic head, a 48 mm expansion shell and a 48/28 polyethylene inlay. The operation was straightforward and carried out according to the manufacturer's instructions. In February 2003, she was referred back to the Orthopaedic outpatient office complaining for right groin pain and crepitus, with no significant history of trauma. Radiographs showed a multiple fragmented ceramic head and significant notching of the cone (Fig. 1a). The patient underwent revision surgery. Intraoperatively findings included diffuse metallosis, a pseudocapsule containing black metalloid fluid, excessive wear of the cone, a multifragmented head and major wear of the insert (Fig. 1b). The uncemented stem and the acetabular component were not loose. Metalloitic tissue was thoroughly excised, ceramic debris were carefully removed, the area was well irrigated and the polyethylene insert was revised with a similar one. As there were severe notching of the taper of the stem, an effort was made to revise it, but this was proved impossible, as it was absolutely stable. Actually, during the procedure of removal, a non-displaced fracture at the greater trochanter was created. A 28 small cobalt-chromium femoral head was finally placed at the existing taper whereas non-absorbable transosseous sutures were used for greater trochanter fixation. At the 24-month follow-up examination, the patient had no pain, used no walking aids, and had normal activity without any signs of loosening or other implant pathology in plain radiographs (Fig. 1c). We were able to re-examine her 13 years after the revision operation because of left knee pain and she still had normal activity, no pain and full range of motion at her hip joint. The Harris-Hip score was excellent (95). An x-ray of her hip 13 years after revision had no signs of wearing or other pathology (Fig. 1d).

especially when a stainless-steel femoral head is used instead of the fractured ceramic head. In our case major wear of the polyethylene insert was found because the cone of the stem had been articulated with it. Since the acetabular component was intact and quite stable, we simply replaced the damaged insert with a similar one.

More controversies exist about the type of head, which had to be used for replacement of the fractured ceramic head. This particular choice is strongly associated with the condition of the cone of the femoral component. The combination of a metal/polyethylene articular pairing, proposed by various authors in the past [17, 24 - 26] is no longer recommended as it is considered a cause of diffuse metallosis and loosening [4, 6, 24, 25, 27]. Alain *et al.* [4] reported a 47% incidence of repeat revision(s) when a stainless-steel femoral head had been used, whereas the rate was only 17% and 11% when a ceramic or a cobalt-chromium head had been used in correspondence. Lee *et al.* [27] reported recently on 9 third-generation ceramic bearing fractures (6 heads and 3 liners) that were treated with bearing change to Metal on Polyethylene (MoP). Mean follow-up was 4.3 years. During follow-up, 2 of 3 liner-fractured hips and 1 of 6 head-fractured hips showed radiologic signs of metallosis and elevated serum chromium levels. The authors suggested avoidance of MoP in cases of ceramic bearing fractures. In contrast, Sharma *et al.* [28] followed up 8 hips that were revised to MoP articulations using cobalt chromium heads after fracture of ceramic heads. The authors found no revisions or aseptic loosening at a mean 10.5 years follow-up. They emphasized, however, that the key to the long-term success of any revision for a ceramic head fracture is performing a thorough anterior and posterior synovectomy. The use of a ceramic head for replacement, in order to avoid third body damage of metal, have been proposed by some authors [21] even in cases with mild cone wear. In our case, we decided to replace the fragmented head with a cobalt-chromium one because the cone was severely notched and it was impossible to revise the stem unless an extensive and complex approach was utilized.

In our case the corrosion of the cone was severe, the ceramic head had not been replaced by a new ceramic head but the implants remained stable for 13 years and the patient provided an excellent clinical and radiological outcome.
