Rock Slope Stability Problem Modeling and Remediation of the Arabian Shield Rocks: A Case Study From Werka Descent Road West of Saudi Arabia

Bahaaeldin Sadagah*

King Abdulaziz University, P.O. Box 80099, Jeddah 21589, Saudi Arabia

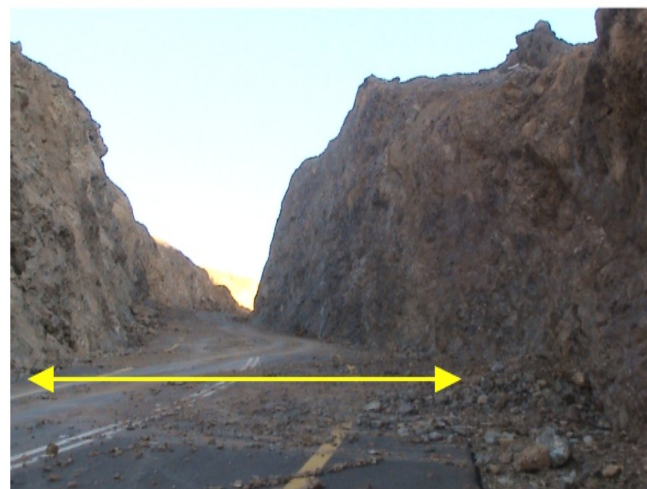
Fig. (1). Werka descent 8 meter road, at Alkharar town, Tabuk governate.

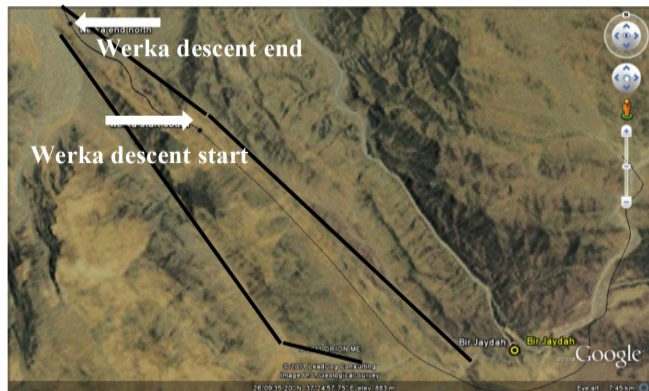
Fig. (3). Location of the Werka descent is shown on Google Earth image. The black thin line is the present road in the study area, and the black thick line represents the faults.

The rocks at Werka descent lie between two faults striking between $\text{N } 45^{\circ}\text{S}$ and $\text{N } 70^{\circ}\text{W}$. A number of minor faults (Fig. 3) are located in the area at small and micro scale. Faults strikes are in the same direction of major faults in the quadrangle between $\text{N } 45^{\circ}\text{S}$ and $\text{N } 70^{\circ}\text{W}$. Schistosity direction of the rocks has the faults attitudes. Folds strikes are taking the same directions as faults.
