# Suitability of Current Assessment Techniques to Retrodict the Seismic Damage of Buildings: A Case Study in Van, Turkey

**Abstract:** Two strong earthquakes hit the region of Van (Turkey) in 2012, generating major losses. A large part of the building stock was damaged causing the evacuation of the residents. A post-earthquake investigation team dispatched by the UNESCO through the IPRED platform, six month after the earthquakes, observed the damage state in some still standing buildings. Ten buildings having different structural characteristics were observed. Slight structural damage and severe non-structural damage were observed in three multi-storey apartment buildings, being evacuated at the time of the investigation. Despite the slight structural damage, two multi-storey reinforced concrete shear wall buildings were listed for demolition based on the results of the post-earthquake rapid assessment. These two buildings were recently built based on modern seismic design regulations. The design blueprints were available to the investigation team with the support of the local community of Van. Various rapid post-earthquake investigation techniques applied by the investigation tea

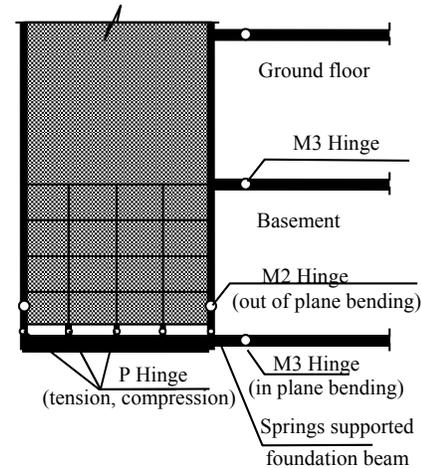
Fig. (4). Modelling assumptions.

Nonlinear M3 hinges were introduced at the end of each beam. Nonlinear P-M2-M3 hinges were introduced at the bottom of each column, directly above the foundation beams. Nonlinear P hinges were introduced at the boundary columns of shear walls. Nonlinear P hinges were used to simulate the yielding of the vertical reinforcement in the web of the shear walls, as well (Fig. 4).

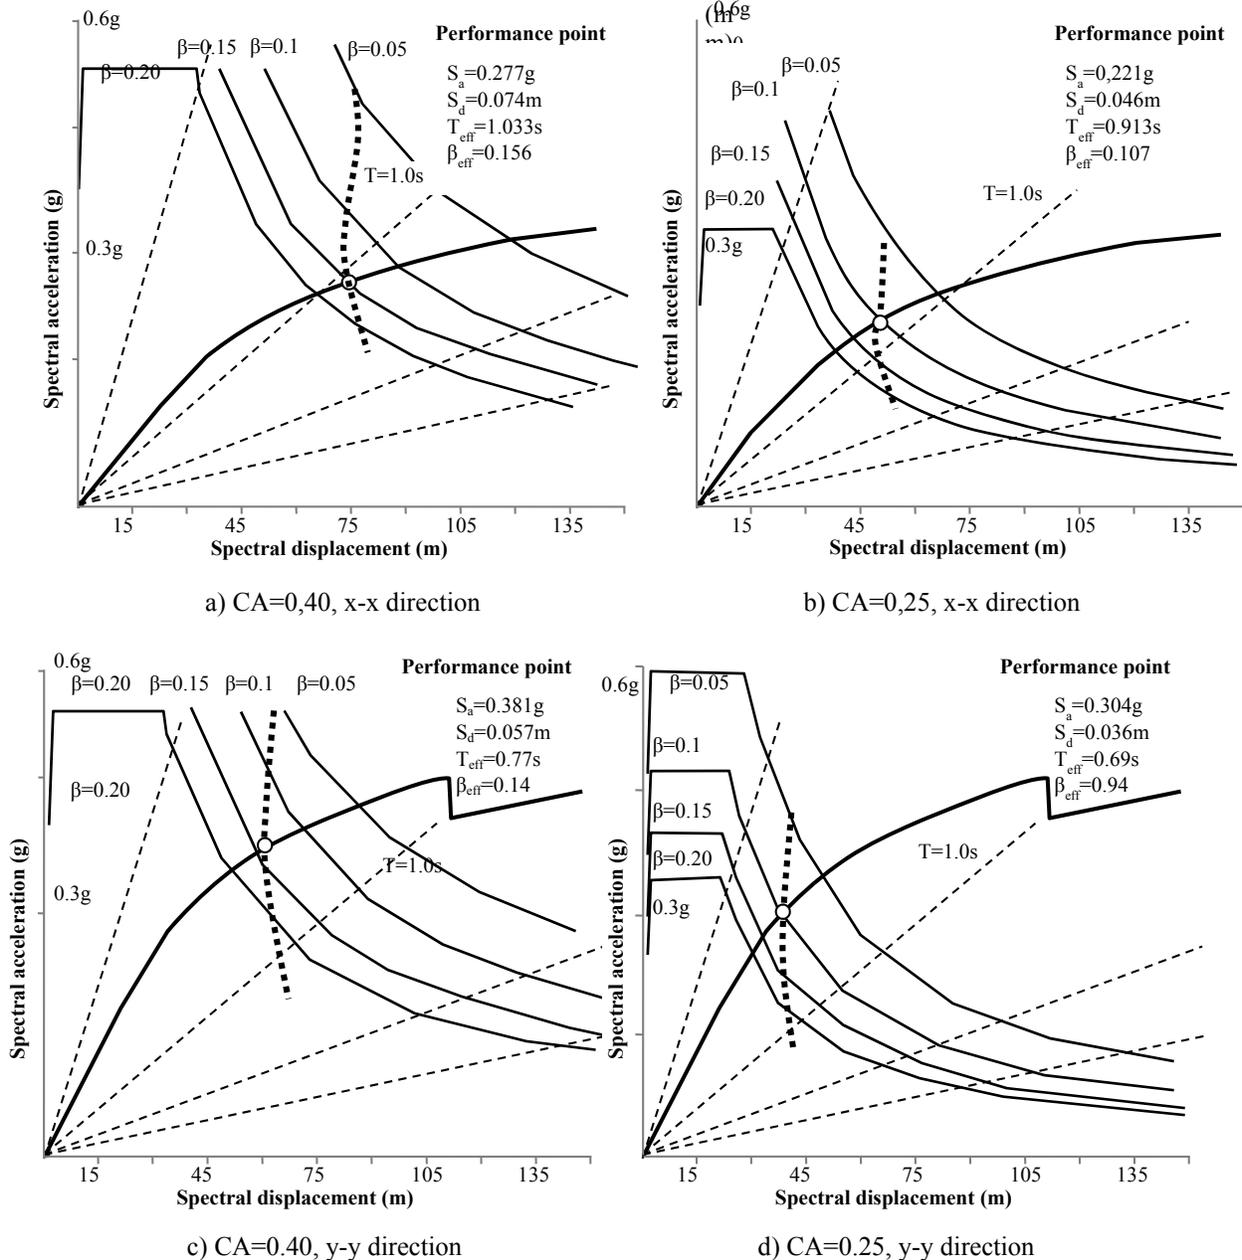
Fig. (8). Capacity spectrum method.

essentially elastic response of the structure. The same comment is valid noticing the location of the performance points in Figs. (8b) and (8d).

These relatively low values of the lateral displacement demand can be explained by the short control period of the acceleration response spectrum for the building site and the relatively high lateral strength of the building. Regarding the strength of the building, a lateral overstrength factor of 2.0 corresponding to a reduction factor  $R=4$  suggested that limited nonlinear behaviour can be expected.

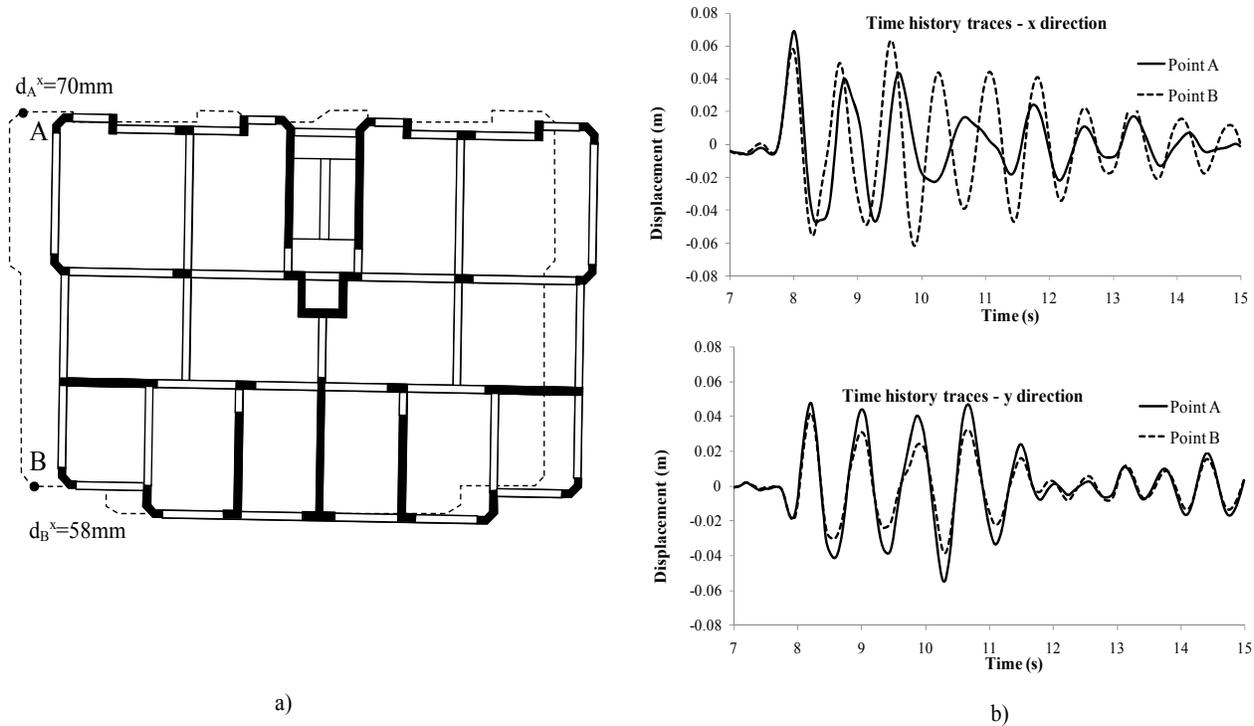
Fig. (10). Amplification of the lateral displacement caused by torsion and time history traces at the roof level.

The time history analysis revealed that the building can experience a relatively strong torsional response. Only the inherent torsion caused by the eccentricity between the centre of mass and centre of rigidity was considered in the analysis. Accidental torsion was not accounted for. Peak displacements in the longitudinal direction at roof level varying from 58mm to 70mm on the building perimeter were obtained (Fig. 10a). This represents a 10% amplification of the perimeter displacements in comparison with the displacement calculated in the centre of mass. This amplification increased in the following cycles but the absolute value of the displacement decreased (Fig. 10b).

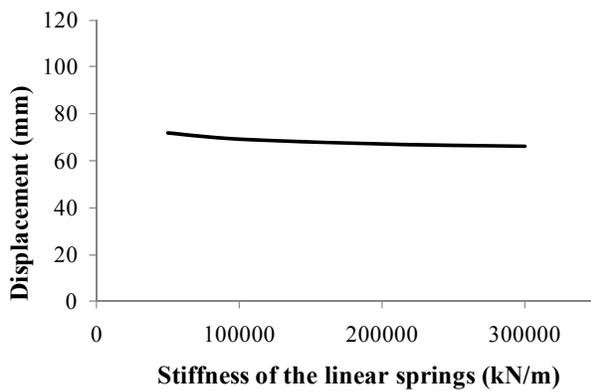
Fig. (12). The variation of the peak displacement with the stiffness of the support springs.

A similar sensitivity study was performed to determine the variation of the peak displacement demand with the stiffness of the linear springs that vertically supports the foundation beams. The results presented in Fig. (12) showed that the stiffness of the support springs have little influence on the calculated peak displacement demands at roof level.
