Stress Corrosion Crack Growth Mechanism on SUS316L Stainless Steel

Abstract: The stress corrosion cracking (SCC) of stainless steel is one of the biggest problems for maintaining atomic power and chemical plants. However the mechanism has not been solved because of difficulty in observing hydrogen movement. In order to solve this problem, the author has developed a new SCC test method that enables the super Kelvin force microscope (SKFM) and the Kelvin force microscope (KFM) observations. By using this test method, the crack tip deformation and surface potential distribution on SUS316L stainless steels were observed by SKFM and KFM. The existence of hydrogen-induced martensite was examined by the magnetic force microscope (MFM) observations. The results showed that a less noble potential region existed near the crack tip. MFM and KFM observation showed hydrogen-induced martensite existed at the less noble potential region. Repeated SKFM observations revealed that the crack is formed by the movement of hydrogen-induced martensite.

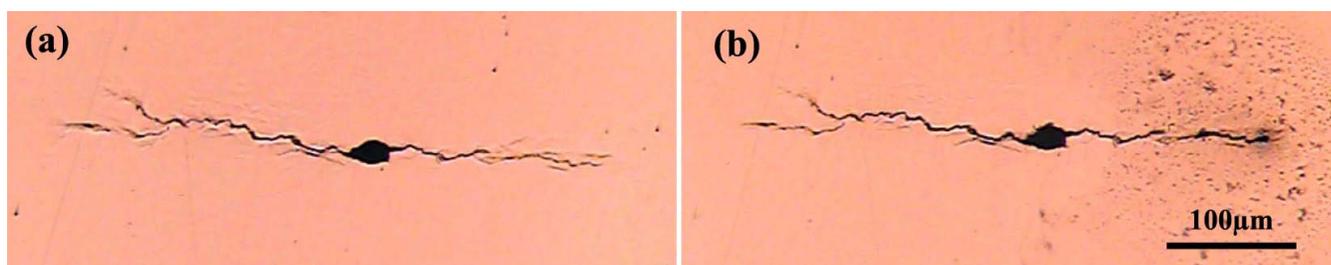
Fig. (1). Optical microscope images of crack produced at applied stress of 1030 MPa for 8 days. (a) Before Ag decoration, (b) after Ag decoration.

Fig. (1) shows the optical microscope images of crack (a) before Ag decoration and (b) after Ag decoration. The crack was produced at applied stress of 1030 MPa for 8 days. The crack usually initiated from a pit and propagated to the maximum stress direction (horizontal direction). Ag which is proved by EDX image mapping analysis (Fig. 2) precipitated only right side of the crack tip. The change of color was often observed near the crack tip where large amount of silver precipitated. Fig. (3) shows the SKFM observation of

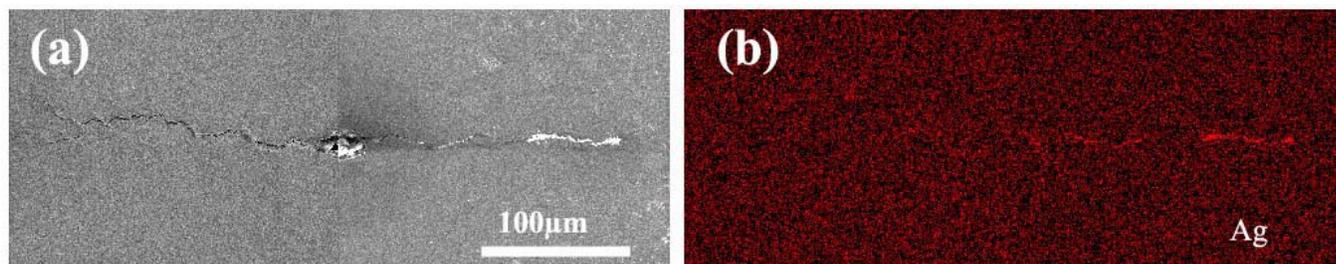
Fig. (2). EDAX image mapping analysis of crack produced at applied stress of 1030 MPa for 8 days. (a) SEM image, (b) EDX image mapping of Ag.

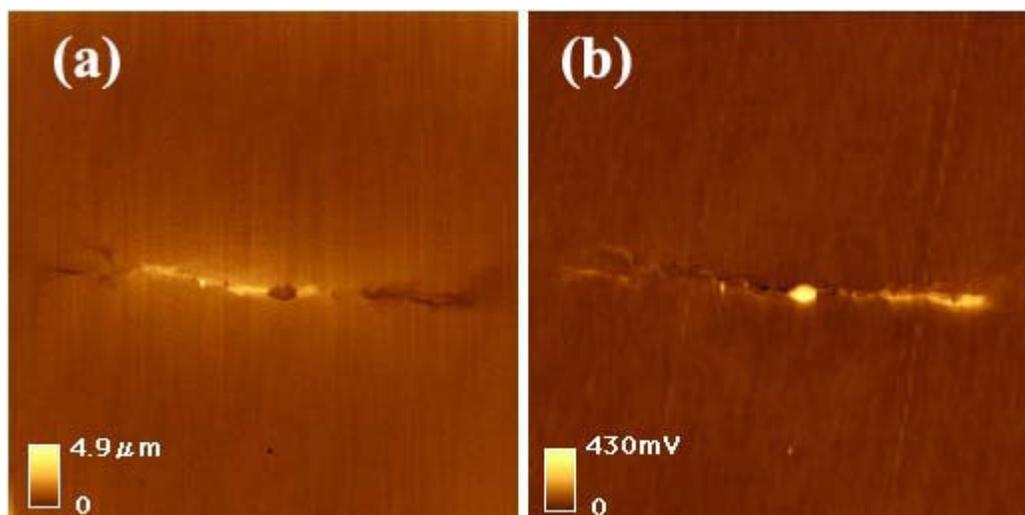
Fig. (3). SKFM image of crack produced at applied stress of 1030 MPa for 8 days. Image size: 0.6 mm X 0.6 mm. (a) Topography, (b) potential distribution image.

the crack. Less noble potential region was observed near the crack tip of right side. Fig. (4) shows the optical microscope images of crack (a) before Ag decoration and (b) after Ag decoration. The crack was produced at applied stress of 588 MPa for 8 days. Ag which is proved by EDX image mapping analysis (Fig. 5) precipitated in the pit and left side of the crack tip. The precipitation of Ag in the pit was usually observed in this stress level. The change of color was observed at the left side of the crack tip. Fig. (6) shows SKFM observation of the crack. Less noble potential region was observed near the crack tip of left side. Thus there is a very good correlation between hydrogen distribution and less

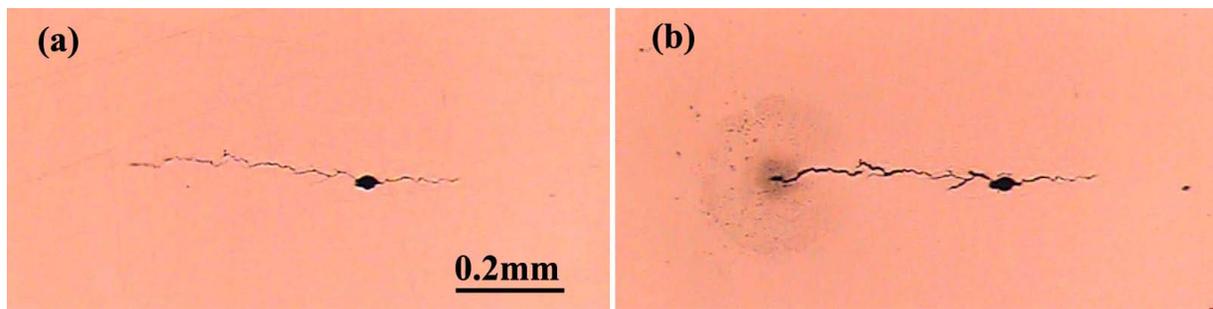
Fig. (4). Optical microscope images of crack produced at applied stress of 588 MPa for 8 days. (a) Before Ag decoration, (b) after Ag decoration.

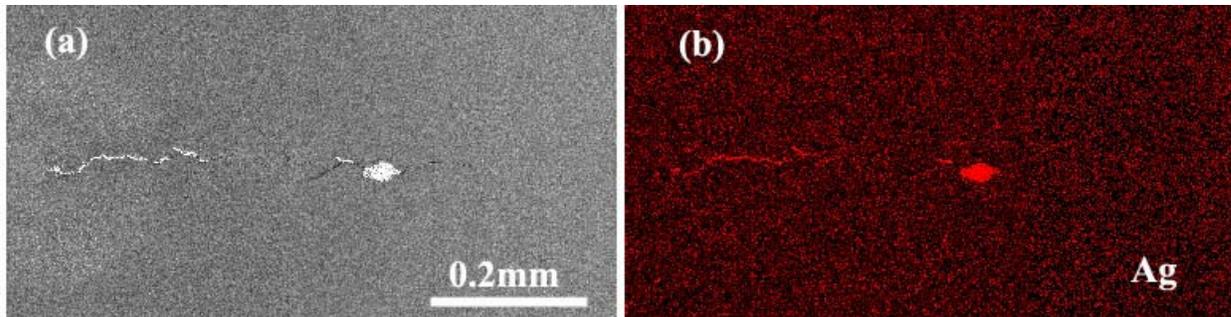
Fig. (5). EDAX image mapping analysis of crack produced at applied stress of 588 MPa for 8 days. (a) SEM image, (b) EDX image mapping of Ag.

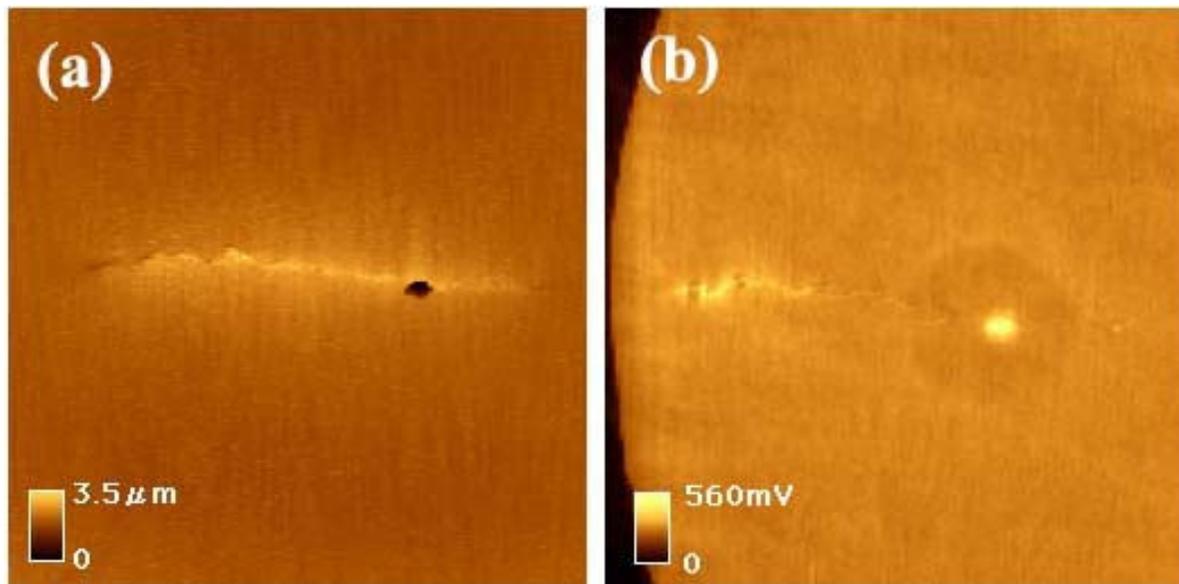
Fig. (6). SKFM image of crack produced at applied stress of 588 MPa for 8 days. Image size: 0.6 mm X 0.6 mm. (a) Topography, (b) potential distribution image.

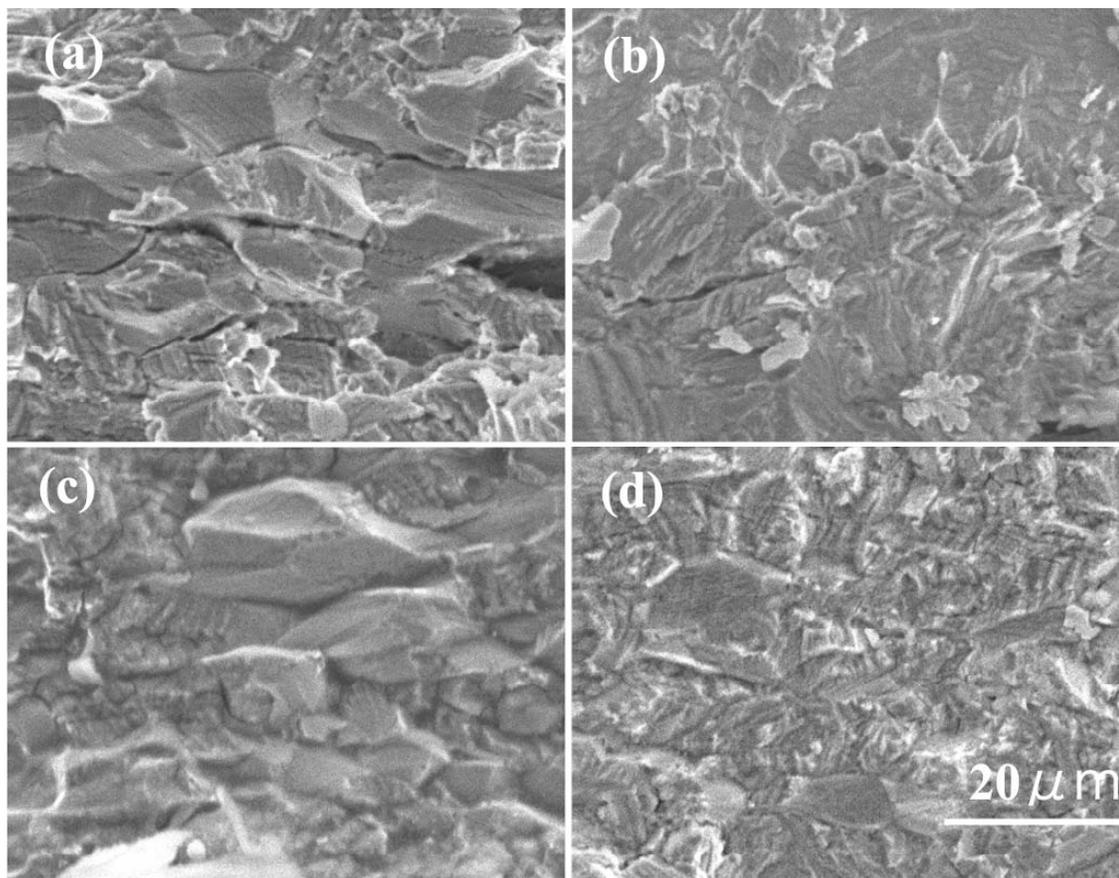
Fig. (7). SEM images of fracture surface produced at applied stress of (a), (b) 1030 MPa for 30 days and (c), (d) 588 MPa for 33 days.

noble potential region. Fig. (7) shows SEM images of the fracture surface produced at applied stress of (a), (b) 1030 MPa for 30 days and (c), (d) 588 MPa for 33 days. Intergranular and transgranular fracture surfaces were observed both on the fracture surface produced at applied stress of 1030 MPa and 588 MPa. No difference was found on the fracture surface produced at applied stress of 1030 MPa and 588 MPa.

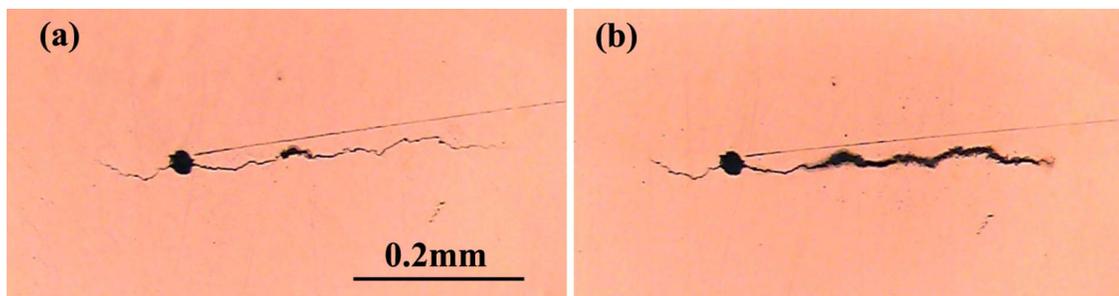
Fig. (8). Optical microscope images of crack produced at applied stress of 515 MPa for 12 days. (a) Before Ag decoration, (b) after Ag decoration.

Fig. (8) shows the optical microscope images of crack (a) before Ag decoration and (b) after Ag decoration. The crack was produced at the applied stress of 515 MPa for 12 days. The crack usually initiated from a pit and propagated to the maximum stress direction (horizontal direction). Ag which is proved by EDX image mapping analysis (Fig. 9) precipitated

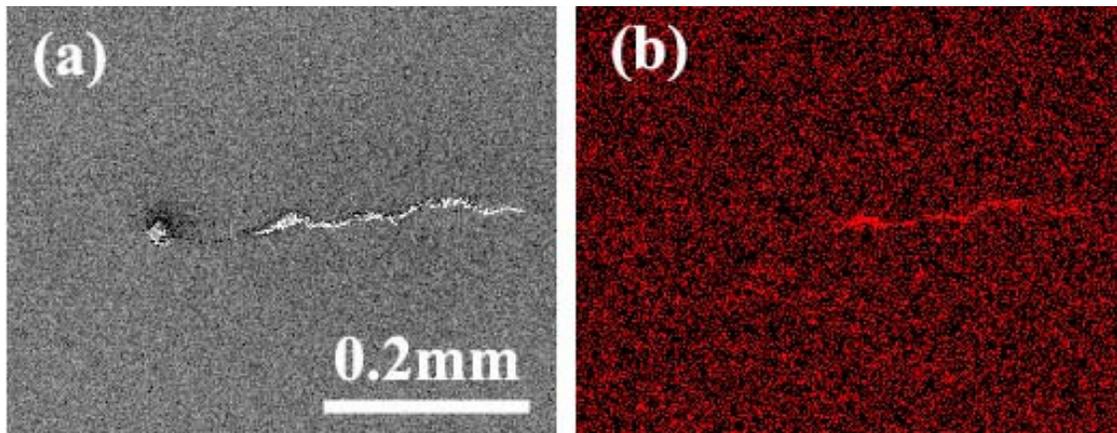
Fig. (9). EDAX image mapping analysis of crack produced at applied stress of 512 MPa for 12 days. (a) SEM image, (b) EDX image mapping of Ag.

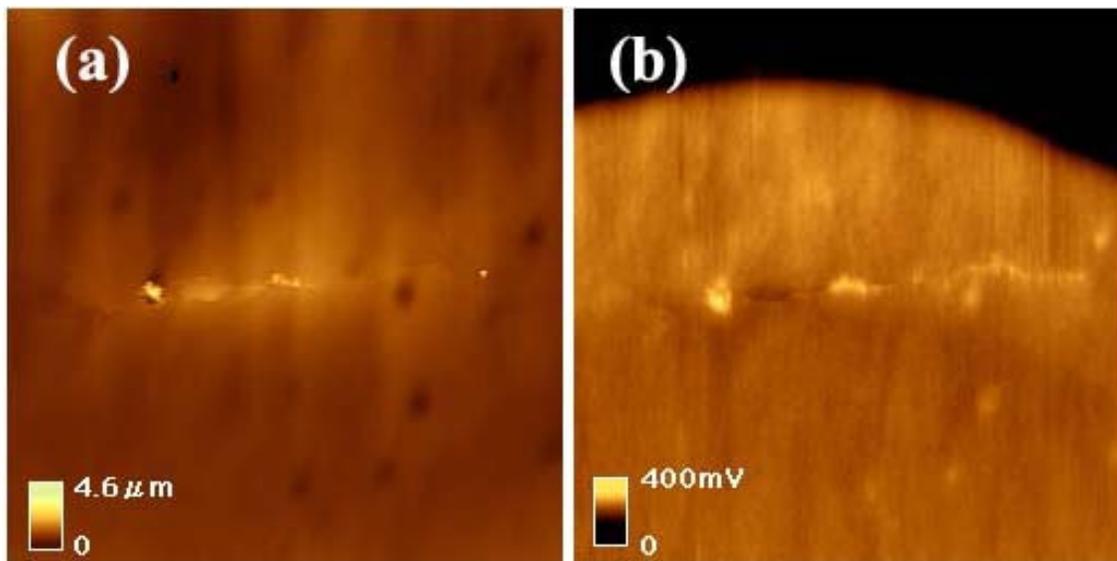
Fig. (10). SKFM images of crack produced at applied stress of 512 MPa for 12 days. Image size: 0.6 mm X 0.6 mm. (a) Topography, (b) potential distribution image.

only right side of the crack. Fig. (10) shows SKFM observation of the crack. Less noble potential region was observed near the crack tip of right side. There is very good correlation between the less noble potential region and the region of Ag precipitation. Thus less noble potential region is closely related to the hydrogen distribution. The effect of hardness on SCC behavior is that the ratio of crack initiation probability is different. That is, cracks initiated from most droplets when HV is 310, while cracks initiated from few droplets when HV is 190.

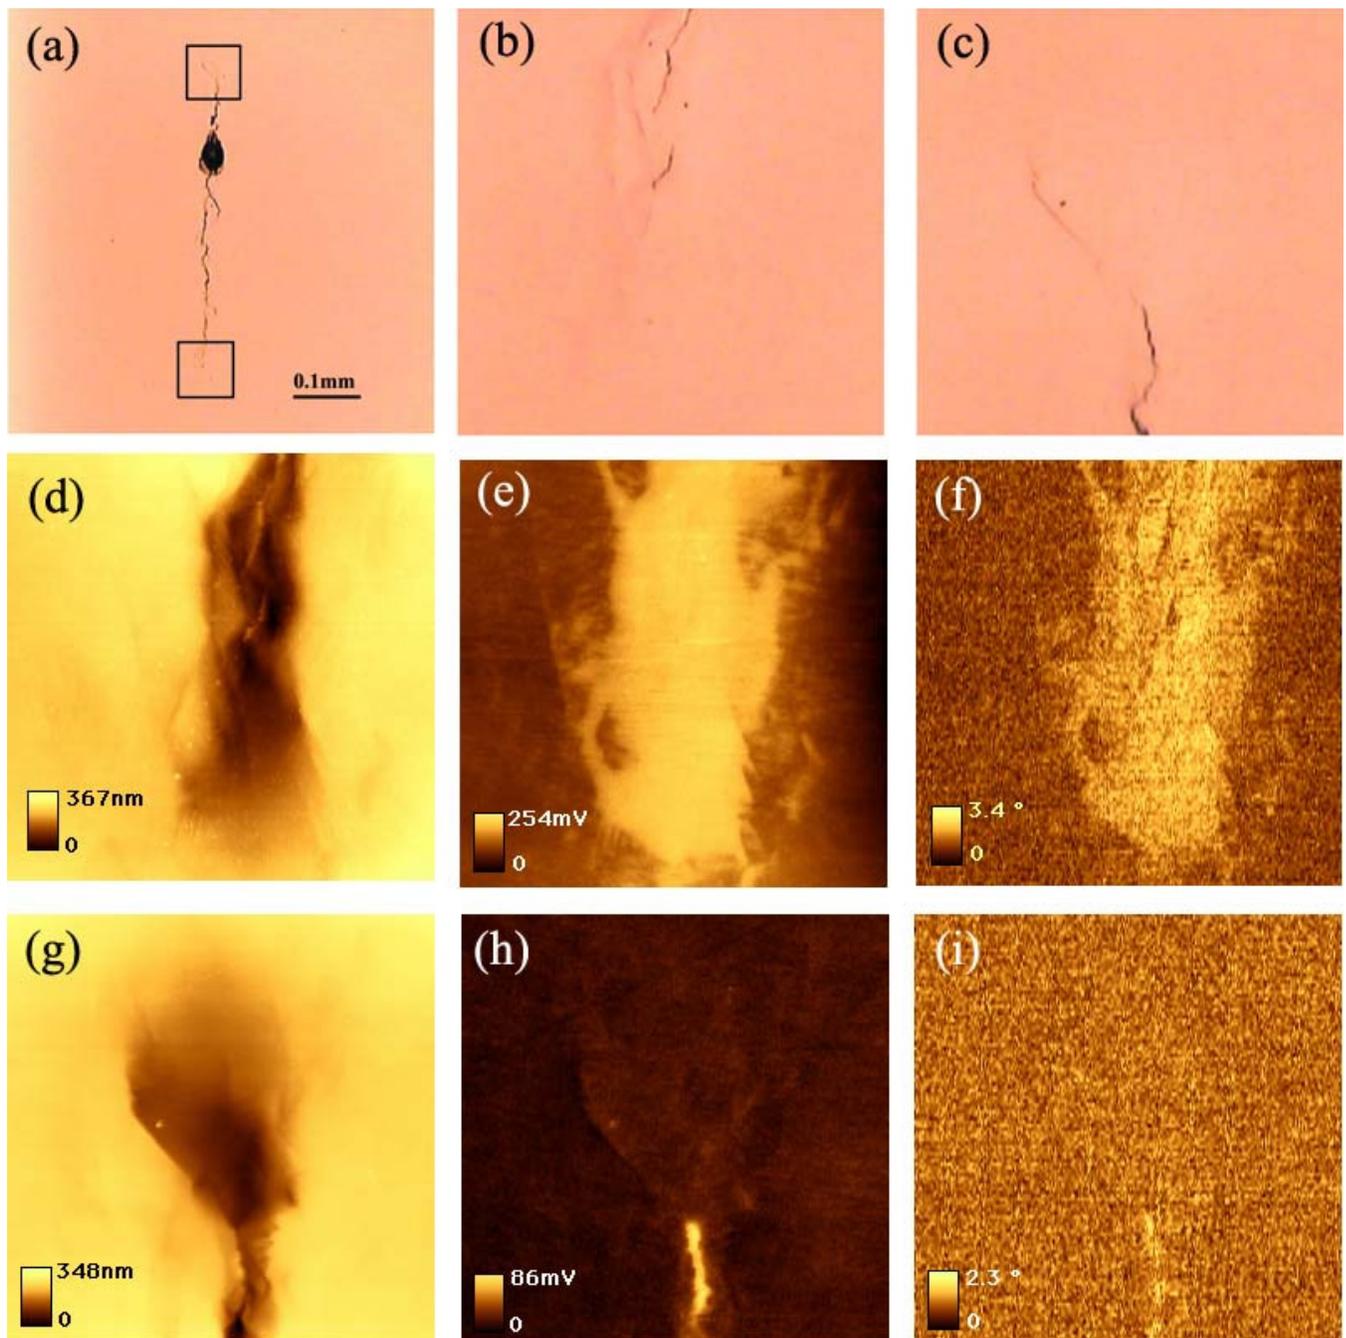
Fig. (11). Images of crack produced at applied stress of 1030 MPa for 4 days. Image size except (a): 0.08 mm X 0.08 mm. Optical microscope image of (a) whole crack and crack tip surrounded by square line (b) at lower part and (c) at upper part in Fig. (11a, d) topography of Fig. (11b, e) potential distribution image, (f) magnetic force distribution image, (g) topography of Fig. (11c, h) potential distribution image, (i) magnetic force distribution image.

Fig. (11) shows the optical microscope images of (a) whole crack and crack tip surrounded by square line (b) at lower part and (c) at upper part in Fig. (11a, d) topography of Fig. (11b, e) potential distribution image, (f) magnetic

force distribution image, (g) topography of Fig. (11c, h) potential distribution image and (i) magnetic force distribution image. The crack was produced at applied stress of 1030 MPa for 4 days. It is clear from the optical microscope image of Fig. (11b, c) that the crack propagates discontinuously. Topography (Fig. 11d) shows that plastic deformation occurs ahead of the crack tip. Less noble potential region was observed around the crack tip in Fig. (11e) and only part of crack in Fig. (11h). MFM observation shows that the less noble potential region corresponds to the region where the attractive force exists. Since the attractive magnetic force does not generate on austenite phase, martensite phase must exist. This martensite is considered hydrogen-induced martensite, since there is no correlation between plastic deformation and martensite phase. The area of martensite phase shown in Fig. (11i) is less than that shown in Fig. (11f). The difference of the area of martensite phase might affect the activity of the crack growth.

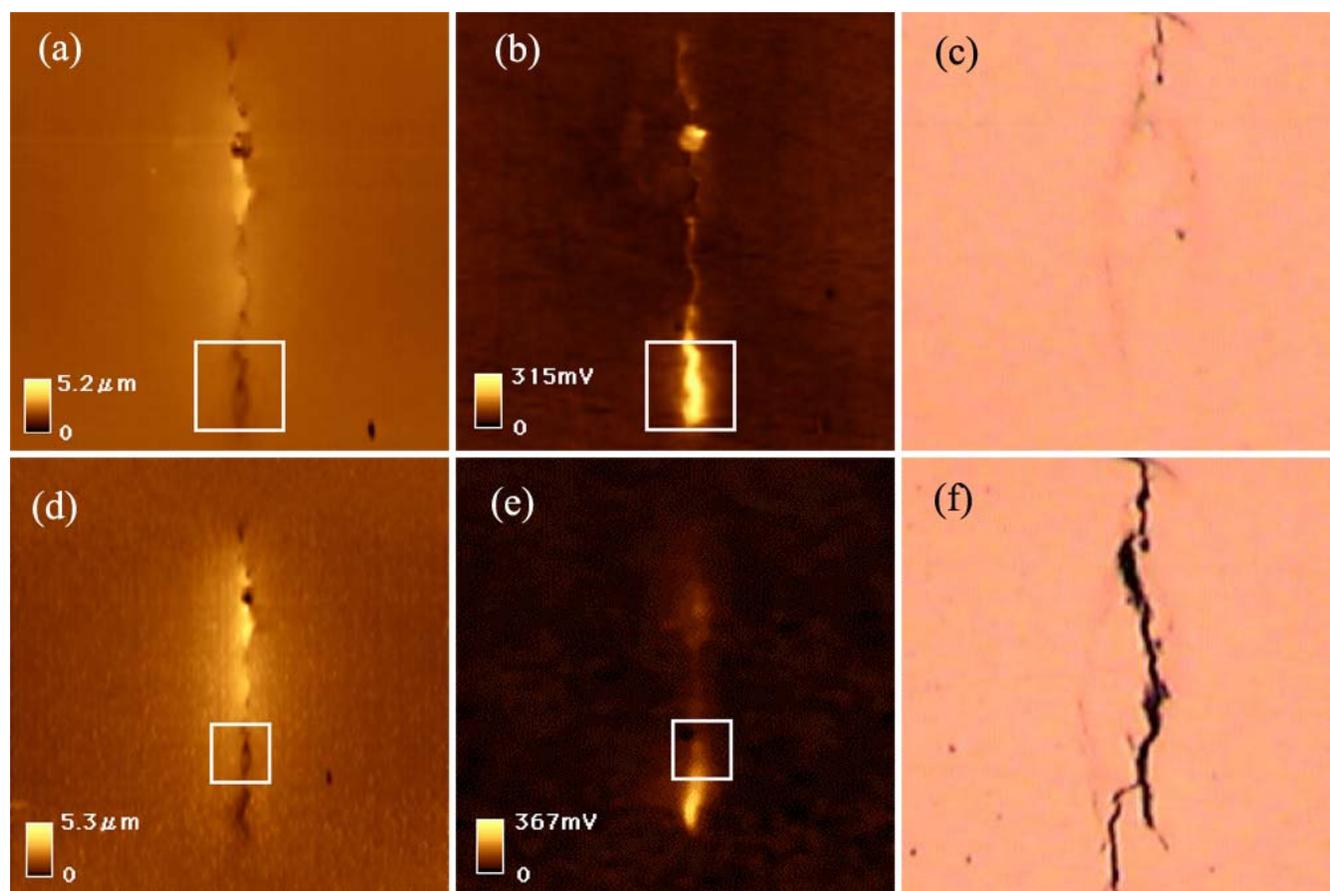
Fig. (12). SKFM images and optical microscope images surrounded by square line in SKFM images. (a) Topography, (b) surface potential distribution image, (c) optical microscope image after 2 days test and (d) topography, (e) surface potential image, (f) optical microscope image after 3 days test. Image size: (a), (b) 0.4 mm X 0.4 mm, (c) 0.08 mm X 0.08 mm, (d), (e) 0.6 mm X 0.6 mm, (f) 0.08 mm X 0.08 mm.

Fig. (12) shows SKFM images of whole crack and optical microscope images surrounded by square line in

SKFM images. The optical microscope images shown in Fig. (12) are the same place. Less noble potential region was observed ahead of the crack tip where plastic deformation occurs (Fig. 12b) after 2 days loading test. Crack was not formed at this moment (Fig. 12c). Less noble potential region moved as a new plastic deformation occurred (Fig. 12e) after 3 days loading test. Then crack was formed (Fig. 12f). The less noble potential region corresponds to the hydrogen-induced martensite phase as shown in Fig. (11), so the movement of less noble potential region indicates the movement of hydrogen. Thus crack was formed when hydrogen moved.

Narita *et al.* [15] studied hydrogen-related phase transformations in austenitic stainless steel by using X-ray diffraction technique and reported that volume increase occurs and compressive stress generates when hydrogen is charged on austenitic stainless steel, and tensile stress generates when charged hydrogen is lost by aging. From repeated SKFM observations as shown in Fig. (12), it is clear that hydrogen tends to accumulate in the plastic deformation
