Iatrogenic Damage to the Periodontium Caused by Endodontic Treatment Procedures: An Overview

Aishwarya Bhat^{1,*}, Syed Sirajuddin², Sandeep S. Prabhu², Sachidananda Chungkham² and Chandrasekhar Bilichodmath²

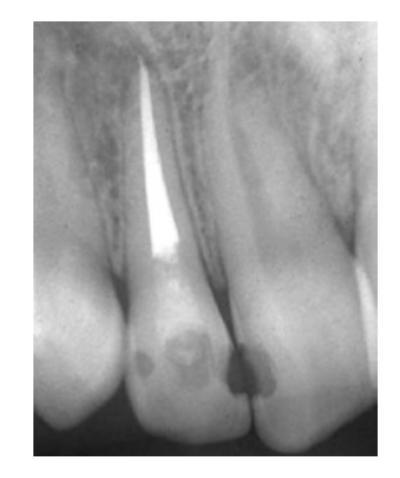
Fig. (1). Periapical radiograph shows overfilling: zinc oxide eugenol, inflicting severe pain to patients.

The effect of overfilling is varied (Figs. 1, 2), determined by the filling substance, filling substance's quantity which passes the apical foramen, and how far the filling substance surpasses the apical foramen. Based on these three factors, the most common effects of overfilling are inflammation reaction of the periapical tissue causing severe pain accompanied by swollen tissue, periodontal ligament breakage, and a periapical lesion [6]. Other effects are necrosis of alveolar bone in the periapical area of the discoloration mucosa membrane covering tooth apex, or even a neurological difficulty such as paraesthesia.

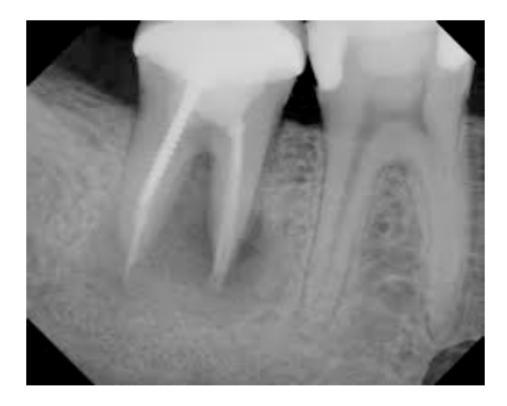
Fig. (2). Iopa of second molar of the lower jaw shows overfilling with guttapercha cone causing abscess and paresthesia.

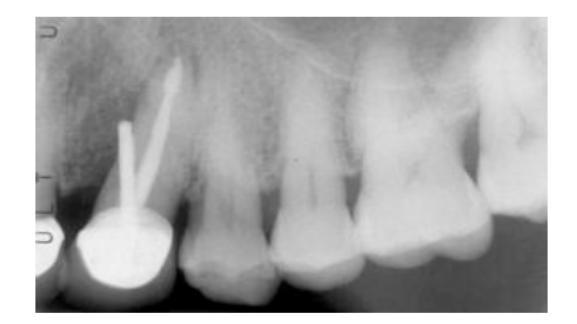
Perforations of the floor of the pulp chamber or root during access (Fig. 3), canal instrumentation or preparation for a post.

These accidents may result in periodontal defects and treatment should be given as soon as the perforation occurs. The healing of the periodontal lesion depends on whether the bacterial infection can be excluded from the wound by obturation of the site of perforation. If a perforation occurs in the cervical portion of the tooth, a surgical flap approach provides enough access to expose perforation and allow a successful seal. But a guarded prognosis is given for such tooth as the lateral perforation is difficult to seal. Additional problems are root resorption and vertical root fracture.

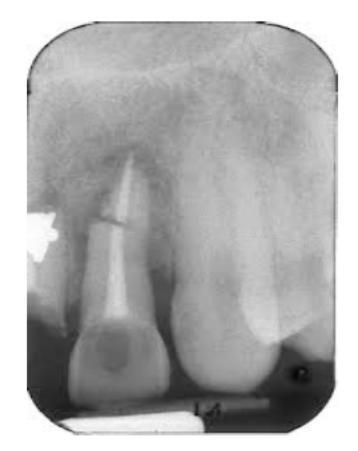
Fig. (4). Root fractures.

Root Fractures (Fig. 4) caused by traumatic forces or restorative endodontic procedures may lead to periodontal involvement through an apical migration of plaque along the fracture when the fracture originates coronal to the clinical attachment and is exposed to the oral environment.
