The Open Civil Engineering Journal

Monitoring of Dynamic Strain Response in Concrete Structure Based on Piezoelectric Sensors

Lei Qin^{*}, Enrong Wang, Qi Qin, Taochun Yang and Feng Gao

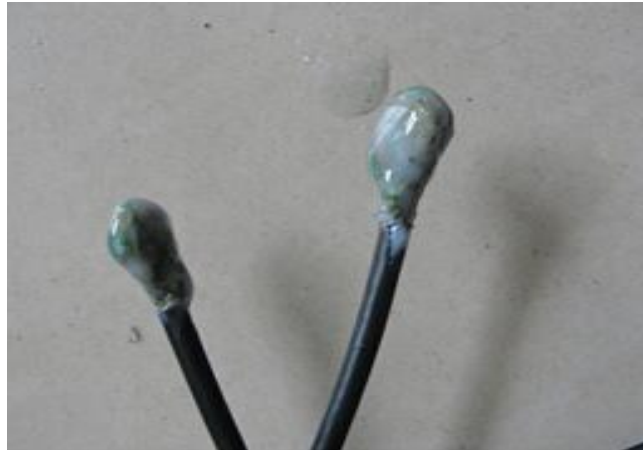
Fig. (1). Piezoelectric sensor.

The piezoelectric sensors in this paper were made of PZT-5 piezoelectric ceramics. First, the opposite electrodes of the piezoelectric ceramic element were connected with coaxial cable by conductive silver paint. Then, the piezoelectric was packaged with epoxy. The piezoelectric sensors were shown in Fig. (1). Before the piezoelectric sensors were embedded into concrete, they should be calibrated. In the calibration, the sensor was embedded into a concrete block of $100 \times 100 \times 100$ mm, the concrete specimen was shown in Fig. (2).

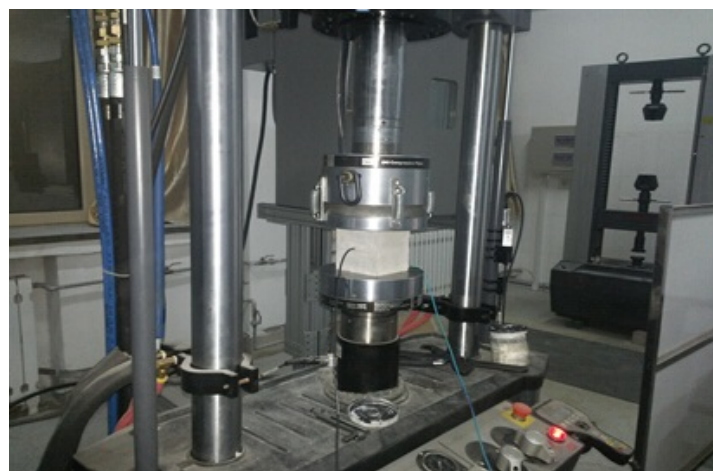
Fig. (3). MTS loading specimen.

As shown in Fig. (3), the concrete block was subjected to two kinds of cyclic loading (by MTS-250 loading

machine). When sine load amplitude (equilibrium of 50 kN, amplitude of 20 kN) remained unchanged, the loading frequency varied from 1 Hz to 35 Hz; When sine load frequency remained unchanged (load frequency of 10 Hz, equilibrium value of 35 kN), the load amplitude varied from 5k N to 25 kN. In this test, data was acquired by TPS2024 oscilloscope.

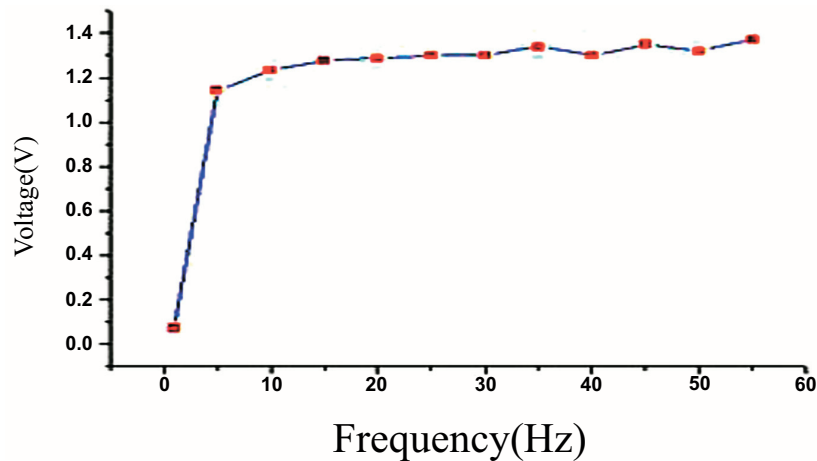
Fig. (4). The test data of piezoelectric sensor.

The test results of sensors were shown in Fig. (4) and Fig. (5). In Fig. (4), when sine load amplitude remained unchanged, voltage raised in the range of 1 Hz to 10 Hz sharply and changed slightly in the range of 10 Hz to 35 Hz. This showed that the embedded piezoelectric sensors had a sensitive frequency response. In Fig. (5), when sine load frequency (10 Hz) was unchanged, the voltage changed linearly with the amplitude of load. It showed that the embedded piezoelectric sensors had a good linear output.

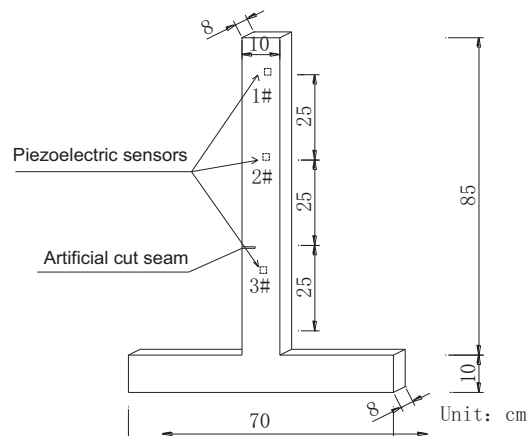
Fig. (6). Concrete cantilever beam and sensors arrangement.

The reinforcing steel bar with diameter of 8 mm was embedded in concrete. In the concrete cantilever beam, three embedded piezoelectric sensors were used. The cantilever beam model was shown in Fig. (6). Before the artificial damage, the natural vibration frequency of the cantilever beam was about 27 Hz.

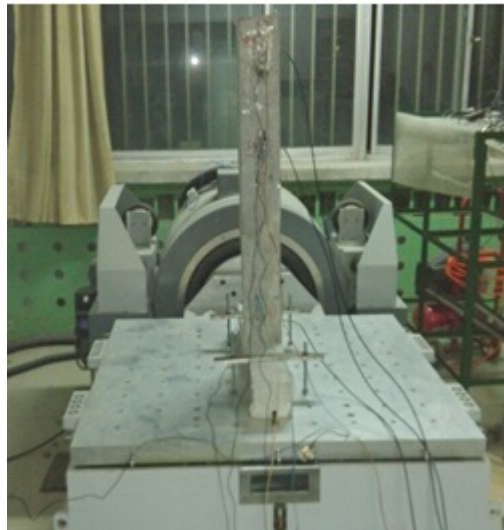
Fig. (7). Horizontal vibration system of concrete cantilever beam.

The transient sine load applied to the concrete cantilever beam was provided by horizontal vibration system. The horizontal vibration system (SC-1010 of Suzhou test instrument) was shown in Fig. (7). In experiment, there were two kinds of loading conditions:

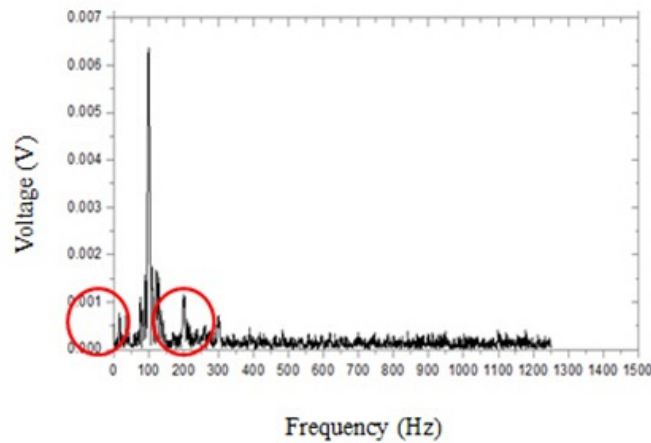
Fig. (11). The FFT of output signal of 1 # sensor.

From the values, it can be seen that the transient sine load system excitation signal and output signal of the 1[#] embedded piezoelectric sensor had the same time interval of 0.15s with the same dominant frequency of 100 Hz. In other words, the output signal of the embedded piezoelectric sensor was basically consistent with the transient excitation signal of SC-1010 system. In addition, in Fig. (11), the output model of 1[#] embedded piezoelectric sensor was only affected by the instrument noise in the range of 200 Hz to 300 Hz, but the output noise value was small. It proved that the embedded piezoelectric sensor had good noise immunity.

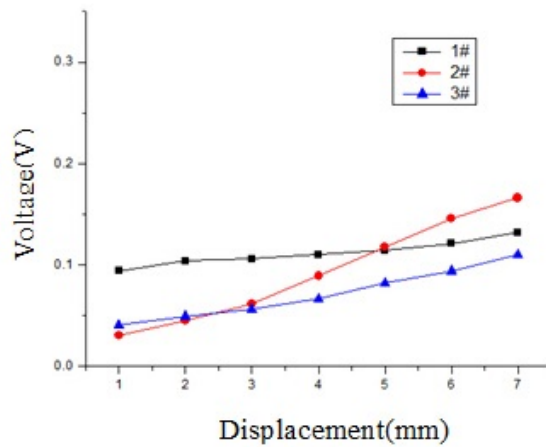
The test data of the concrete cantilever beam in condition 1 before the cantilever beam damaged was shown in Fig. (12). The test data of condition 2 was shown in Fig. (13). When loading displacement of the horizontal vibration was constant, the structural internal force was invariant, too. In Fig. (12), it can be seen that the signal voltage of the embedded piezoelectric sensors changed little with the increasing of the load frequency. It proved that the piezoelectric sensor had good broadband response. Seen from Fig. (13), when the load frequency was constant, the output amplitude of the embedded piezoelectric sensor increased linearly with the increase of the load. It showed that the piezoelectric sensors had a go

Fig. (13). The signal of changing amplitude good linear output.

Comparing values of Fig. (15) and Fig. (13), because of the change of the stiffness in the structure, the deformation of structure was changed from the elastic stage to the elastic-plastic stage. And there was a peak value of the voltage when the loading displacement was 3 mm. When the structure was damaged, the natural vibration frequency changes of the structure could be monitored by measuring the structural dynamic stress response with the piezoelectric materials.

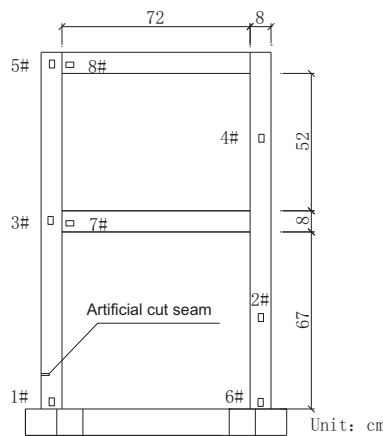
Fig. (16). Concrete frame and sensor arrangement.

Eight piezoelectric sensors were embedded in the concrete frame model. The concrete frame model was shown in Fig. (16). It could be calculated that the first-order natural vibration frequency of the concrete frame model was about 48 Hz. The first-order vibration schematic diagram of the concrete frame model was shown in Fig. (17).

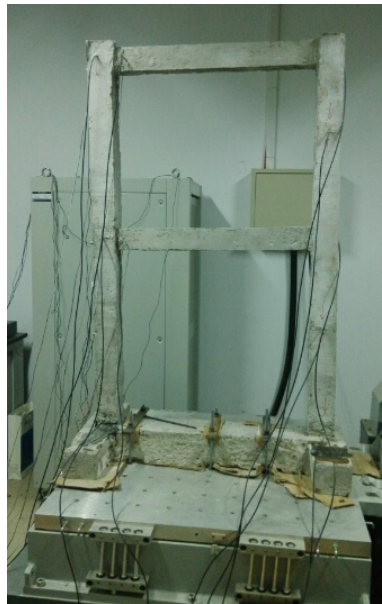
Fig. (18). Fixation of concrete frame.

The procedure of dynamic test of concrete frame was similar to the sine load test of concrete cantilever beam. The concrete frame was shown in Fig. (18).

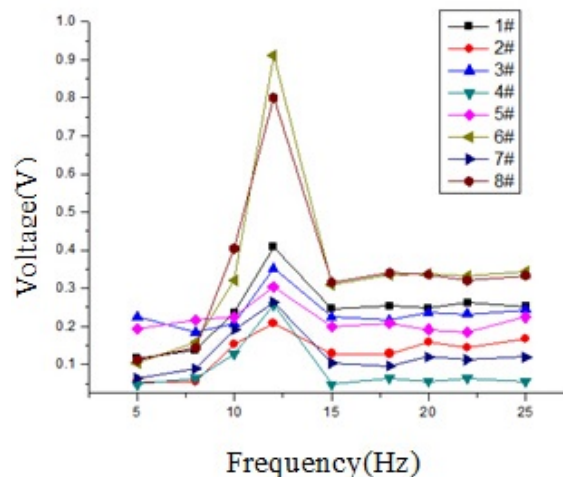
Fig. (19). The signal of changing frequency test.

The test data of Condition 1 for the concrete frame after damaged was shown in Fig. (19). The test data of Condition 2 was shown in Fig. (20).

From the Fig. (19), in the range of 5 Hz to 10 Hz, the output voltage of the piezoelectric sensors increased slightly with the increasing of the loading frequency. In the range of 15 Hz to 20 Hz, the voltage amplitude of the piezoelectric output was no longer changed and kept constant with the increase of the loading frequency. In addition, when the structure was damaged, the first-order natural vibration frequency of the structure changed from 48 Hz to 12 Hz. Seen from Fig. (20), when the load frequency was constant, the output voltage of the piezoelectric output was almost linear with the increase of the load.
